Status of nuclear power plants in Fukushima as of 16:00 March 28 (Estimated by JAIF)

Status of the Nuclear Power Plants after the Earthquake

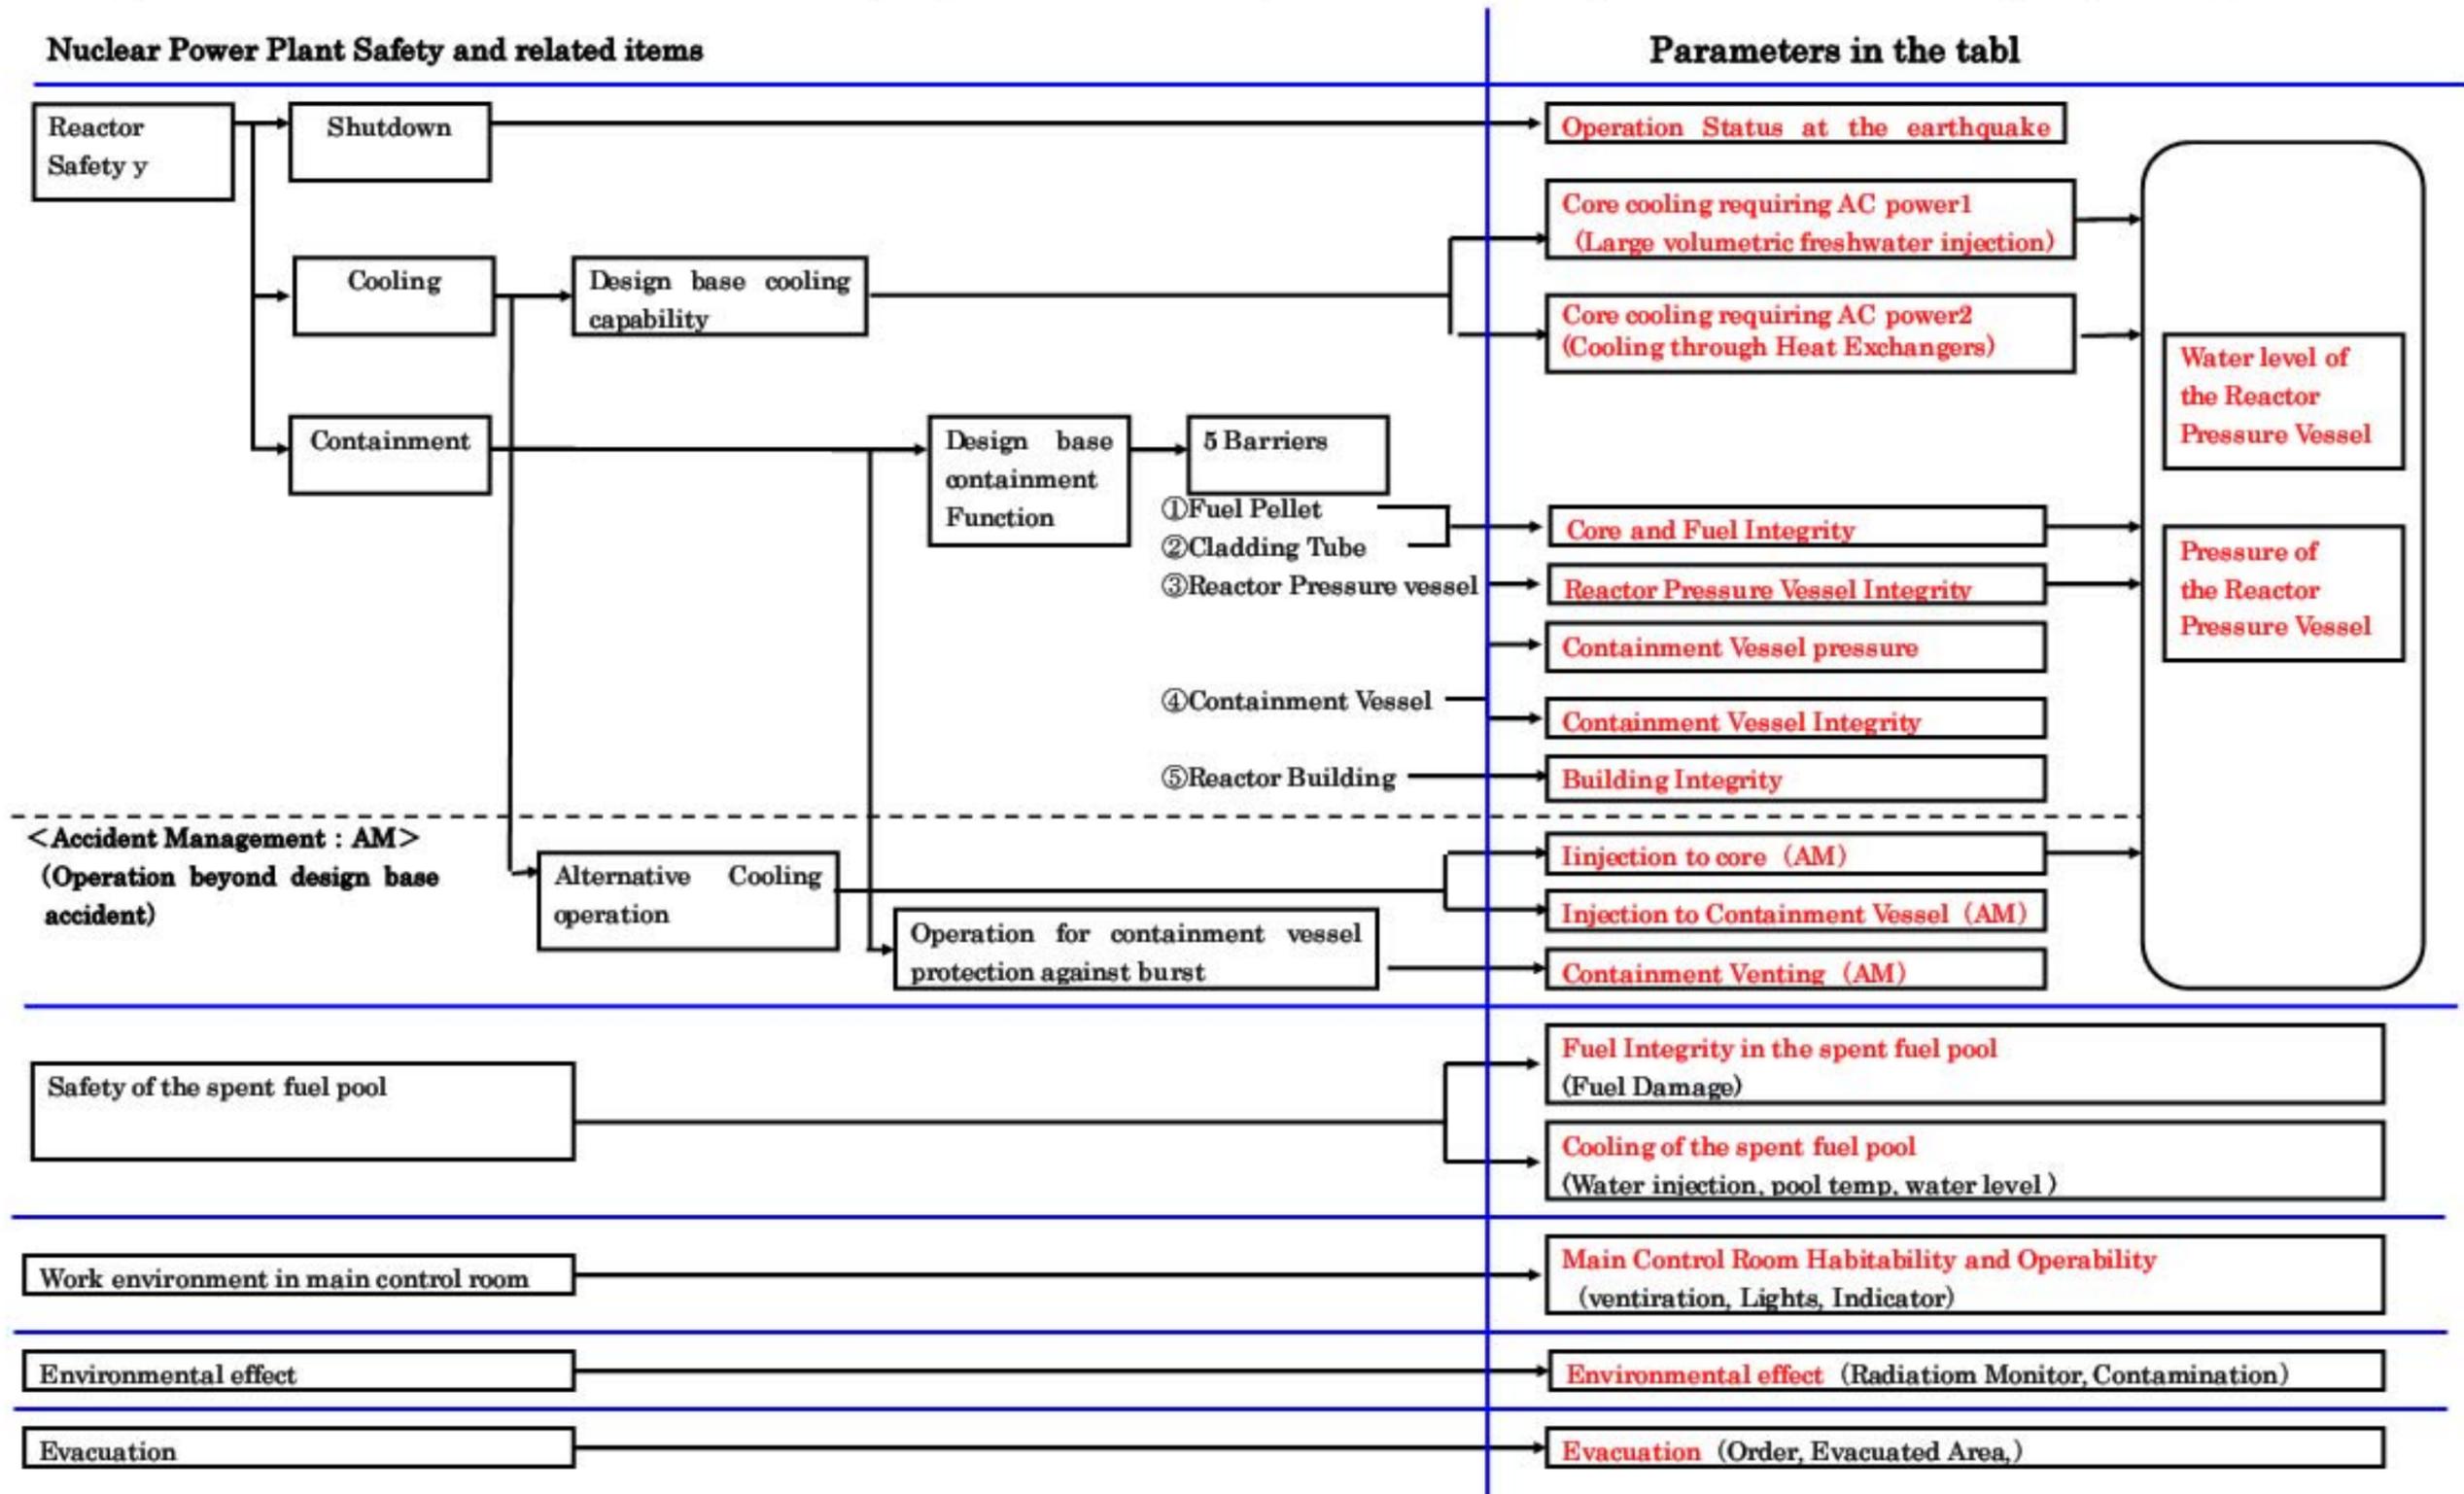
JAIF picks up these parameters to evaluate safety condition of the nuclear plants during this accident from the view point of the principles of nuclear power plant safety, which are "Shutdown", "Cooling" and "Containment". Then we create the chart. The following diagram is to show the correspondence relation of these parameters in the table to nuclear power plant safety.
