# Information on Status of Nuclear Power Plants in Fukushima

Japan Atomic Industrial Forum, Inc.

**Status of nuclear power plants in Fukushima as of 12:00, May 6th (Estimated by JAIF)**

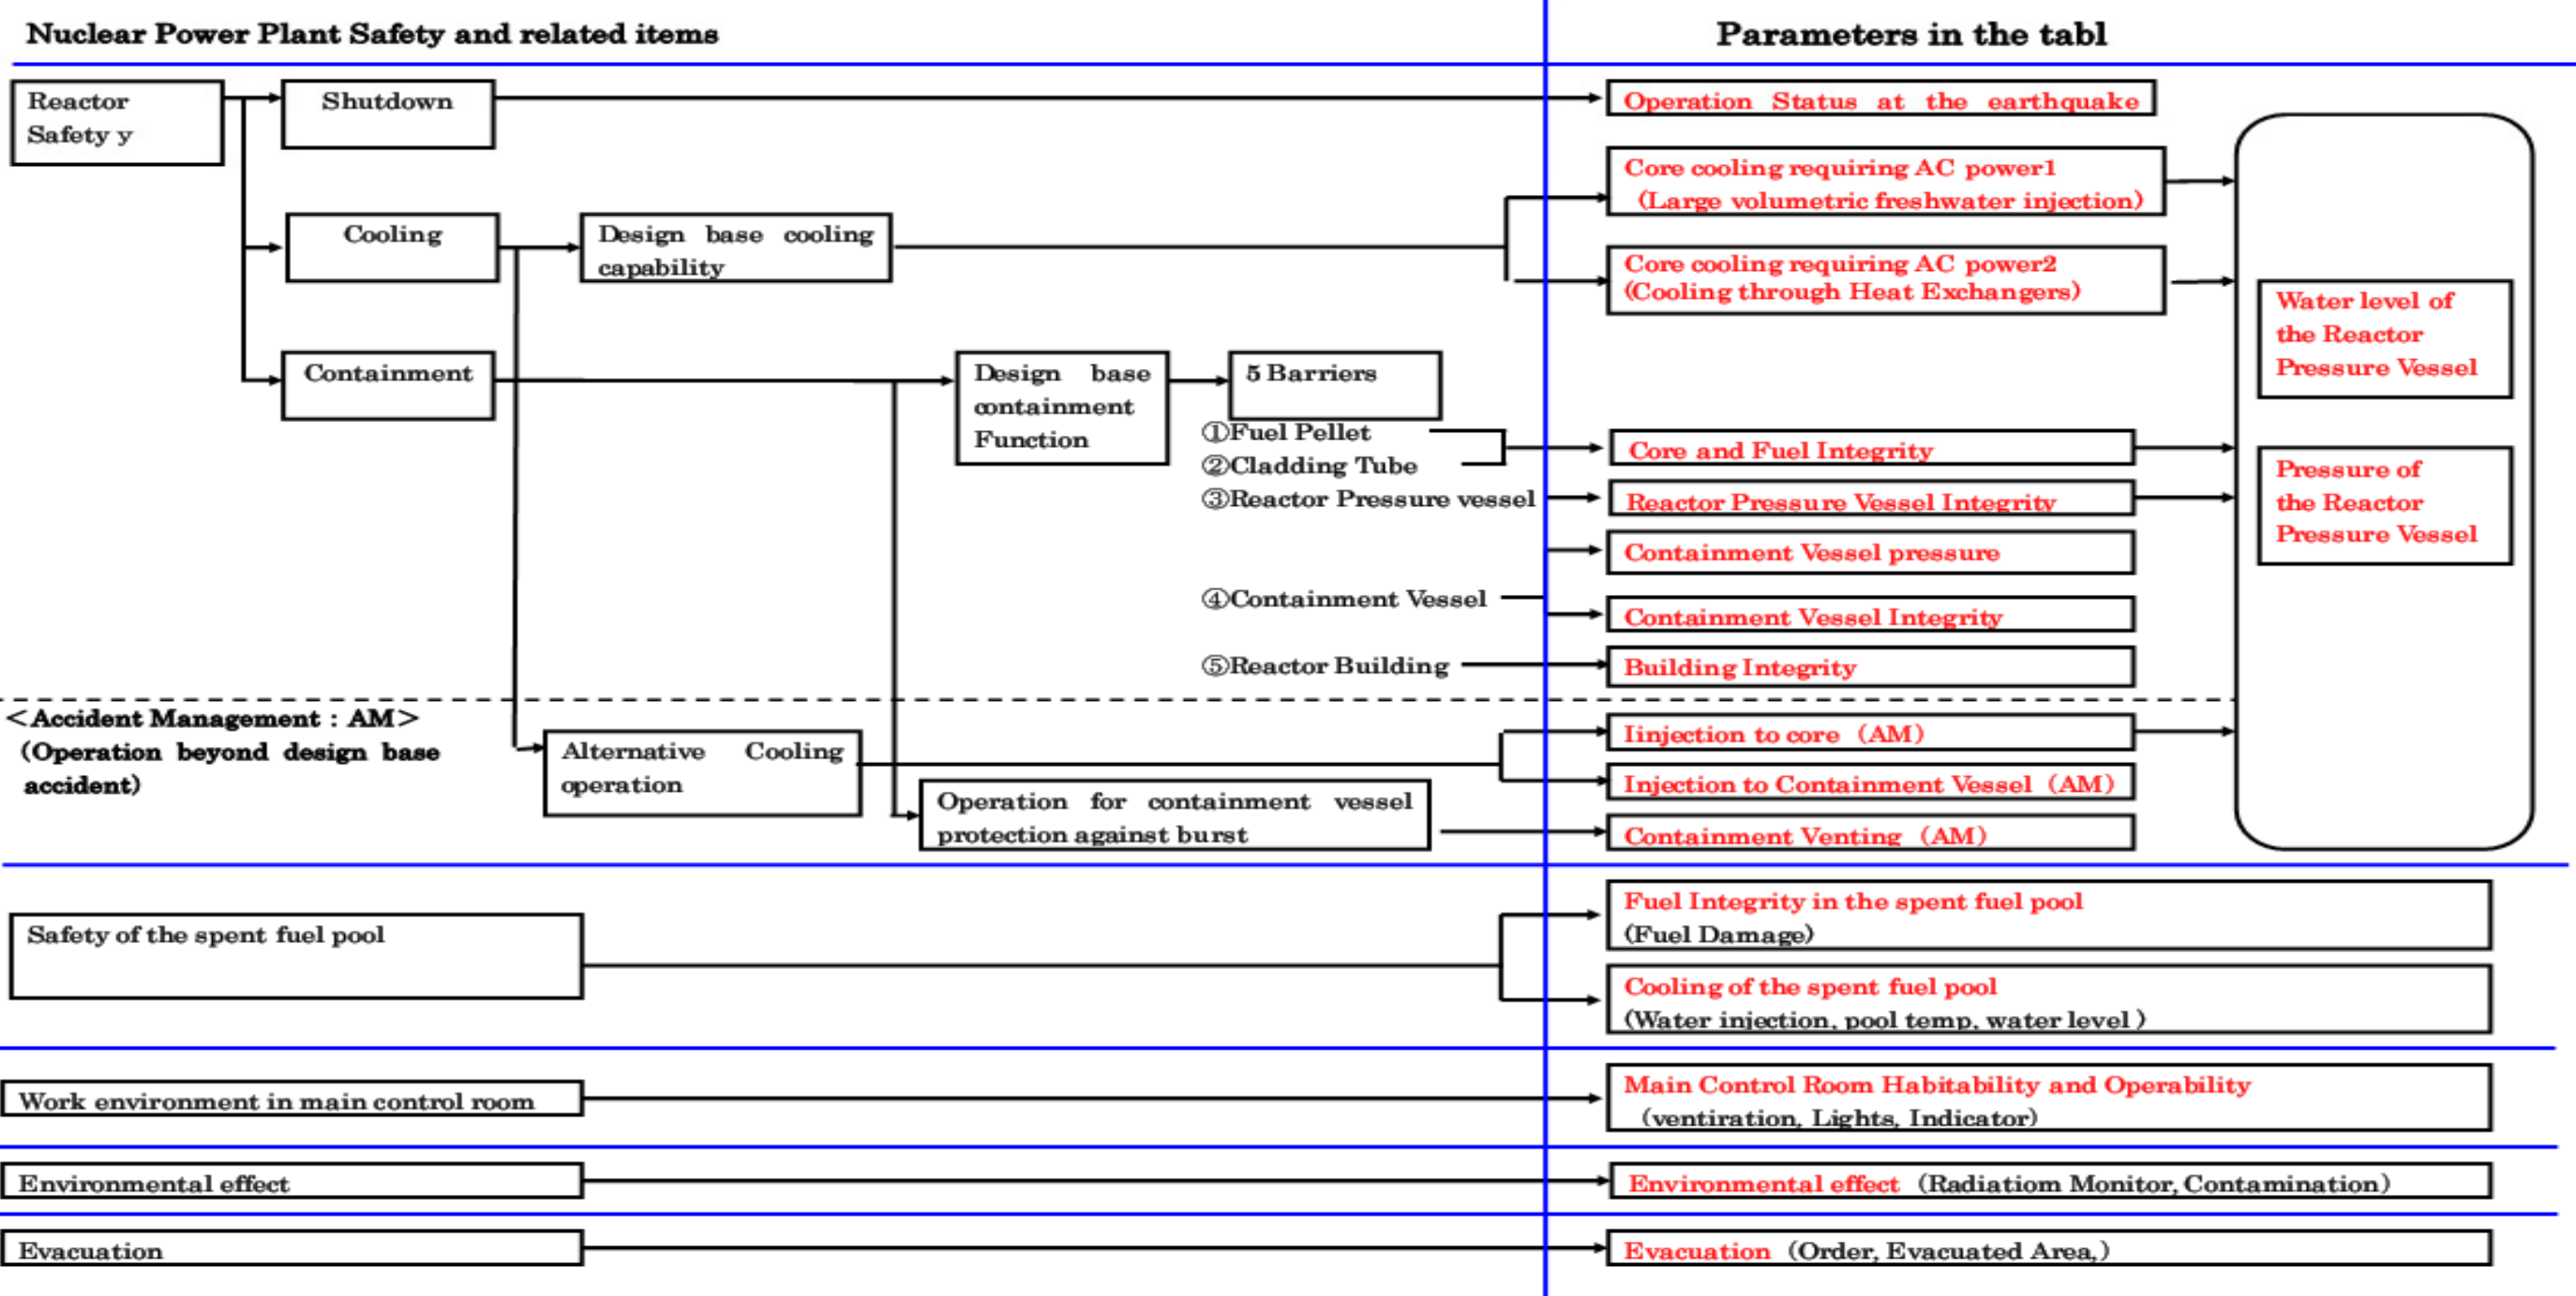
JAIF picks up these parameters to evaluate safety condition of the nuclear plants during this accident from the view point of the principles of nuclear power plant safety, which are "Shutdown", "Cooling" and "Containment". Then we create the chart. The following diagram is to show the correspondence relation of these parameters in the table to nuclear power plant safety.
