Information on Status of Nuclear Power Plants in Fukushima

Japan Atomic Industrial Forum, Inc.

Status of nuclear power plants in Fukushima as of 12:00, May 26th (Estimated by JAIF)

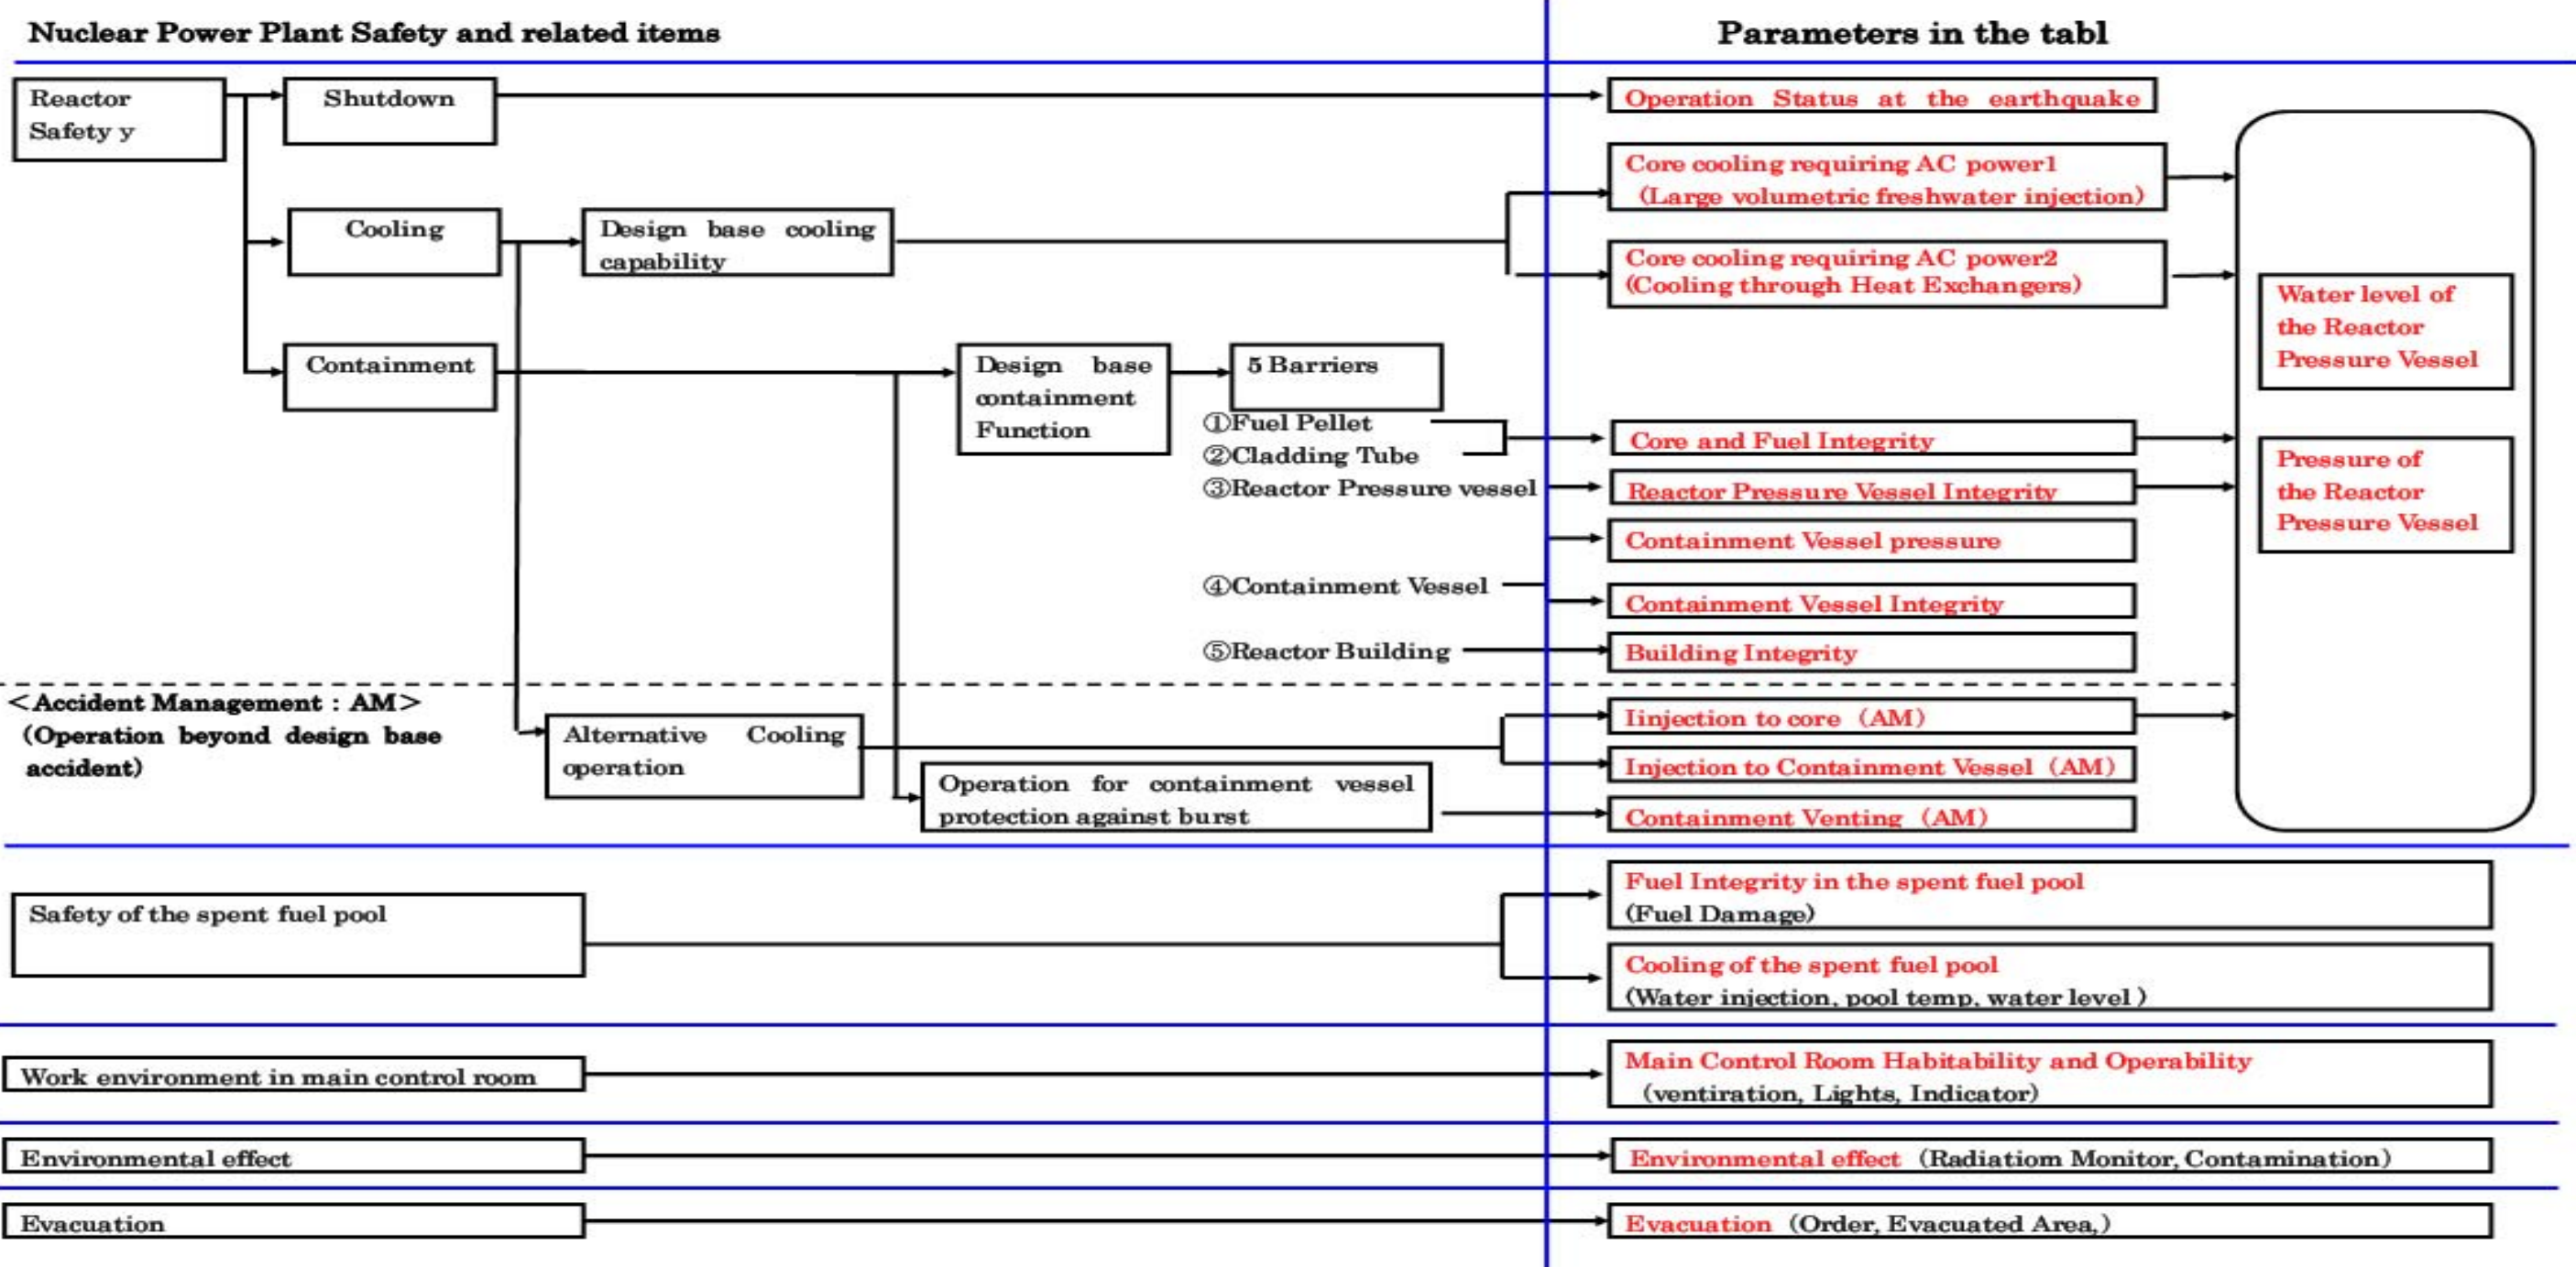
Parameters in the Table

JAIF picks up these parameters to evaluate safety condition of the nuclear plants during this accident from the view point of the principles of nuclear power plant safety, which are "Shutdown", "Cooling" and "Containment". Then we create the chart. The following diagram is to show the correspondence relation of these parameters in the table to nuclear power plant safety.
