# Information on Status of Nuclear Power Plants in Fukushima

Japan Atomic Industrial Forum, Inc.

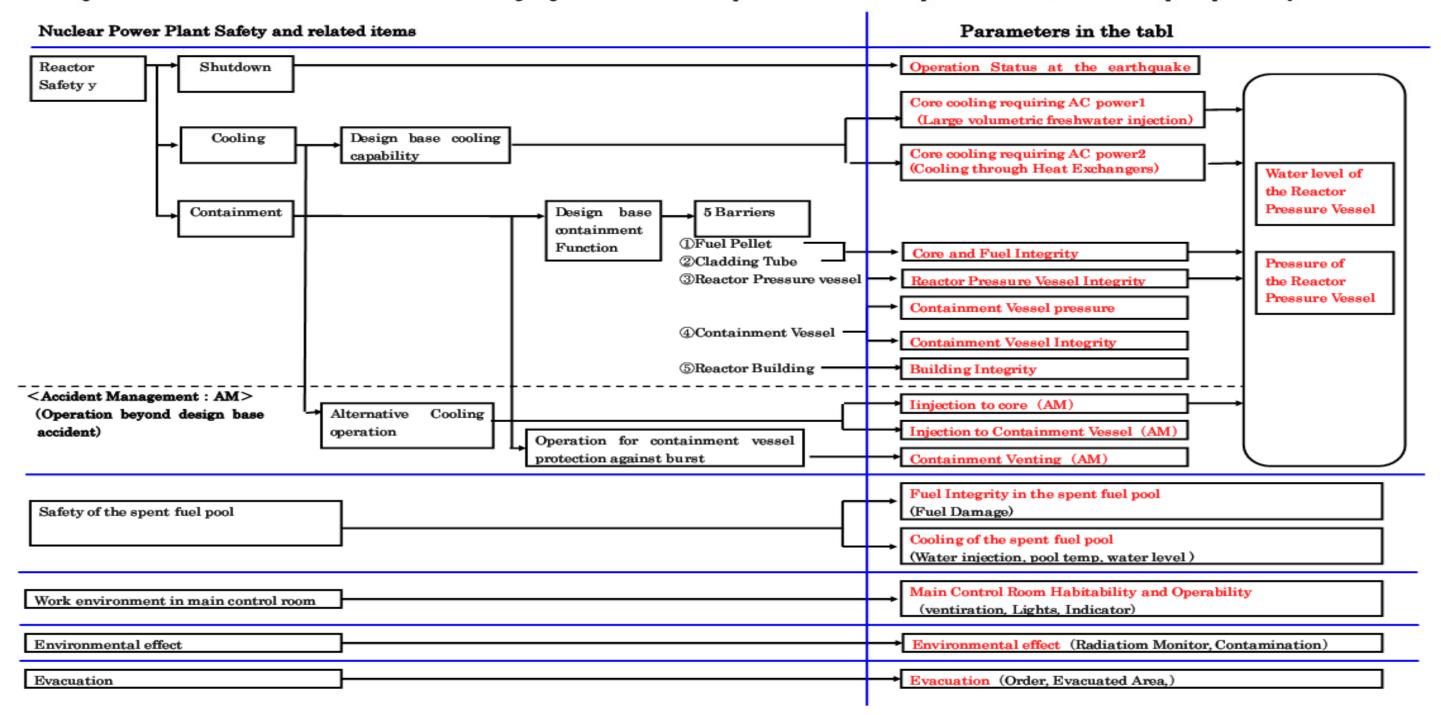
### Parameters in the Table

JAIF picks up these parameters to evaluate safety condition of the nuclear plants during this accident from the view point of the principles of nuclear power plant safety, which are "Shutdown", "Cooling" and "Containment". Then we create the chart. The following diagram is to show the correspondence relation of these parameters in the table to nuclear power plant safety.
