Information on Status of Nuclear Power Plants in Fukushima

Japan Atomic Industrial Forum, Inc.

Status of nuclear power plants in Fukushima as of 12:00, June 2nd (Estimated by JAIF)

Accidents of Fukushima Daiichi Nuclear Power Stations

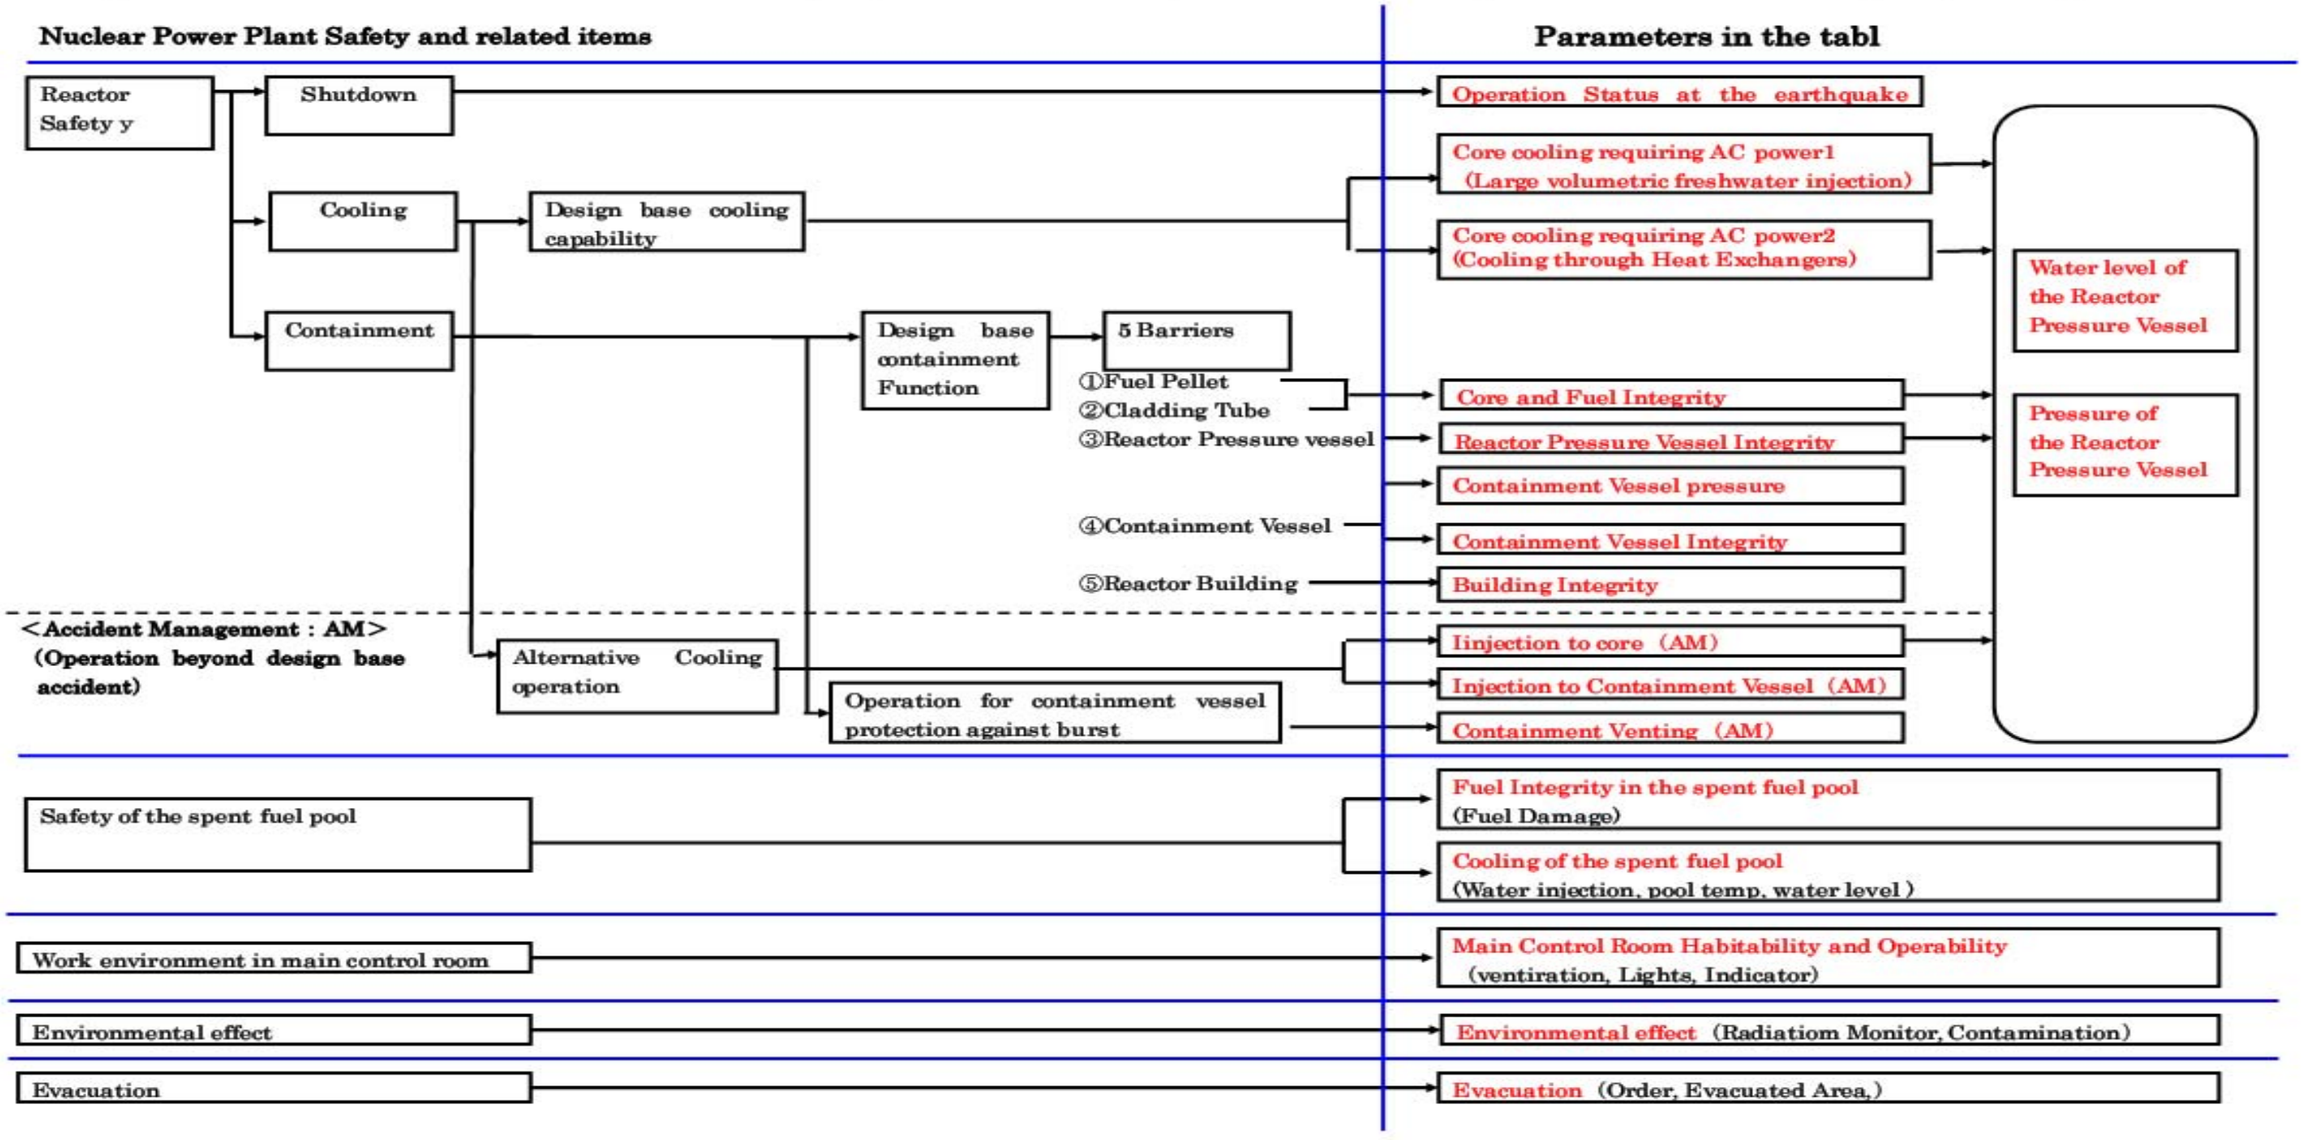
Parameters in the Table

JAIF picks up these parameters to evaluate safety condition of the nuclear plants during this accident from the view point of the principles of nuclear power plant safety, which are "Shutdown", "Cooling" and "Containment". Then we create the chart. The following diagram is to show the correspondence relation of these parameters in the table to nuclear power plant safety.
