# Information on Status of Nuclear Power Plants in Fukushima

Japan Atomic Industrial Forum, Inc.

**Status of nuclear power plants in Fukushima as of 10:00, April 10th (Estimated by JAIF)**

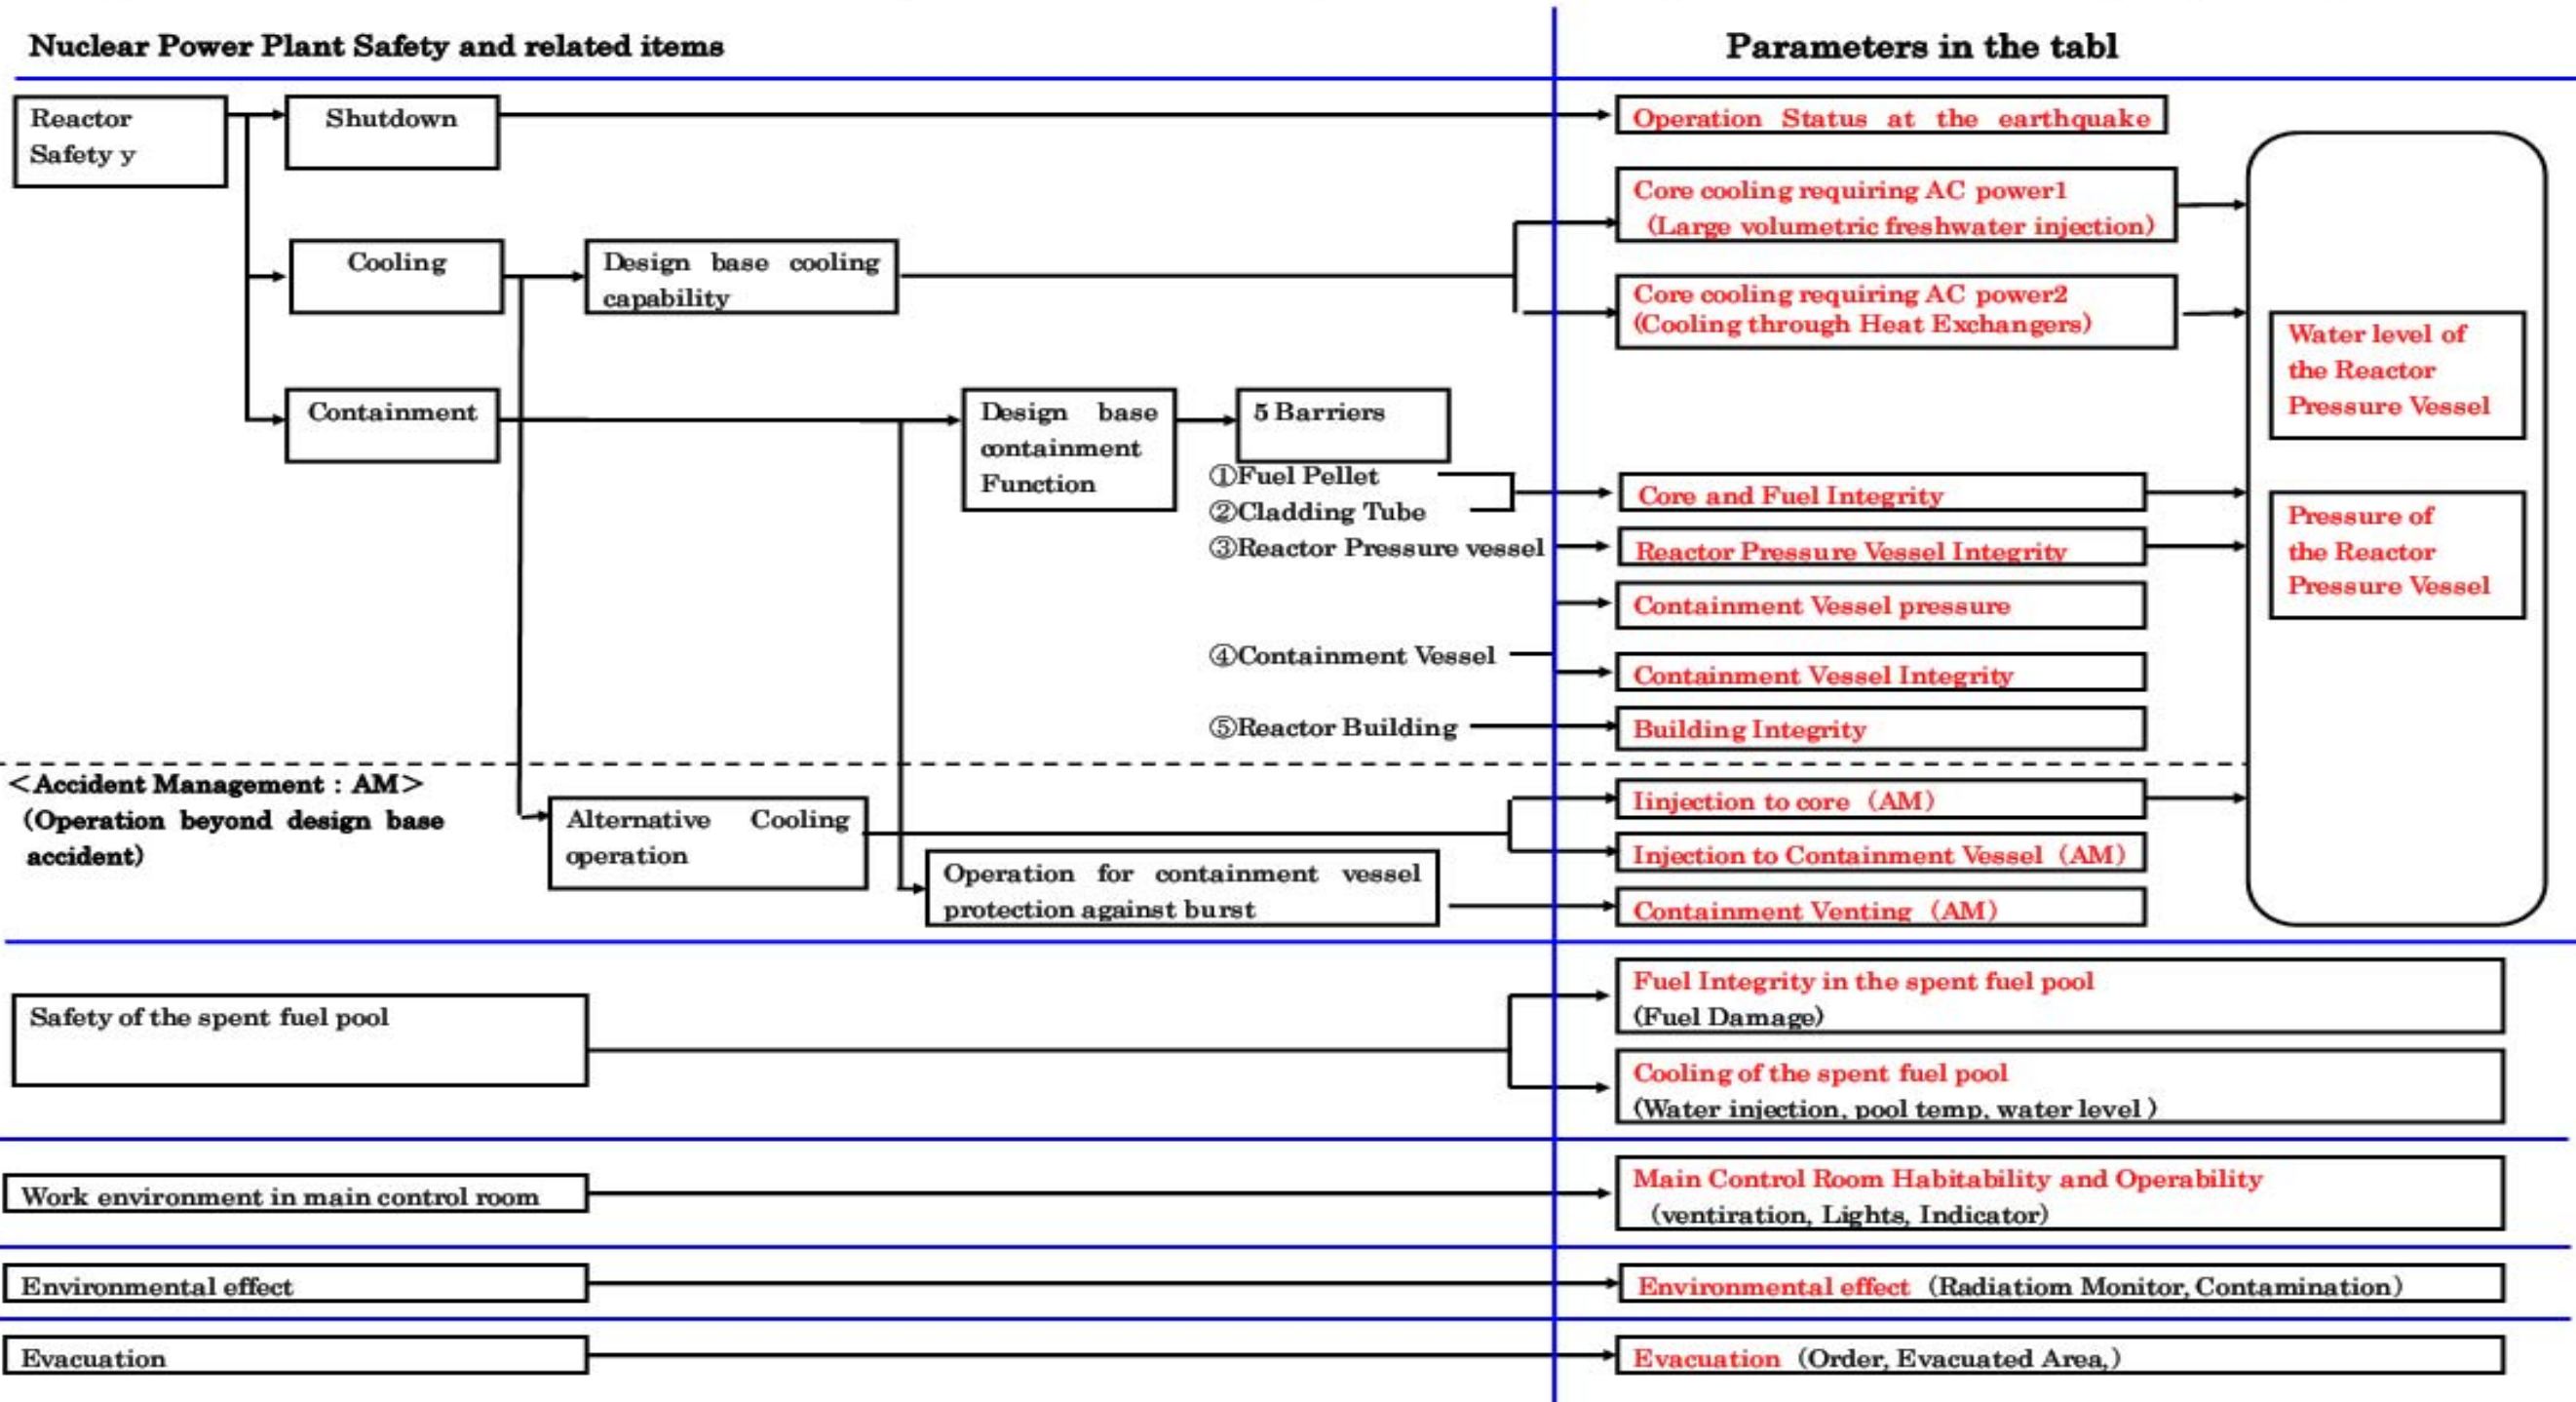
JAIF picks up these parameters to evaluate safety condition of the nuclear plants during this accident from the view point of the principles of nuclear power plant safety, which are "Shutdown", "Cooling" and "Containment". Then we create the chart. The following diagram is to show the correspondence relation of these parameters in the table to nuclear power plant safety.

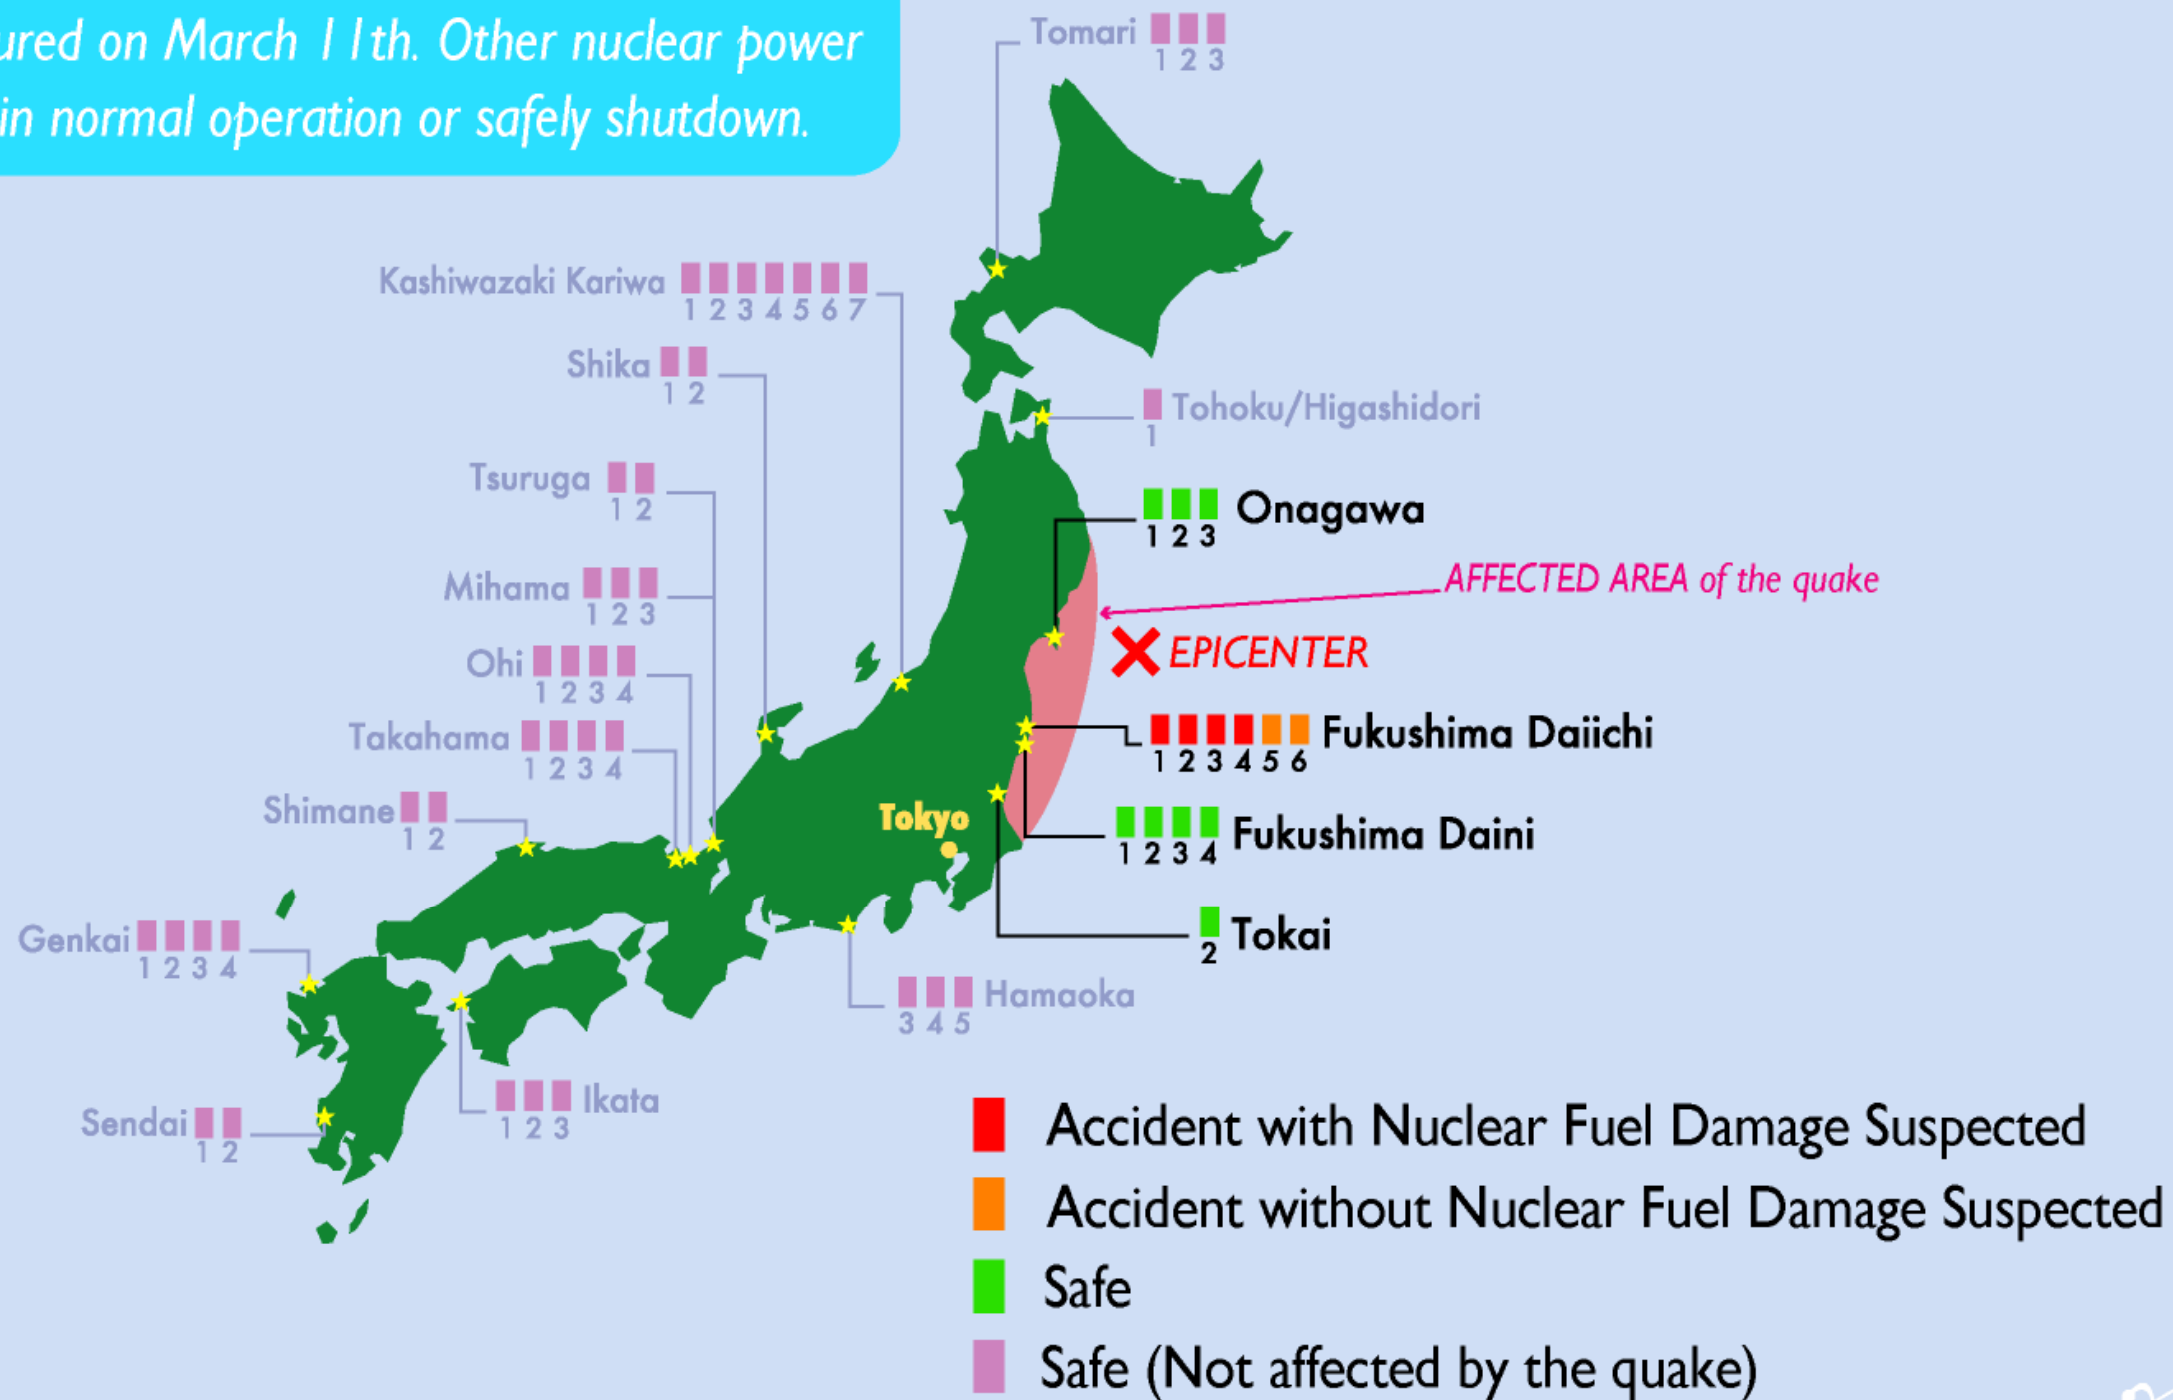
# Status of the Nuclear Power Plants after the Earthquake

The accident that brings environmental impact is going on at several units in Fukushima Daiichi nuclear power Station after the earthquake occurred on March 11th. Other nuclear power plants in Japan are in normal operation or safely shutdown.
