Status of nuclear power plants in Fukushima as of 20:00 March 26 (Estimated by JAIF)

Parameters in the Table

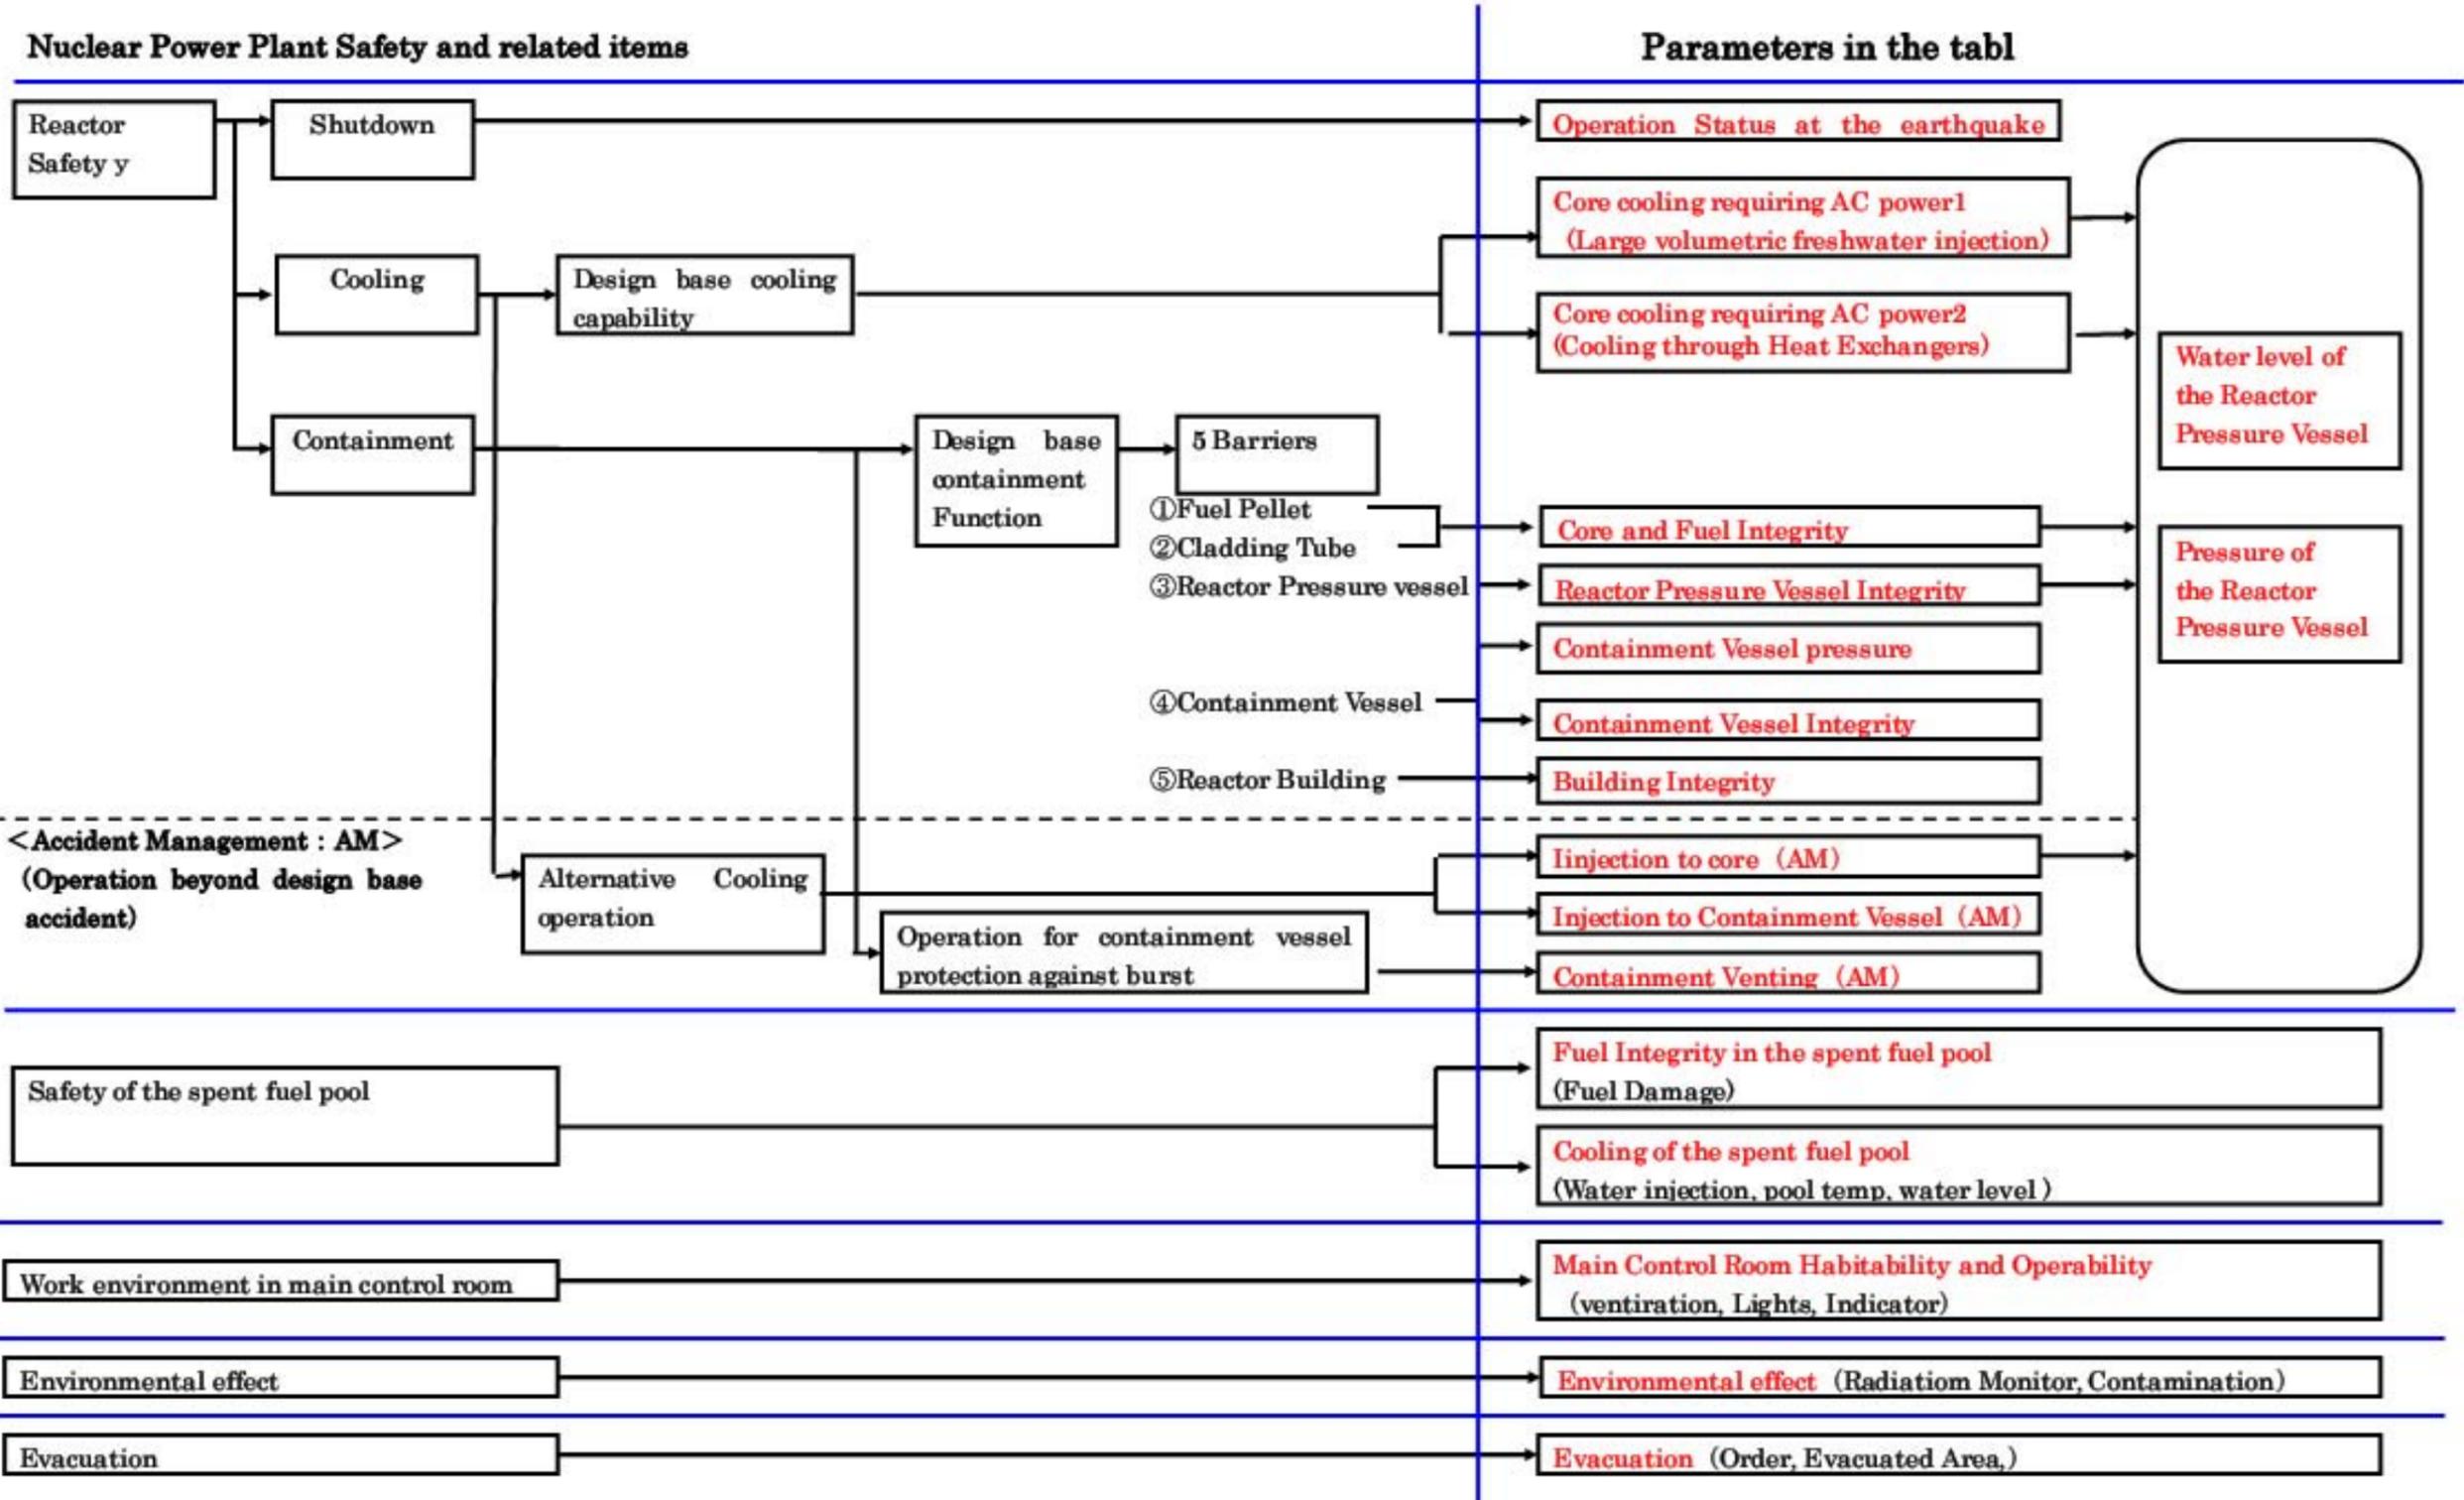
JAIF picks up these parameters to evaluate safety condition of the nuclear plants during this accident from the view point of the principles of nuclear power plant safety, which are "Shutdown", "Cooling" and "Containment". Then we create the chart. The following diagram is to show the correspondence relation of these parameters in the table to nuclear power plant safety.

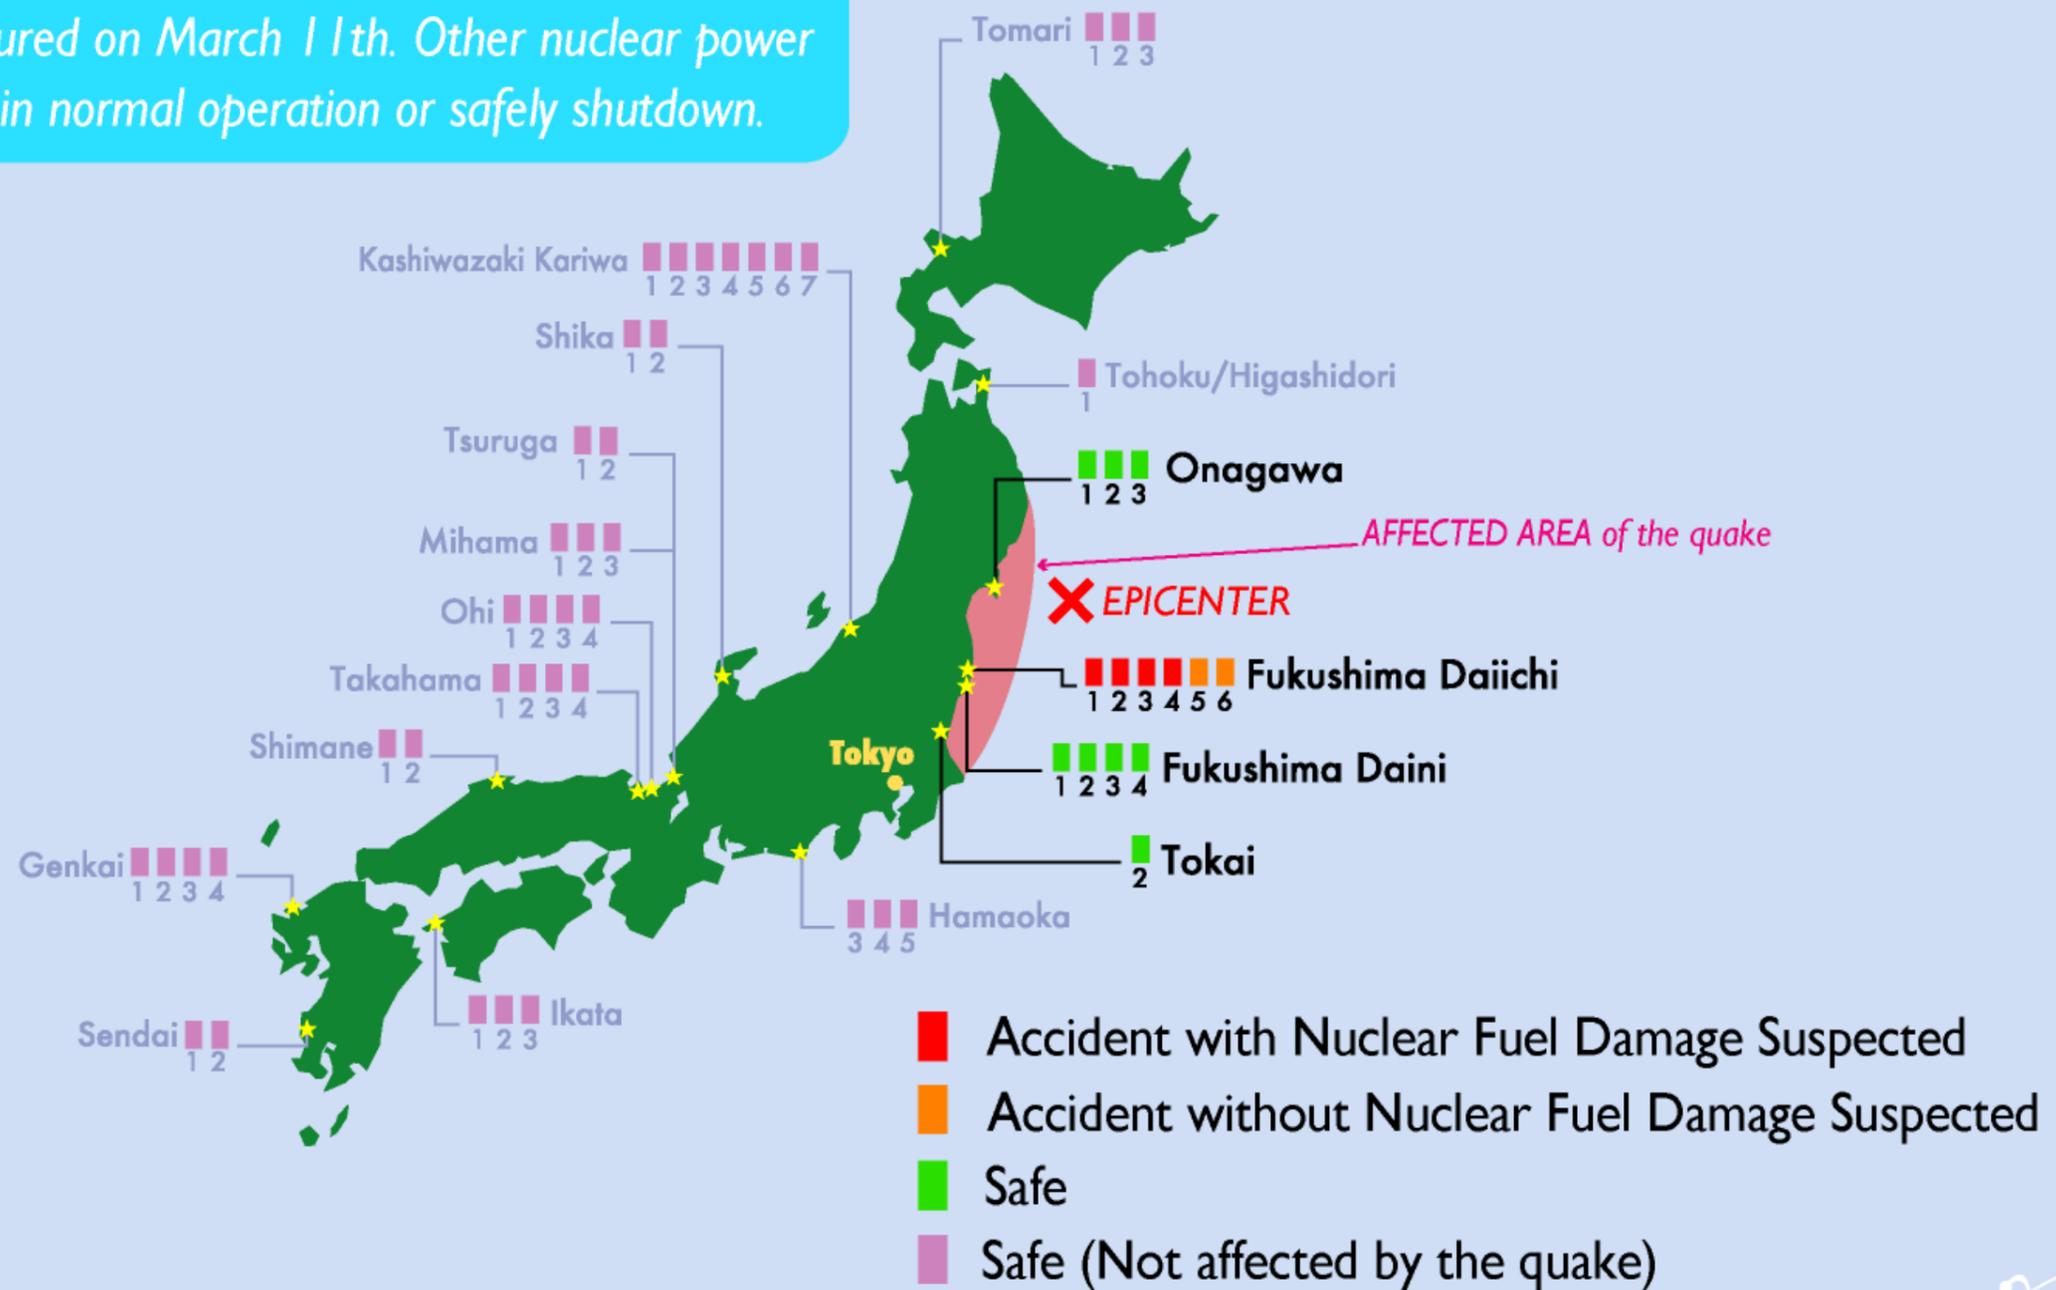
Status of the Nuclear Power Plants after the Earthquake

The accident that brings environmental impact is going on at several units in Fukushima Daiichi nuclear power Station after the earthquake occurred on March 11th. Other nuclear power plants in Japan are in normal operation or safely shutdown.
