# Information on Status of Nuclear Power Plants in Fukushima

Japan Atomic Industrial Forum, Inc.

Status of nuclear power plants in Fukushima as of 20:00 March 29 (Estimated by JAIF)

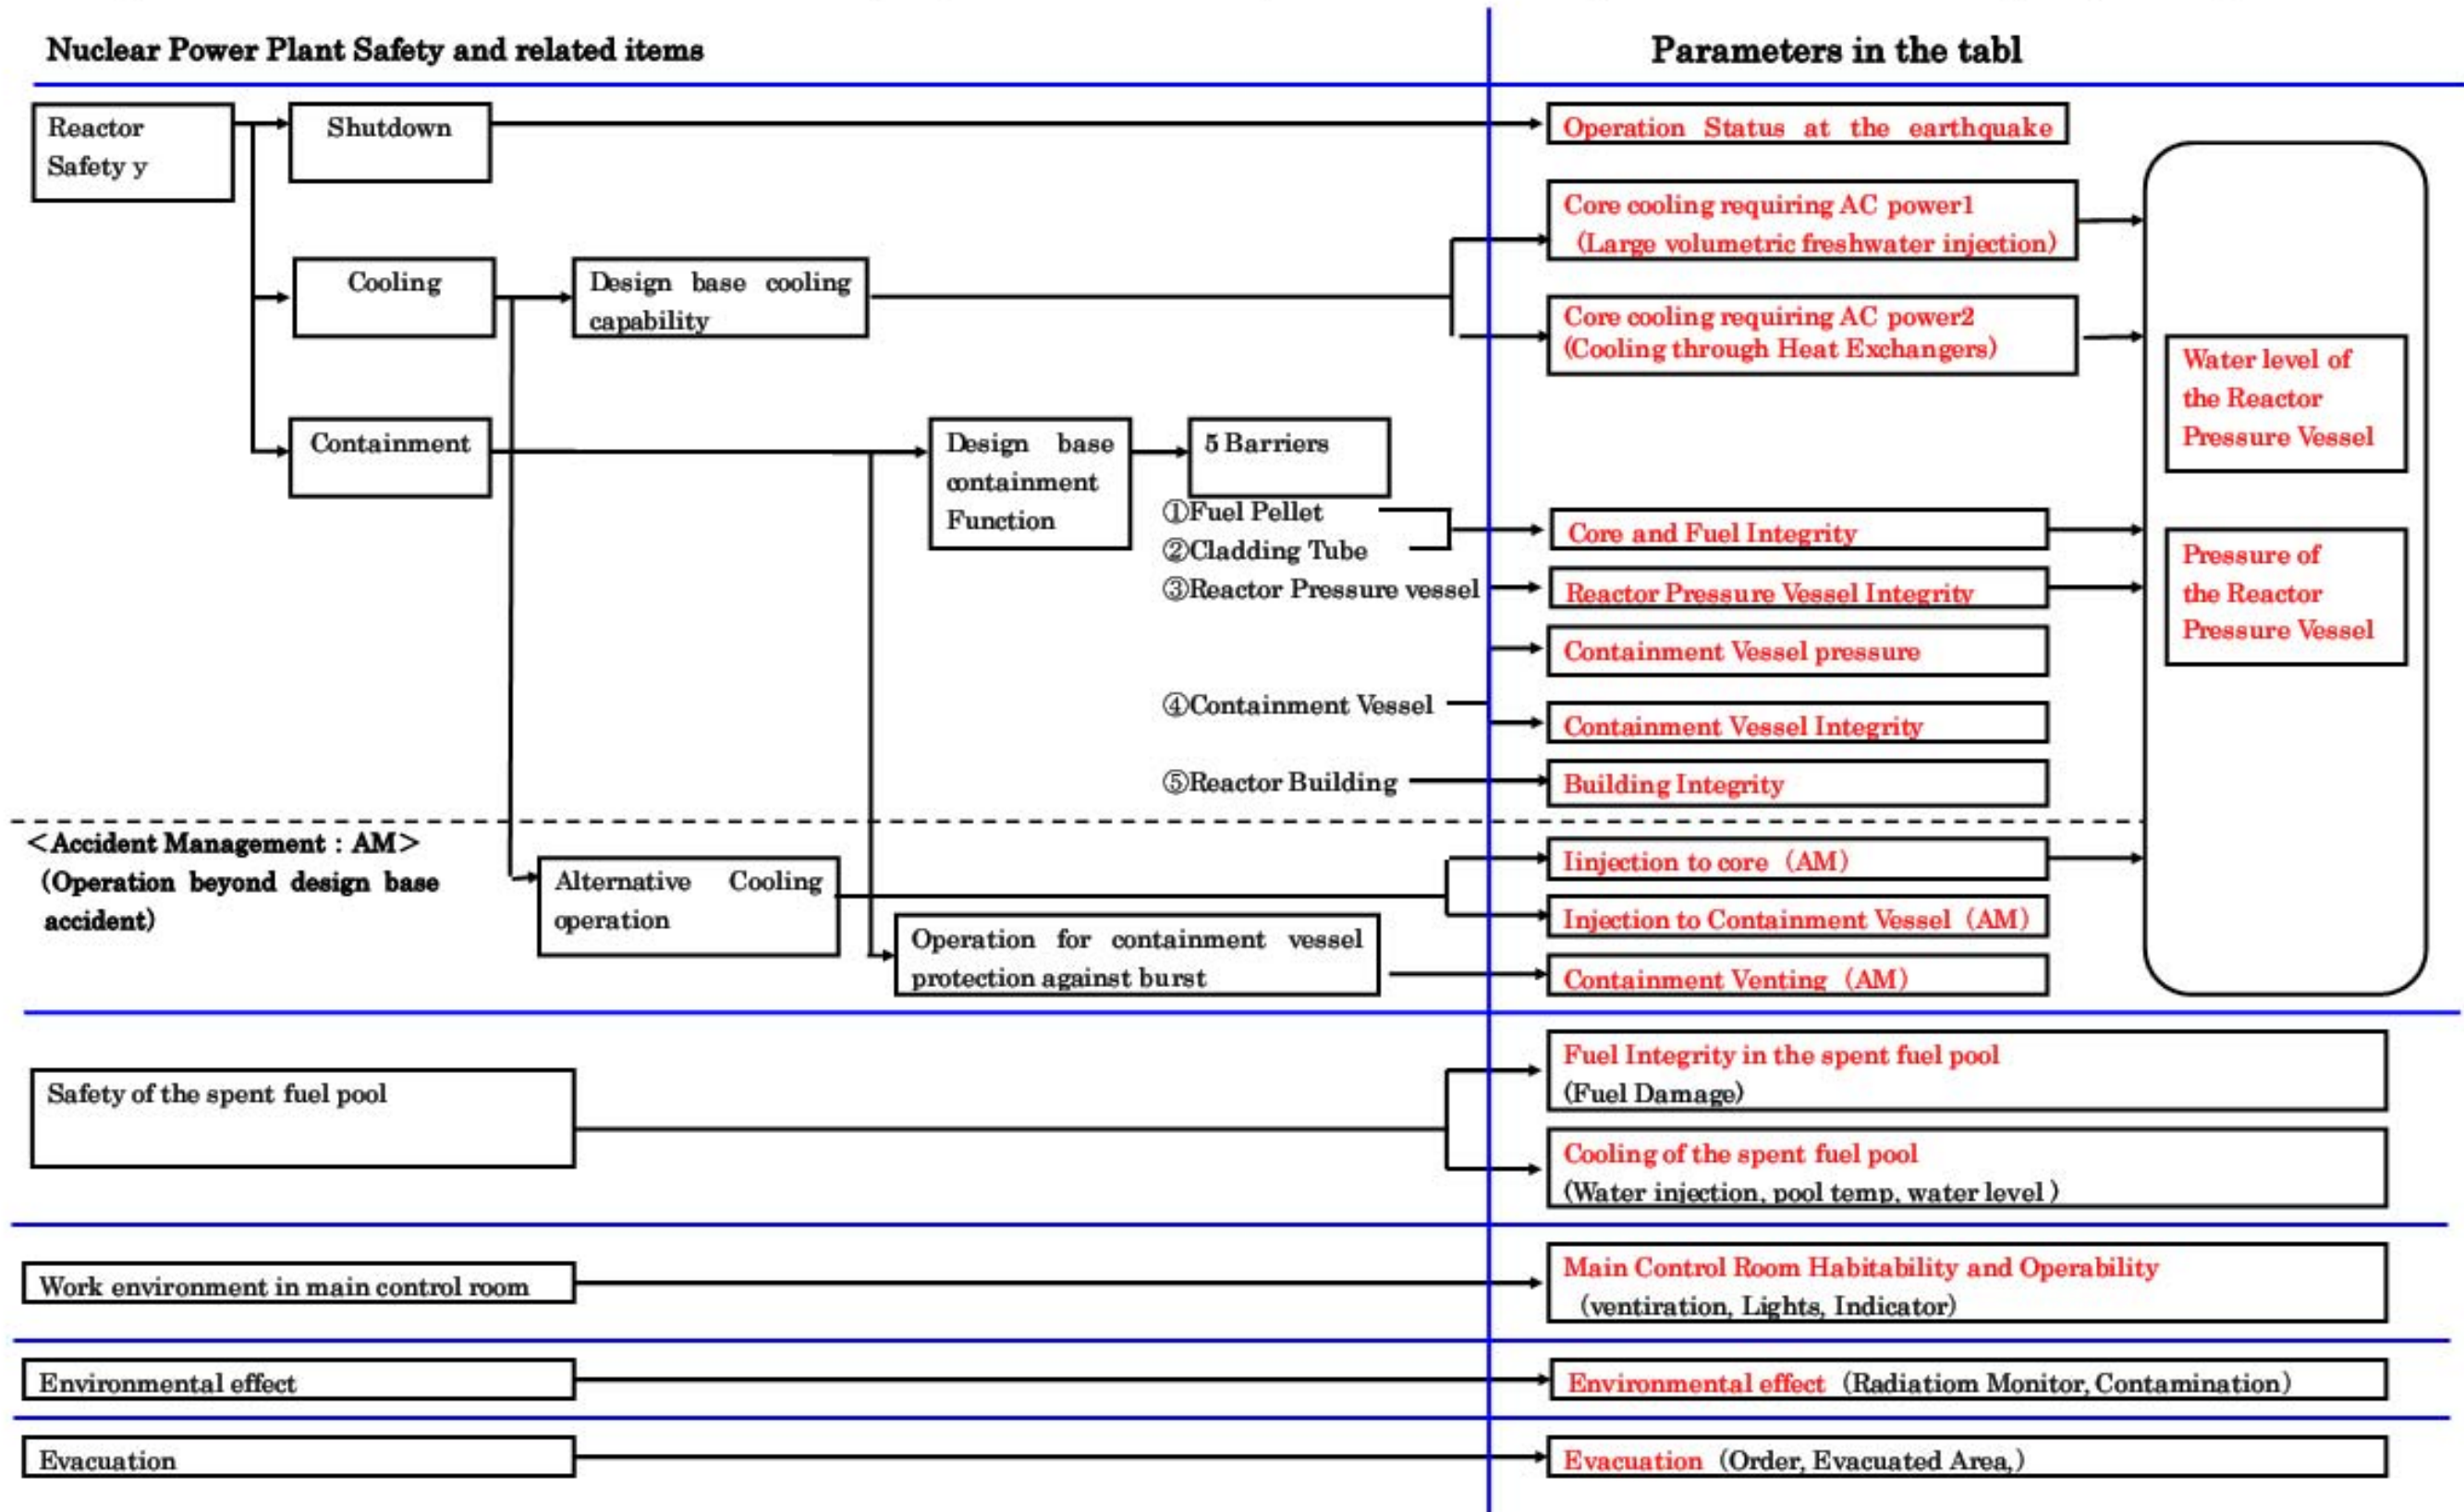
**Parameters in the Table**

JAIF picks up these parameters to evaluate safety condition of the nuclear plants during this accident from the view point of the principles of nuclear power plant safety, which are “Shutdown”, “Cooling” and “Containment”. Then we create the chart. The following diagram is to show the correspondence relation of these parameters in the table to nuclear power plant safety.
