# Information on Status of Nuclear Power Plants in Fukushima

Japan Atomic Industrial Forum, Inc.

**Status of nuclear power plants in Fukushima as of 21:00 March 30 (Estimated by JAIF)**

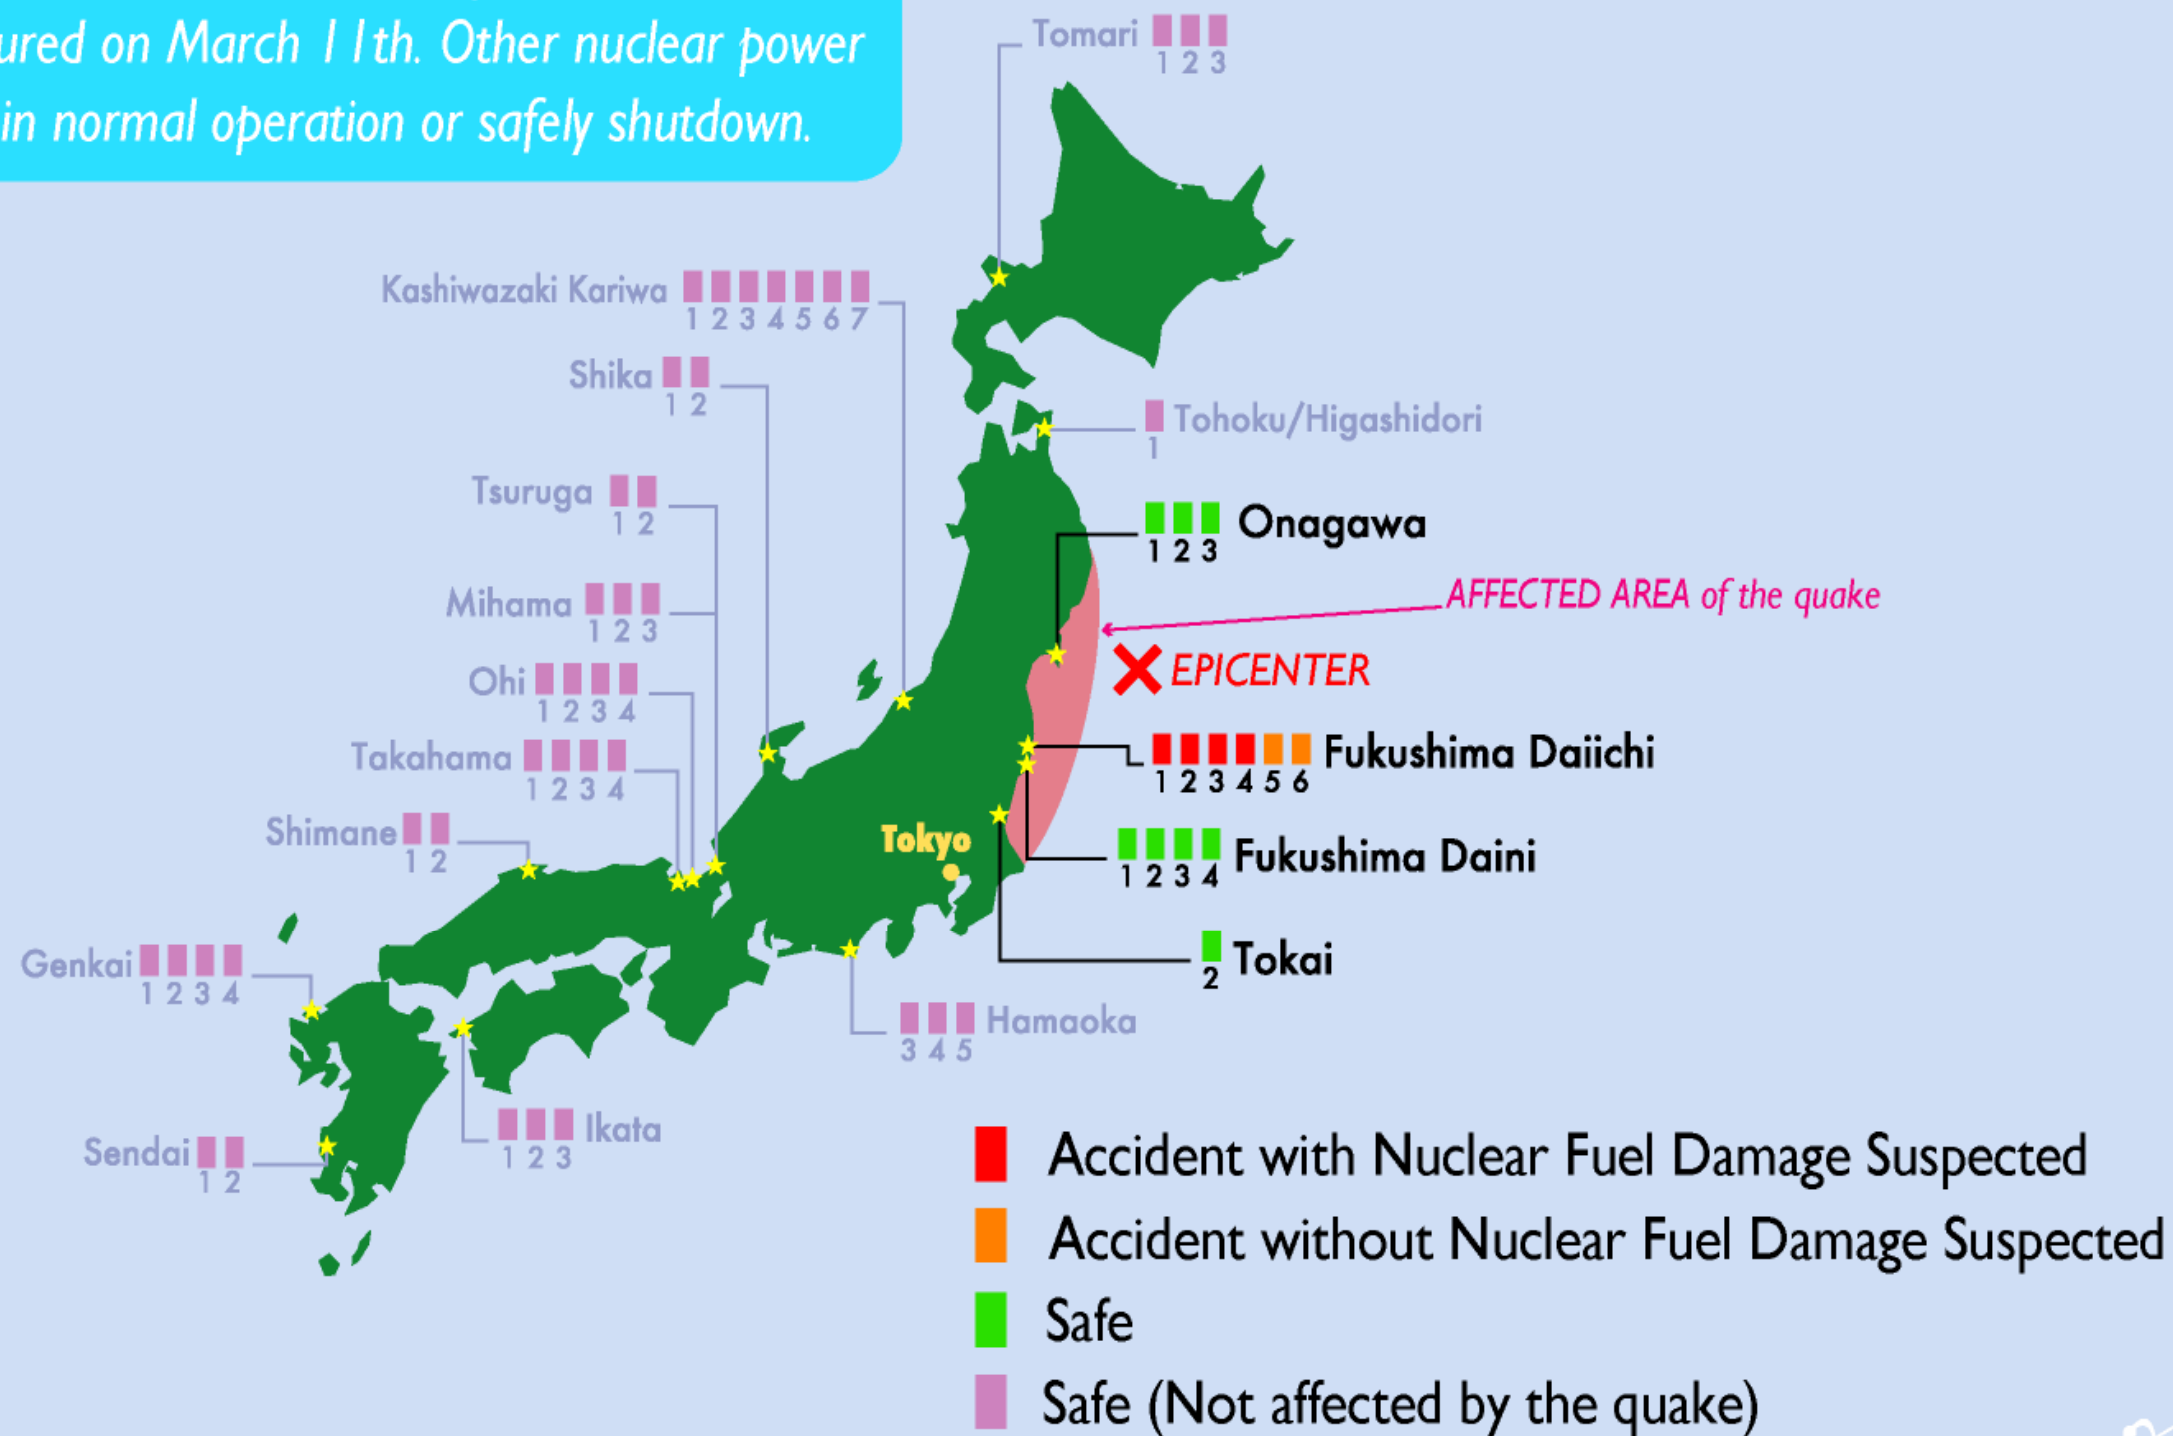
# Status of the Nuclear Power Plants after the Earthquake

The accident that brings environmental impact is going on at several units in Fukushima Daiichi nuclear power Station after the earthquake occurred on March 11th. Other nuclear power plants in Japan are in normal operation or safely shutdown.
