# Information on Status of Nuclear Power Plants in Fukushima

Japan Atomic Industrial Forum, Inc.

**Status of nuclear power plants in Fukushima as of 10:00 April 1 (Estimated by JAIF)**

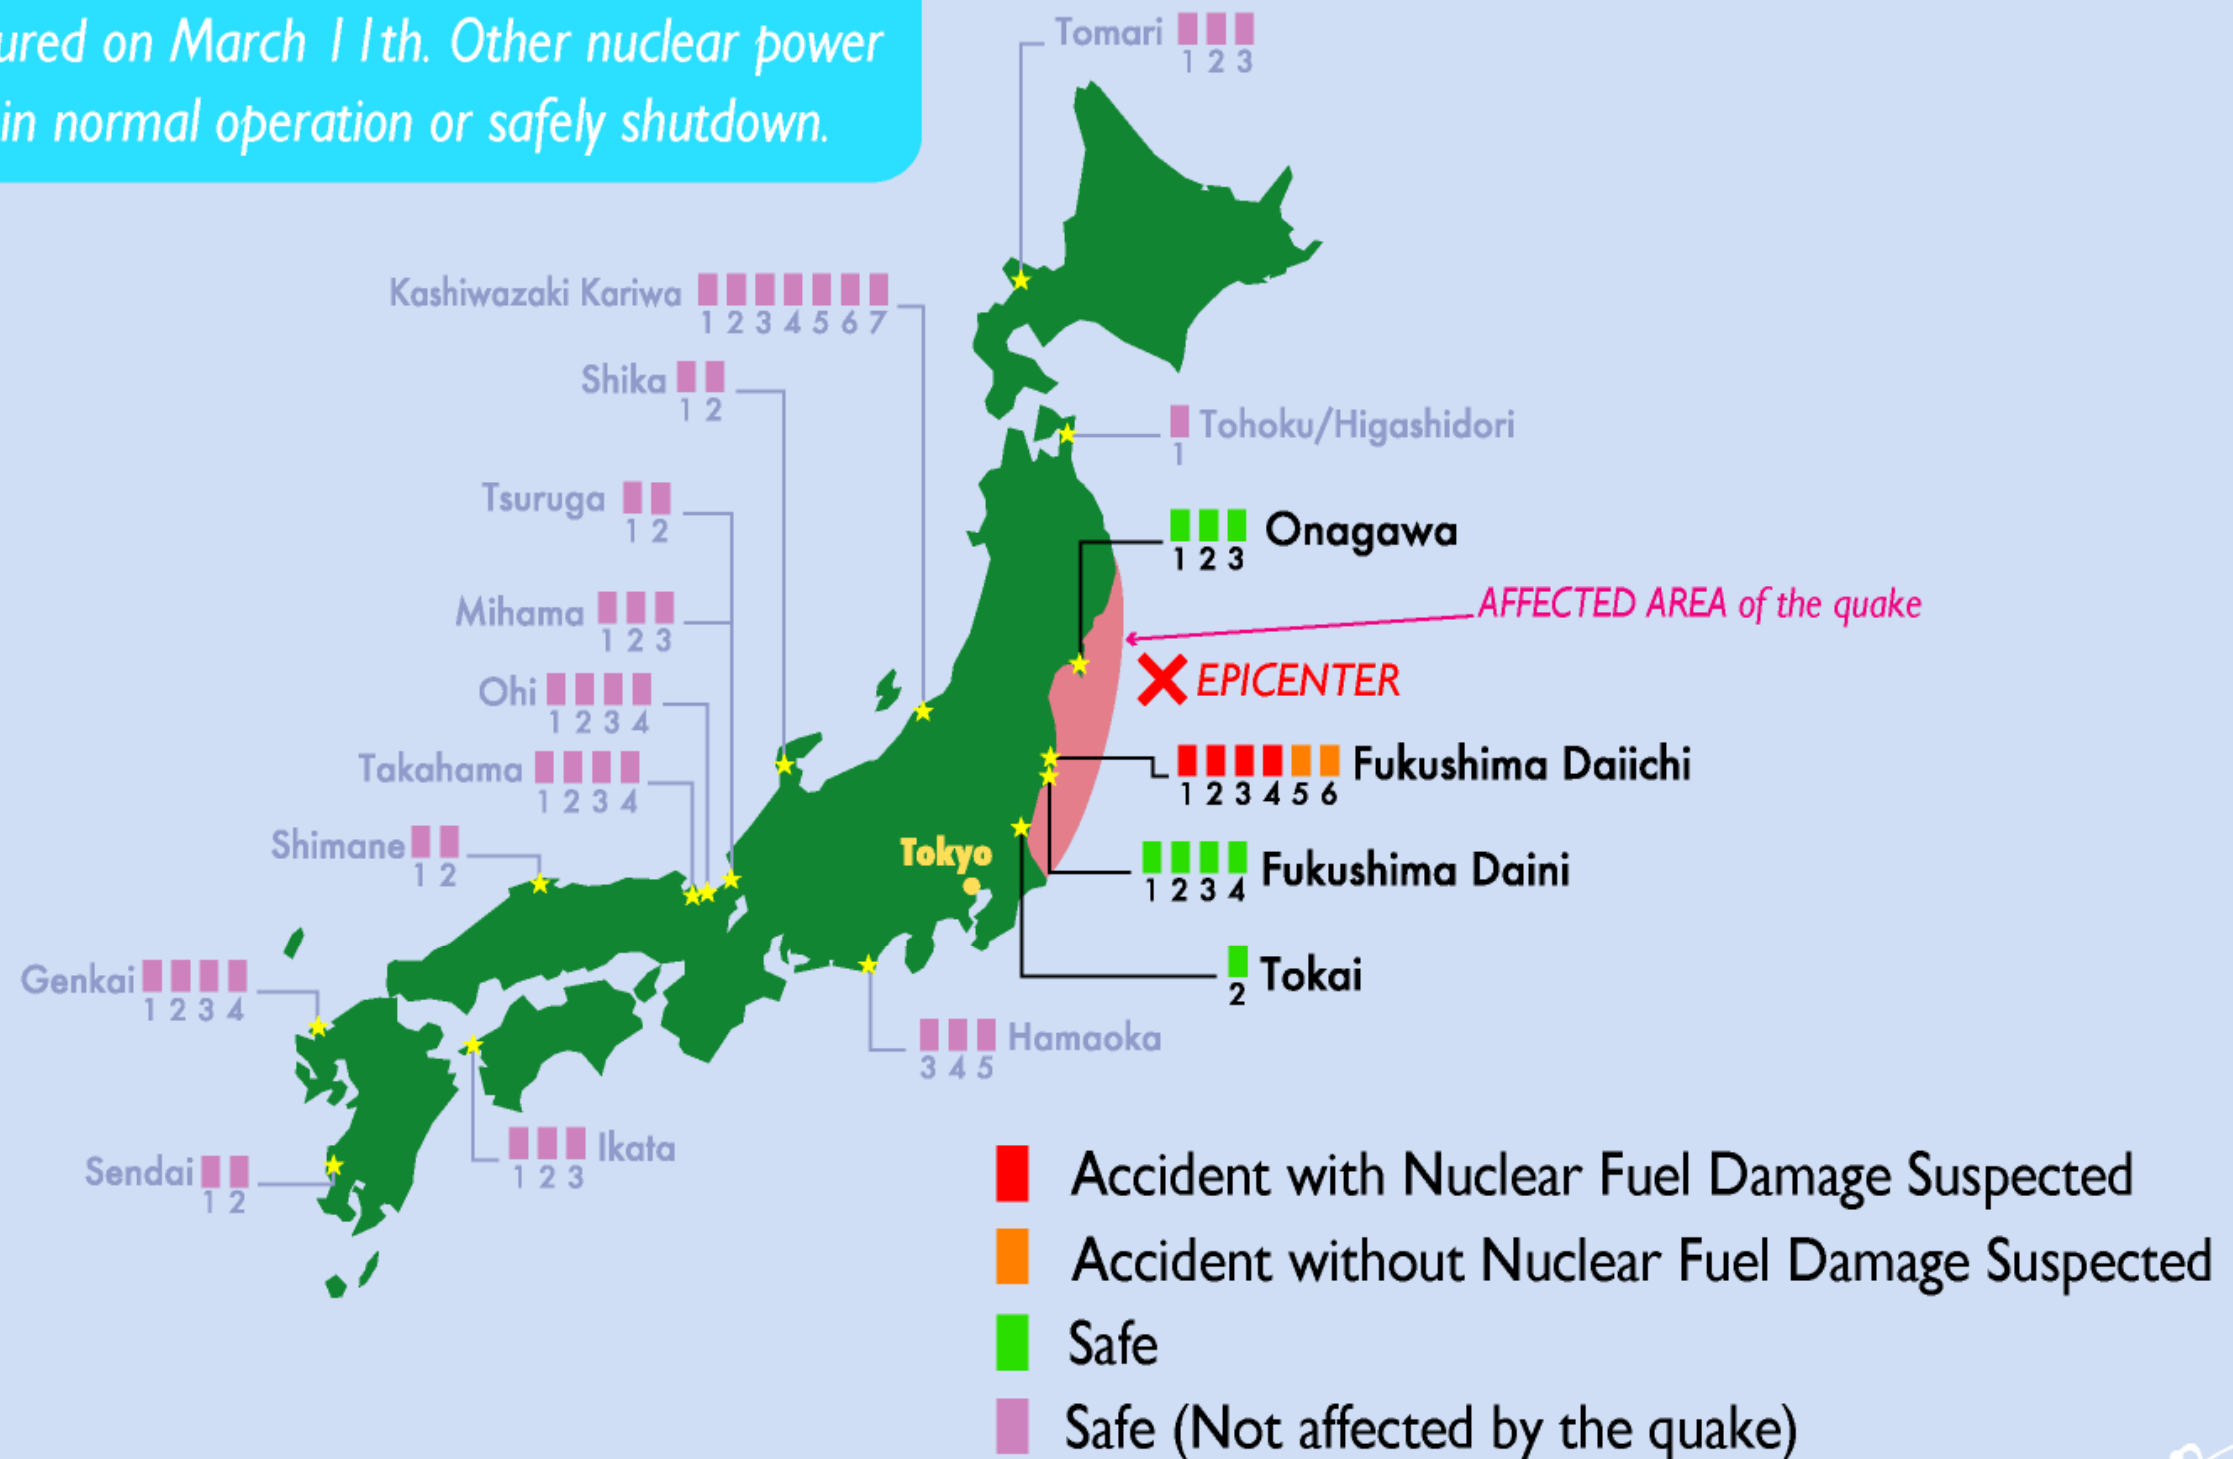
# Status of the Nuclear Power Plants after the Earthquake

The accident that brings environmental impact is going on at several units in Fukushima Daiichi nuclear power Station after the earthquake occurred on March 11th. Other nuclear power plants in Japan are in normal operation or safely shutdown.
