Information on Status of Nuclear Power Plants in Fukushima

Japan Atomic Industrial Forum, Inc.

Status of nuclear power plants in Fukushima as of 21:00, April 4th (Estimated by JAIF)

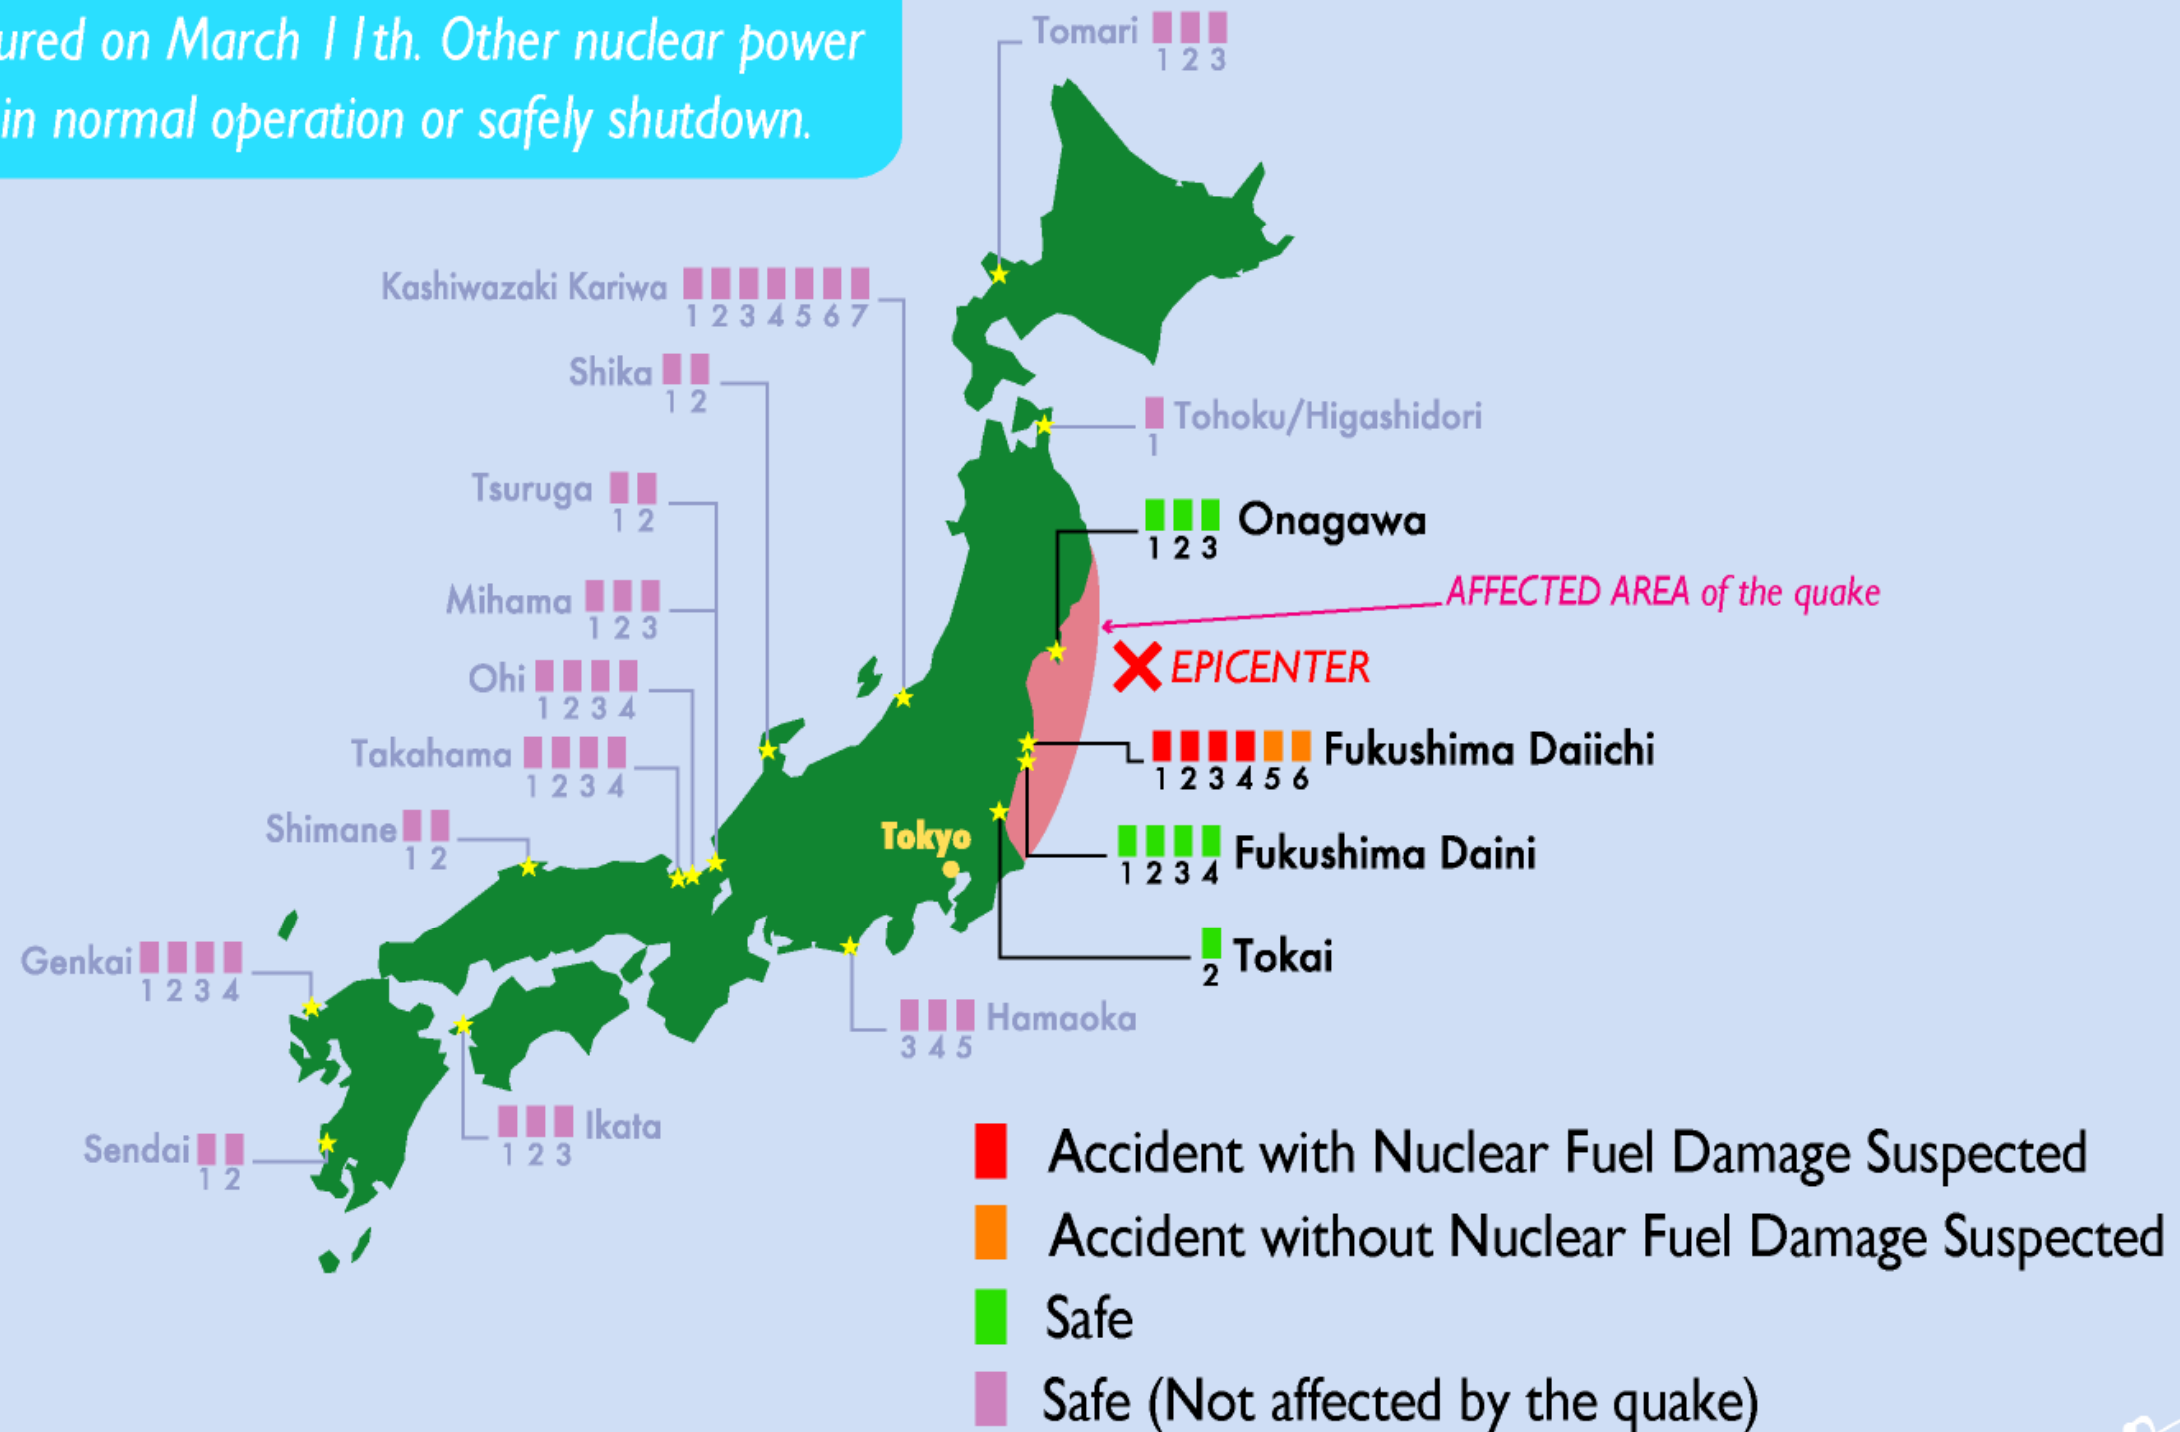
Status of the Nuclear Power Plants after the Earthquake

The accident that brings environmental impact is going on at several units in Fukushima Daiichi nuclear power Station after the earthquake occurred on March 11th. Other nuclear power plants in Japan are in normal operation or safely shutdown.
