Information on Status of Nuclear Power Plants in Fukushima

Japan Atomic Industrial Forum, Inc.

Status of nuclear power plants in Fukushima as of 20:00, April 8th (Estimated by JAIF)

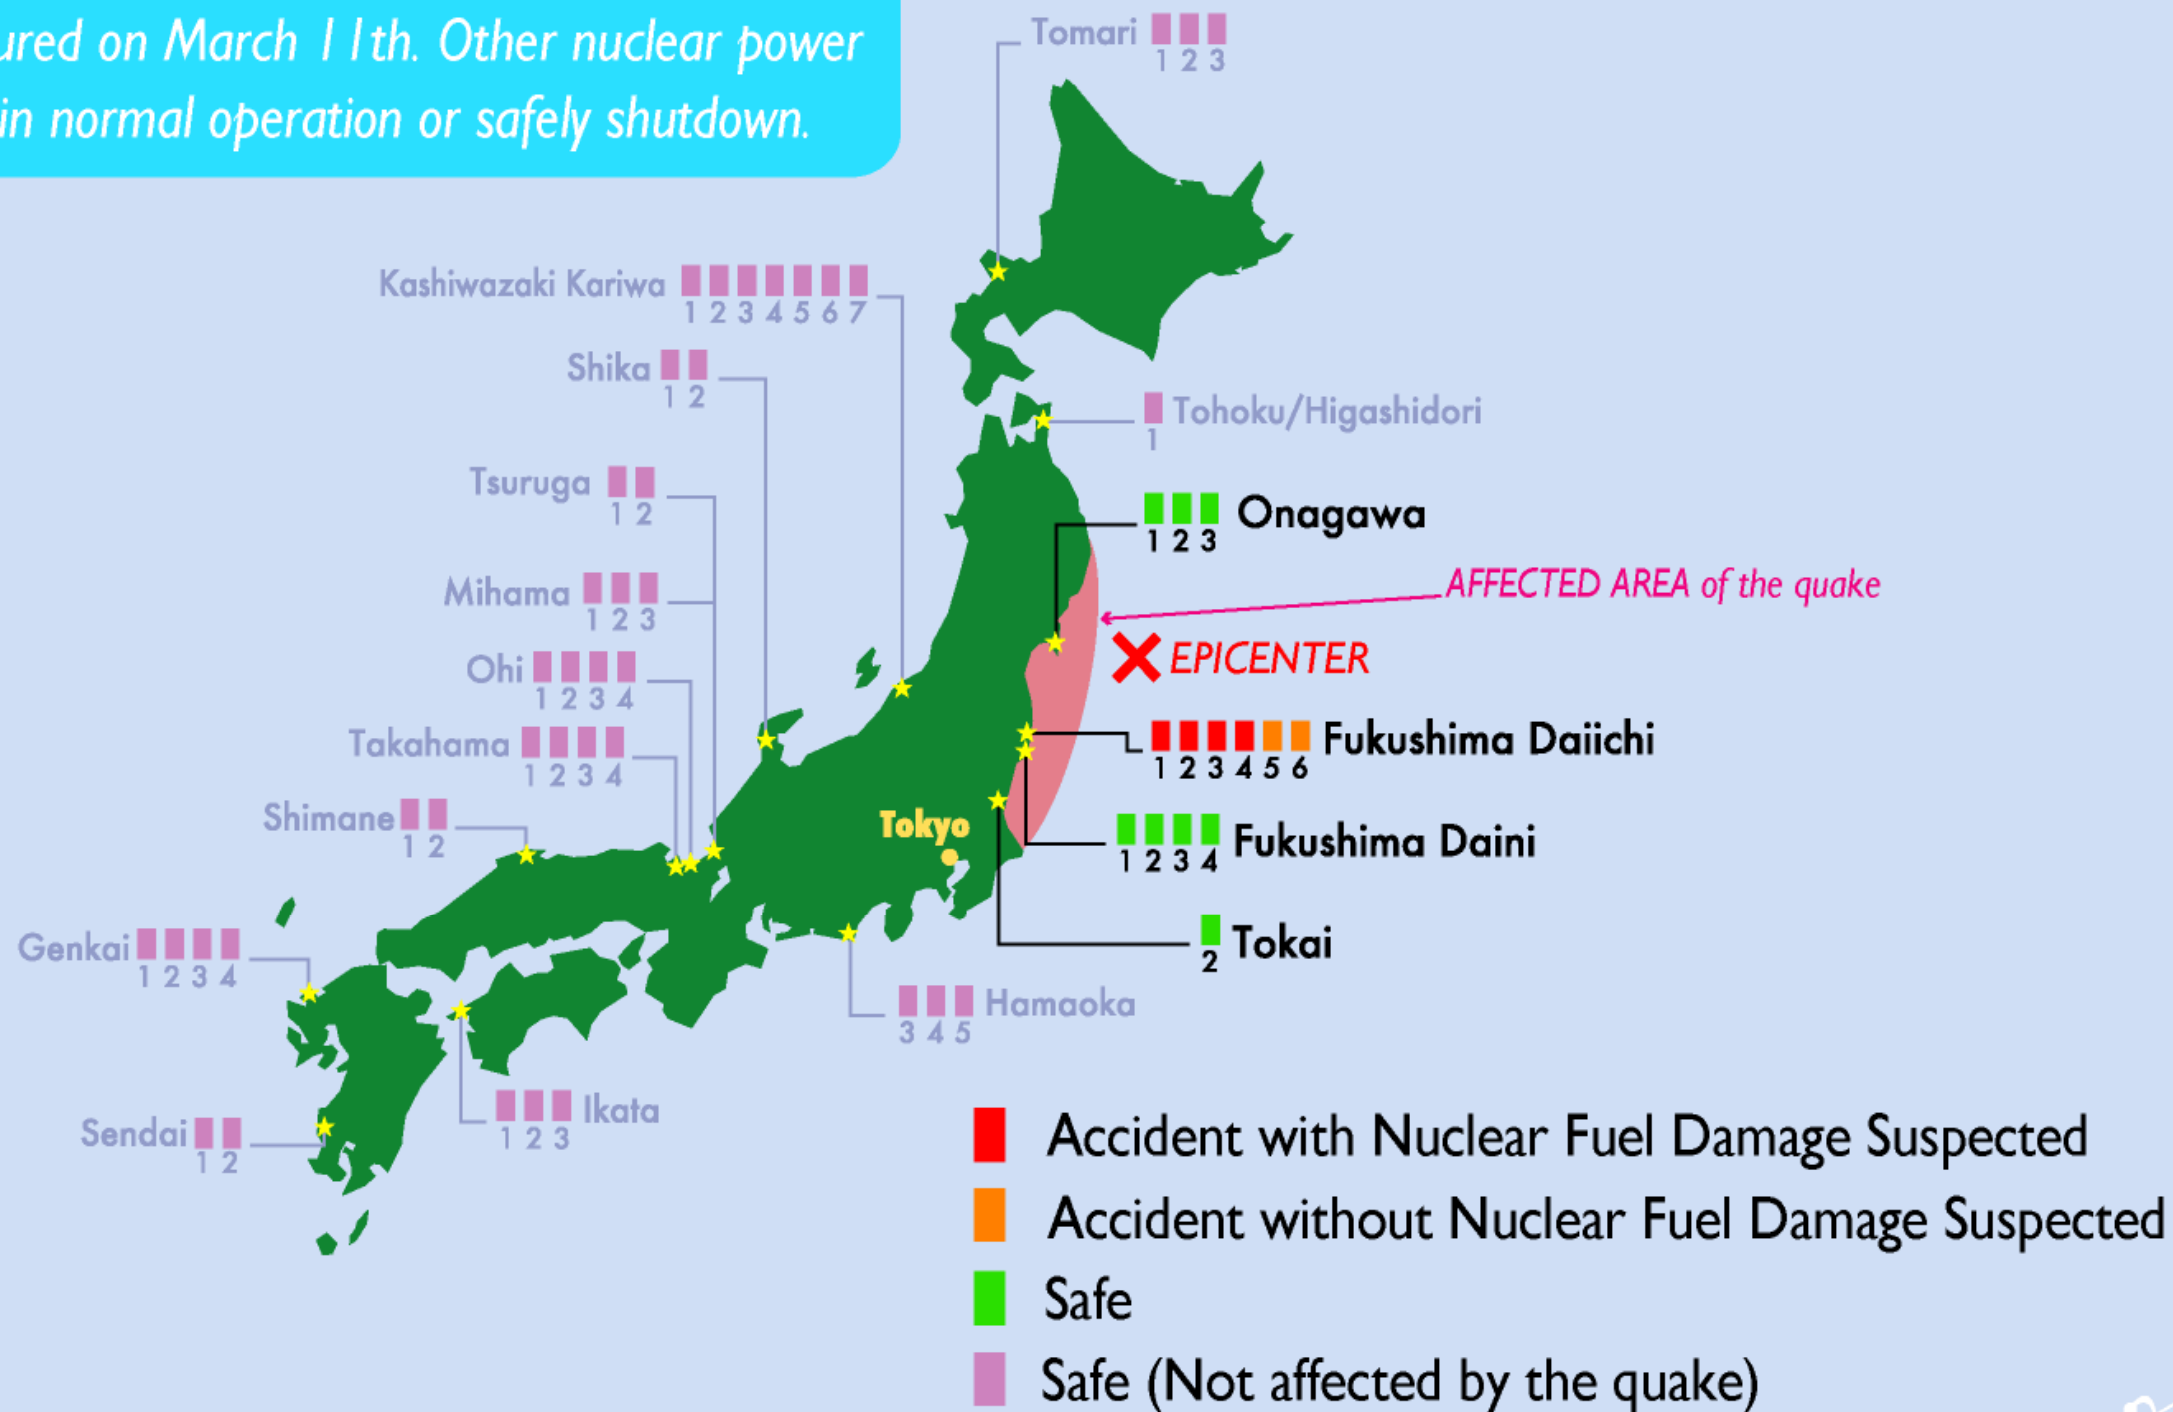
Status of the Nuclear Power Plants after the Earthquake

The accident that brings environmental impact is going on at several units in Fukushima Daiichi nuclear power Station after the earthquake occurred on March 11th. Other nuclear power plants in Japan are in normal operation or safely shutdown.
