Information on Status of Nuclear Power Plants in Fukushima

Japan Atomic Industrial Forum, Inc.

Status of nuclear power plants in Fukushima as of 10:00, April 17th (Estimated by JAIF)

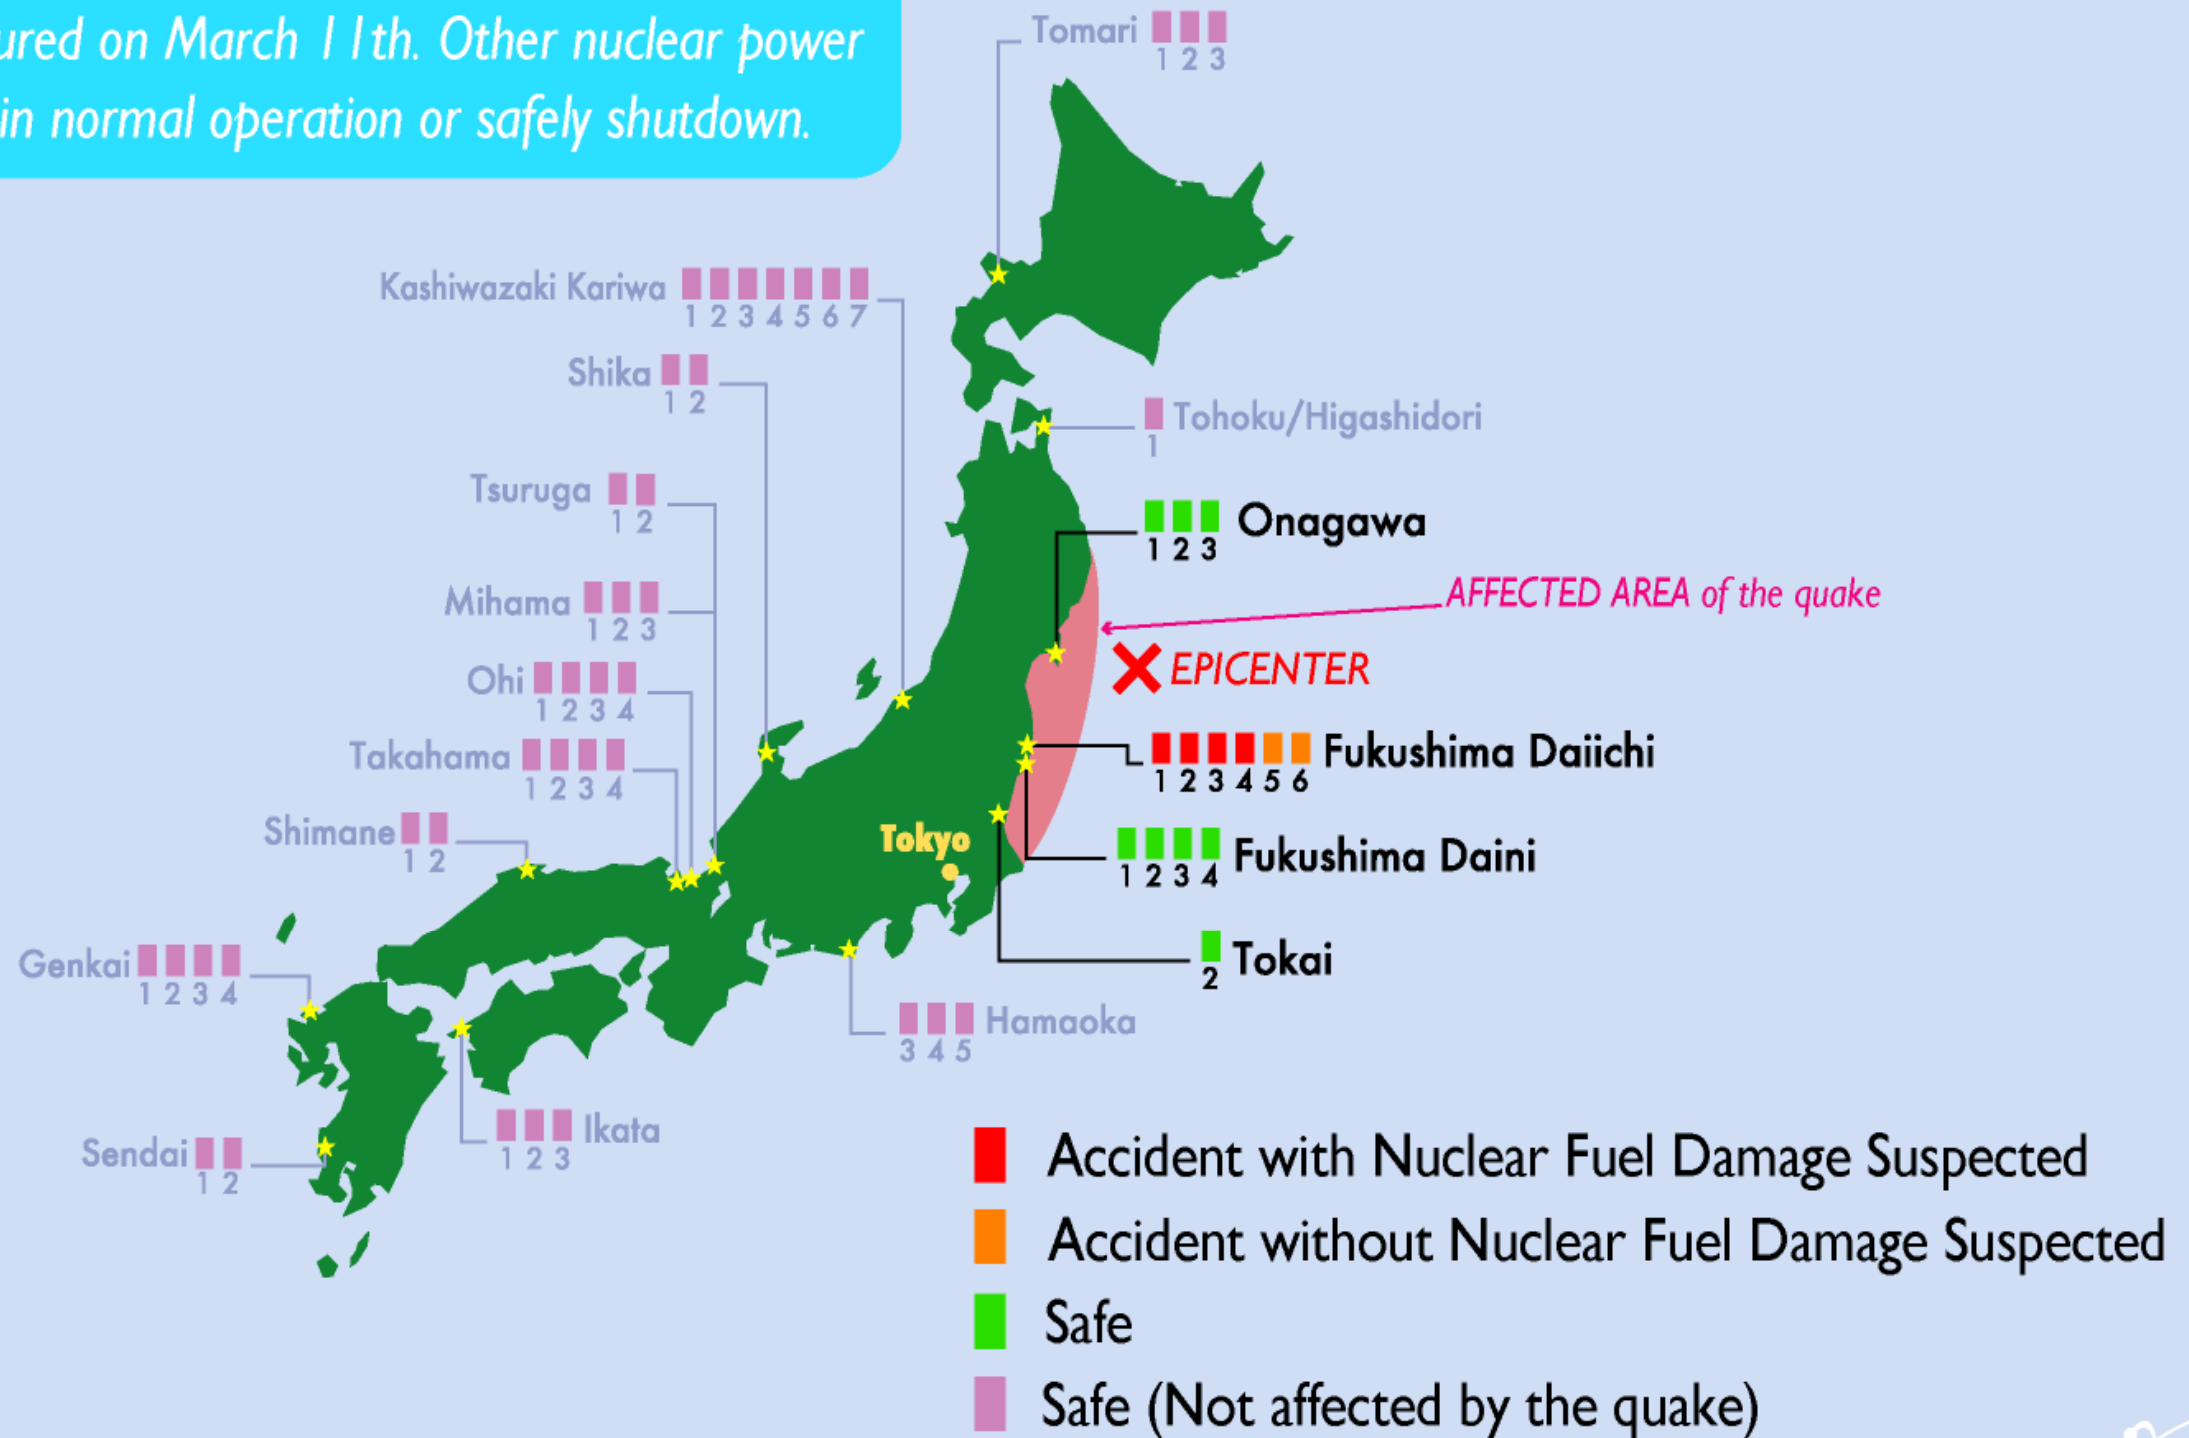
Status of the Nuclear Power Plants after the Earthquake

The accident that brings environmental impact is going on at several units in Fukushima Daiichi nuclear power Station after the earthquake occurred on March 11th. Other nuclear power plants in Japan are in normal operation or safely shutdown.
