Information on Status of Nuclear Power Plants in Fukushima

Japan Atomic Industrial Forum, Inc.

Status of nuclear power plants in Fukushima as of 12:00, April 29th (Estimated by JAIF)

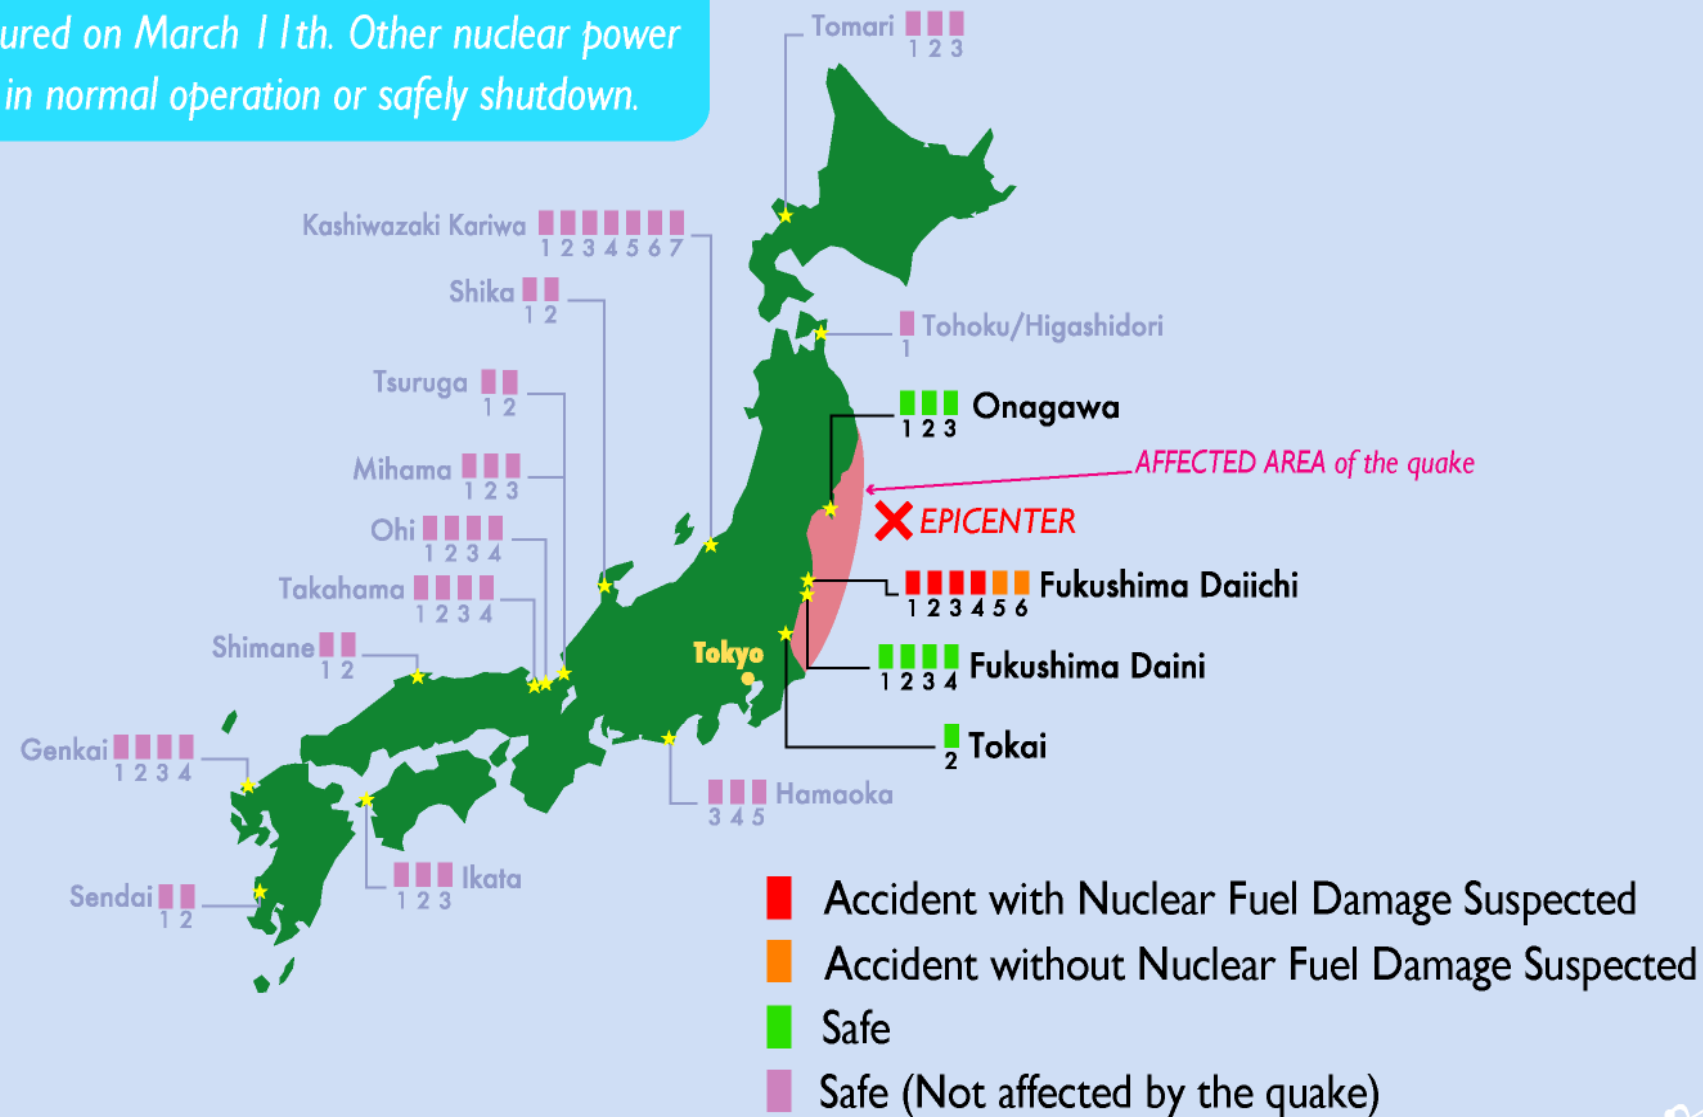
Status of the Nuclear Power Plants after the Earthquake

The accident that brings environmental impact is going on at several units in Fukushima Daiichi nuclear power Station after the earthquake occurred on March 11th. Other nuclear power plants in Japan are in normal operation or safely shutdown.
