# Information on Status of Nuclear Power Plants in Fukushima

Japan Atomic Industrial Forum, Inc.

**Status of nuclear power plants in Fukushima as of 12:00, May 8th (Estimated by JAIF)**

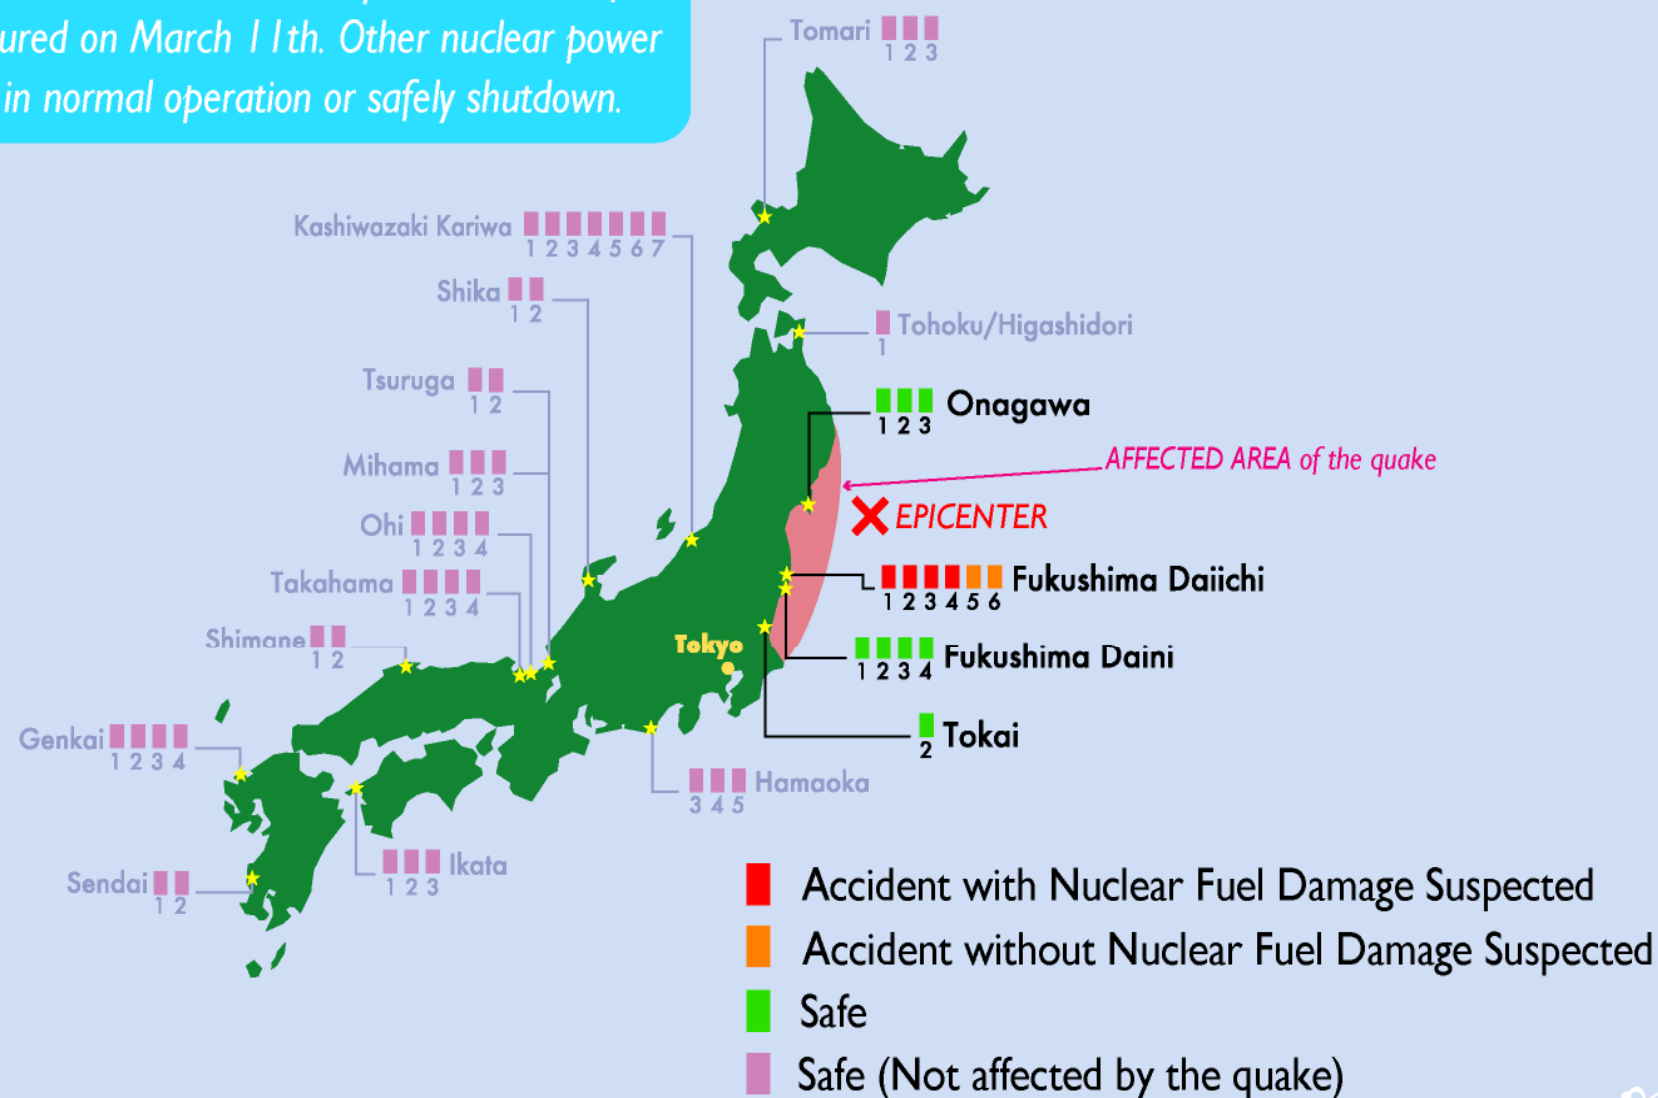
# Status of the Nuclear Power Plants after the Earthquake

The accident that brings environmental impact is going on at several units in Fukushima Daiichi nuclear power Station after the earthquake occurred on March 11th. Other nuclear power plants in Japan are in normal operation or safely shutdown.
