# Information on Status of Nuclear Power Plants in Fukushima

Japan Atomic Industrial Forum, Inc.

**Status of nuclear power plants in Fukushima as of 10:00, April 3rd (Estimated by JAIF)**

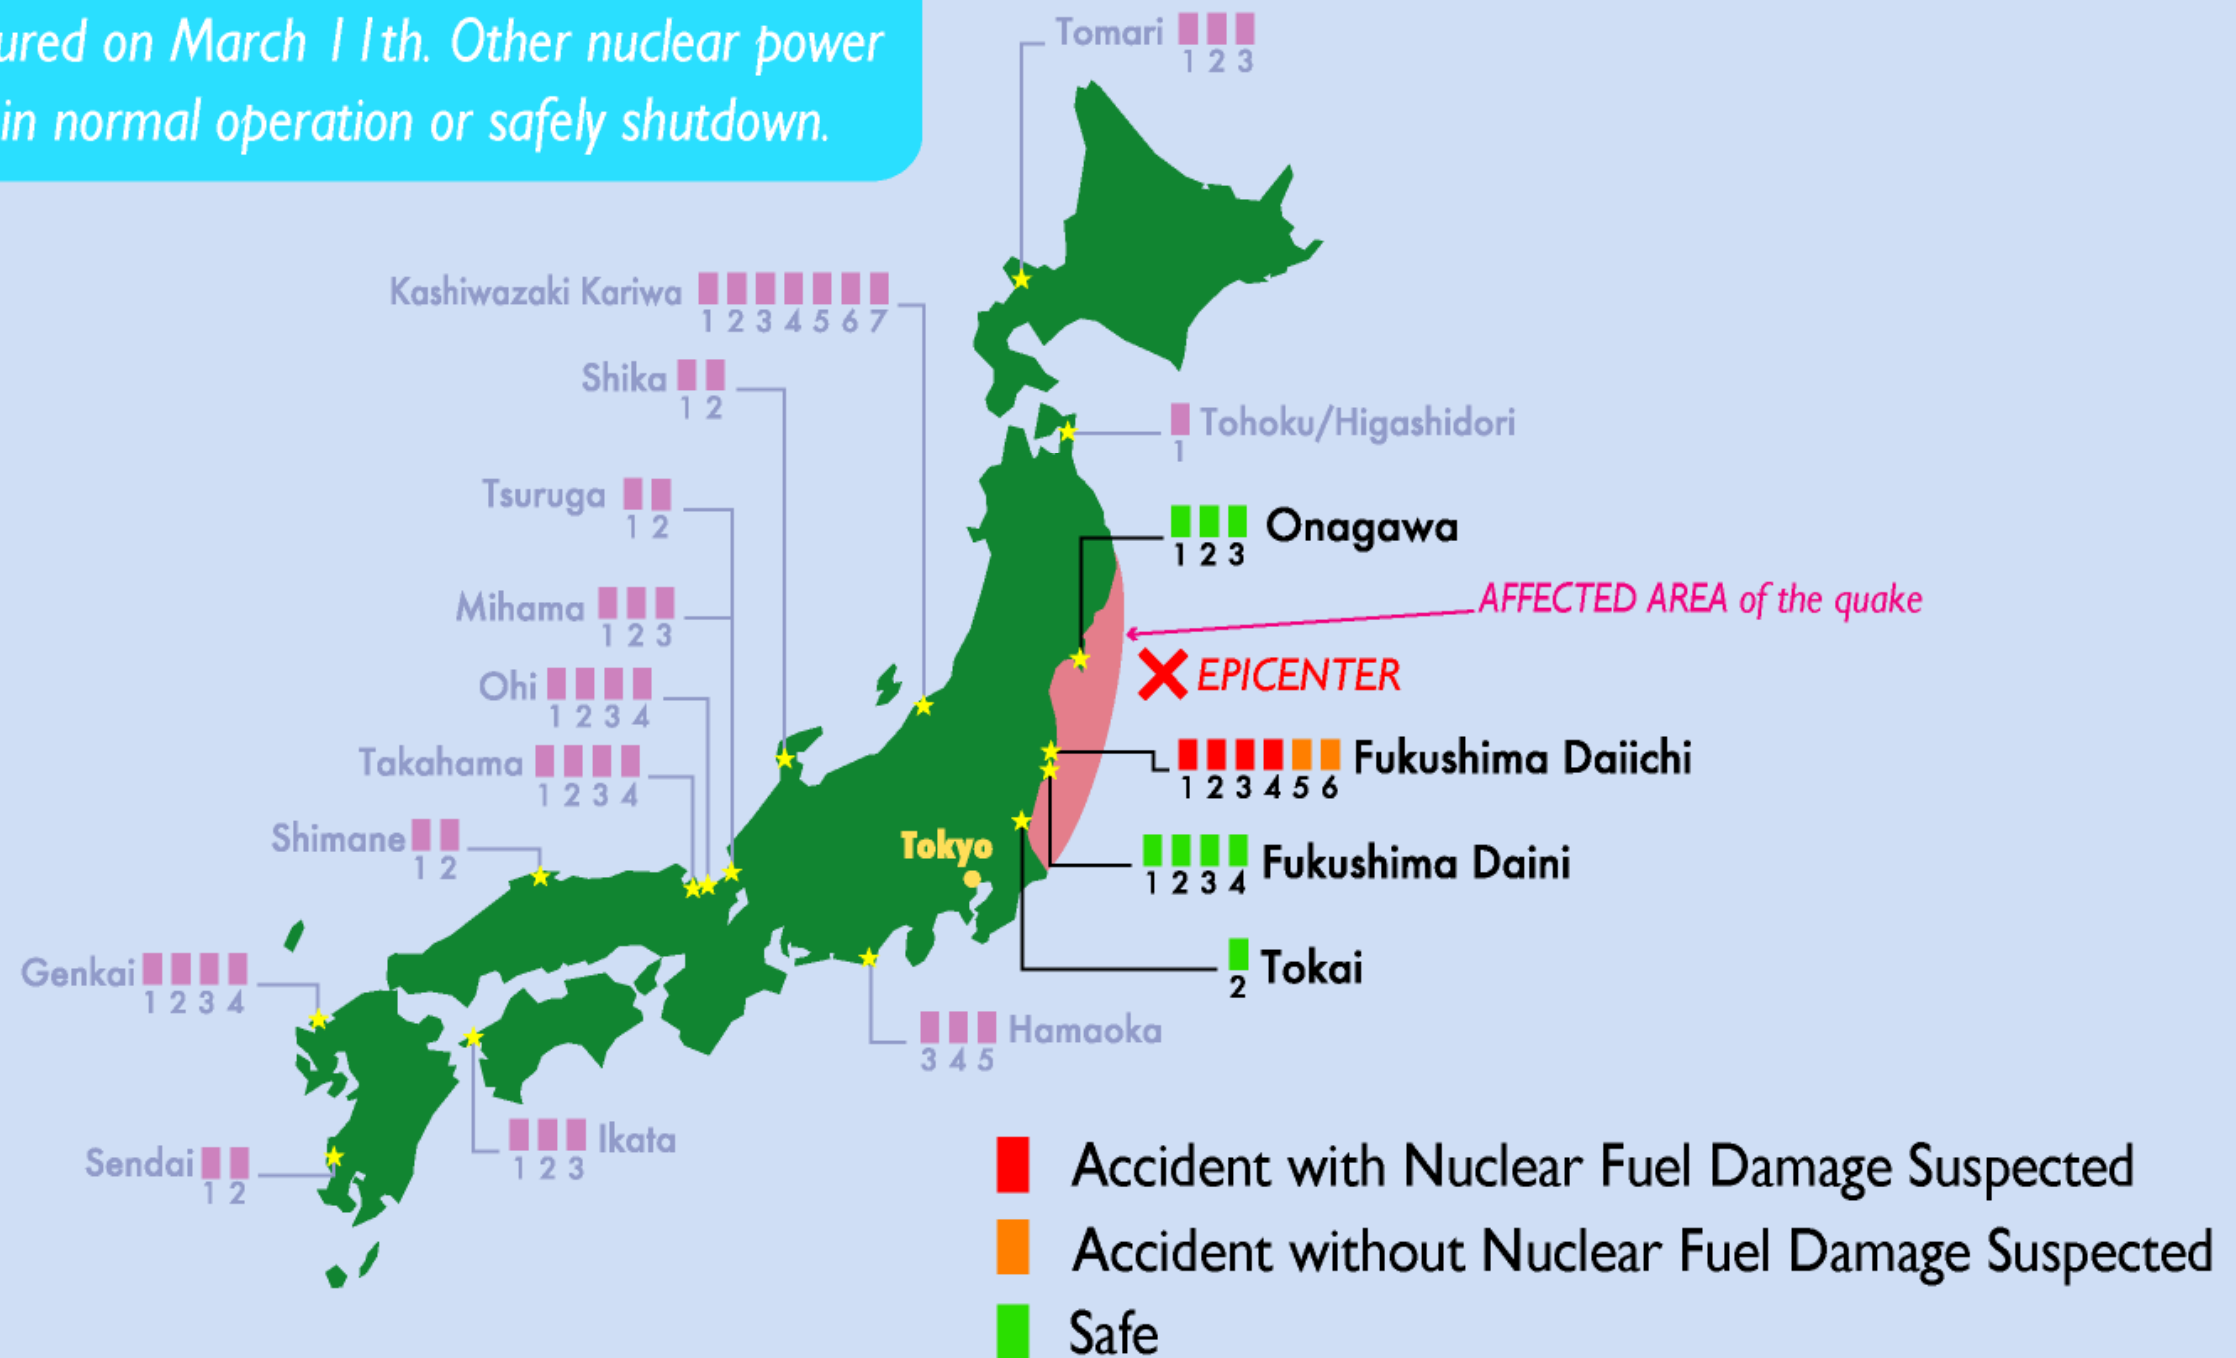
# Status of the Nuclear Power Plants after the Earthquake

The accident that brings environmental impact is going on at several units in Fukushima Daiichi nuclear power Station after the earthquake occurred on March 11th. Other nuclear power plants in Japan are in normal operation or safely shutdown.
