Status of nuclear power plants in Fukushima as of 21:00 March 23 (Estimated by JAIF)

Accidents of Fukushima Dai-ichi and Fukushima-Dai-ni Nuclear Power Stations

(March 23rd, 2011 19:00)

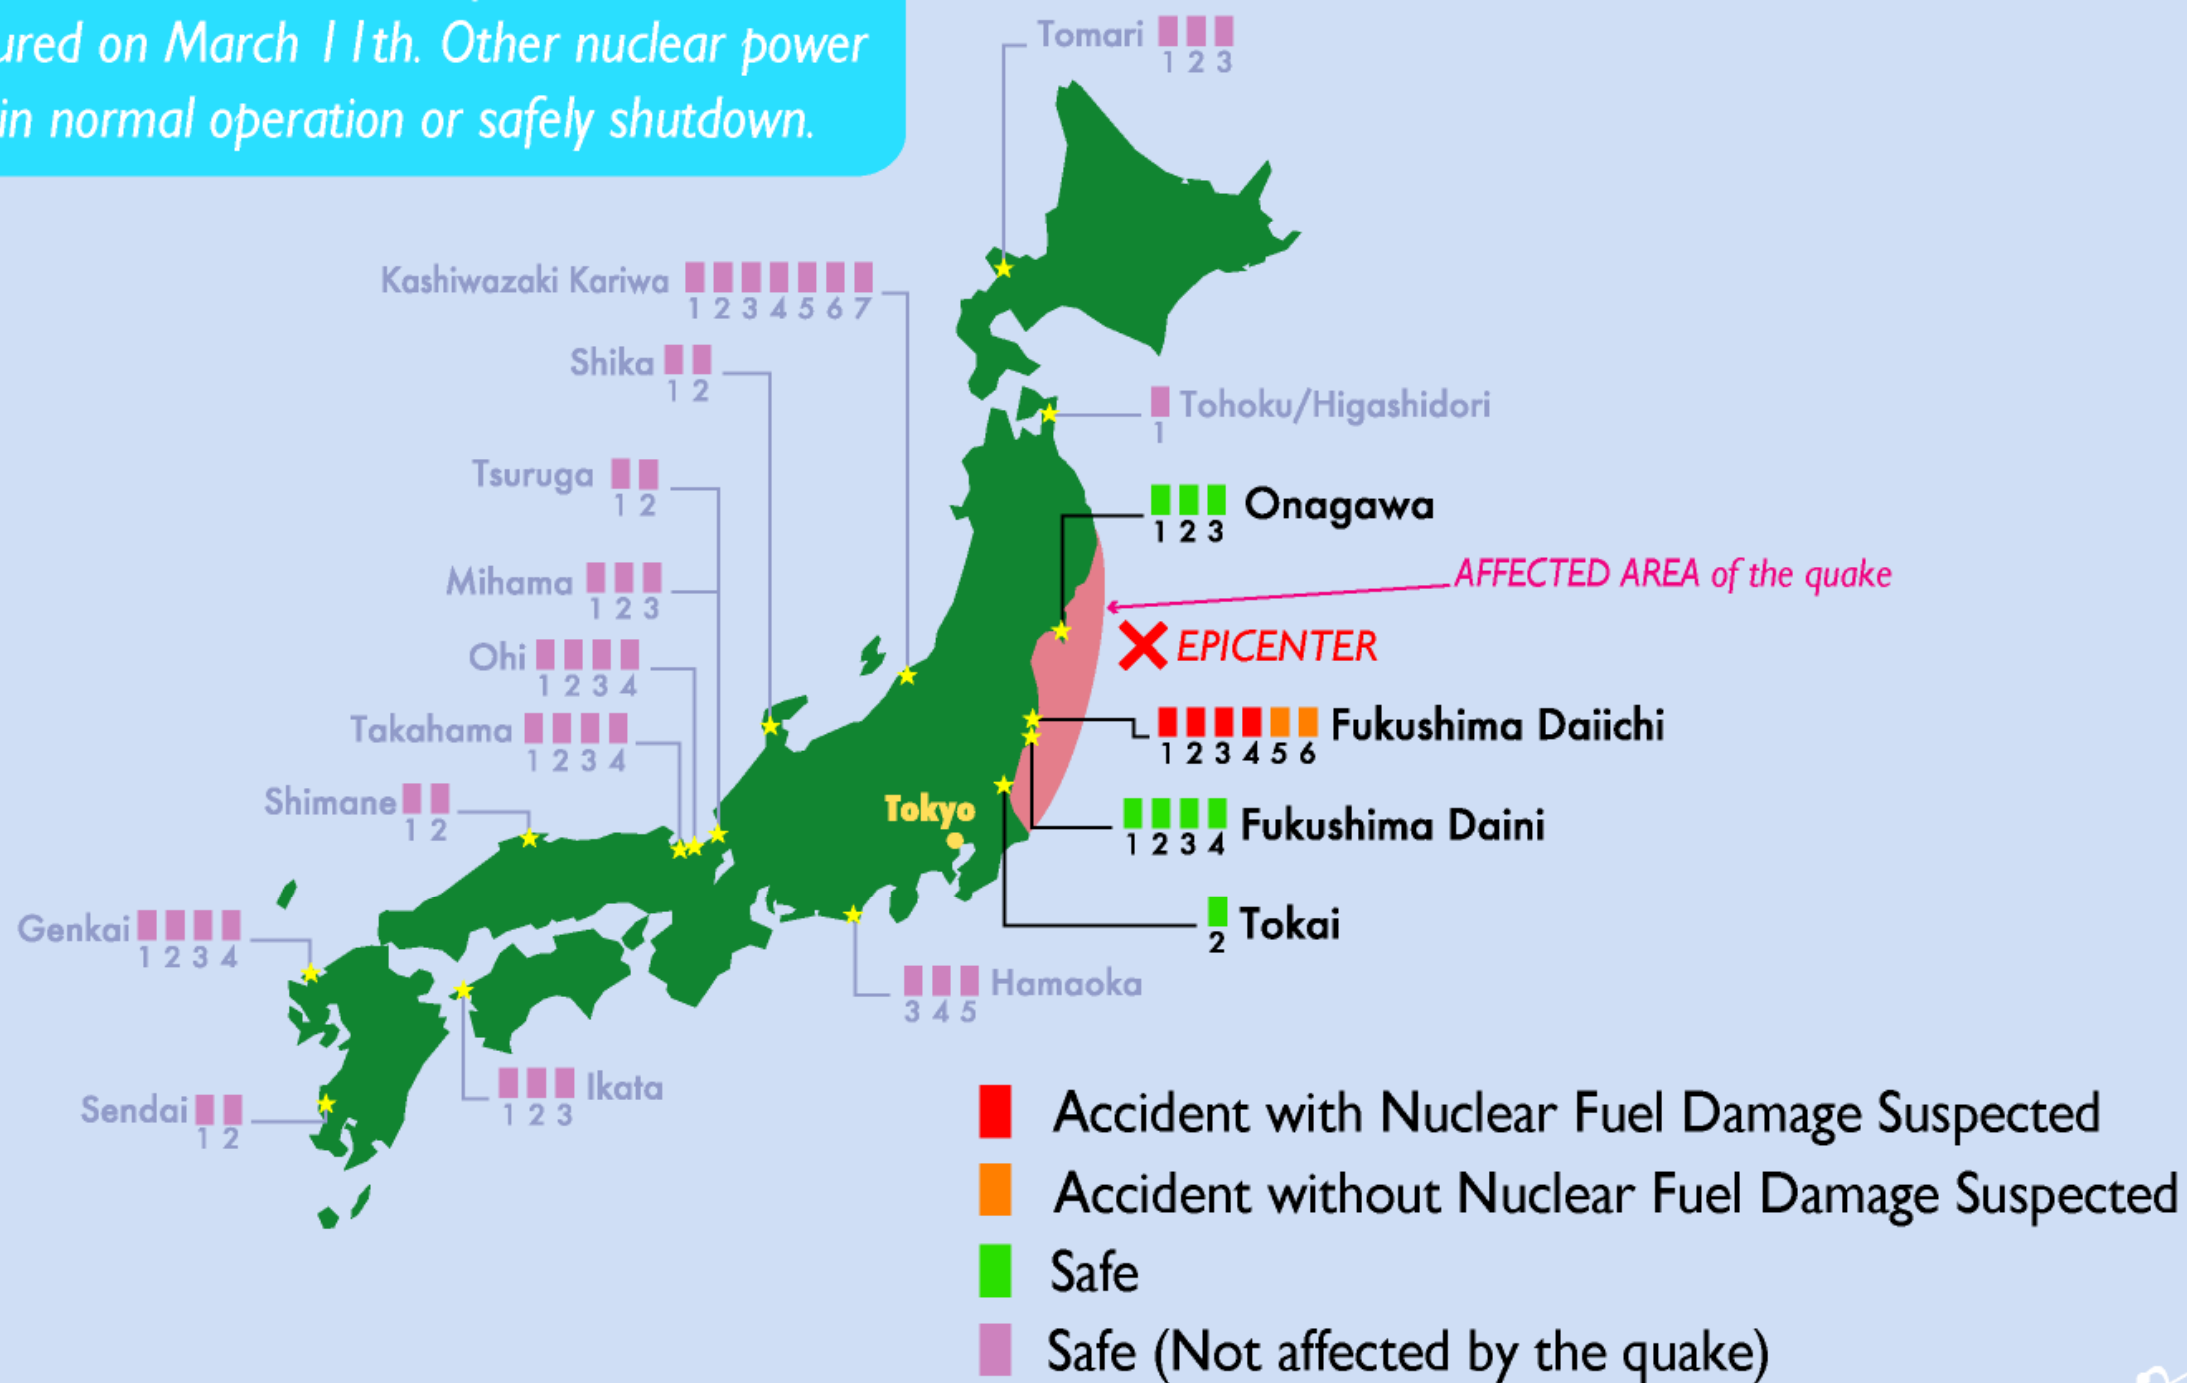
Status of the Nuclear Power Plants after the Earthquake

The accident that brings environmental impact is going on at several units in Fukushima Daiichi nuclear power Station after the earthquake occurred on March 11th. Other nuclear power plants in Japan are in normal operation or safely shutdown.
