Status of nuclear power plants in Fukushima as of 10:00 March 27 (Estimated by JAIF)

# Status of the Nuclear Power Plants after the Earthquake

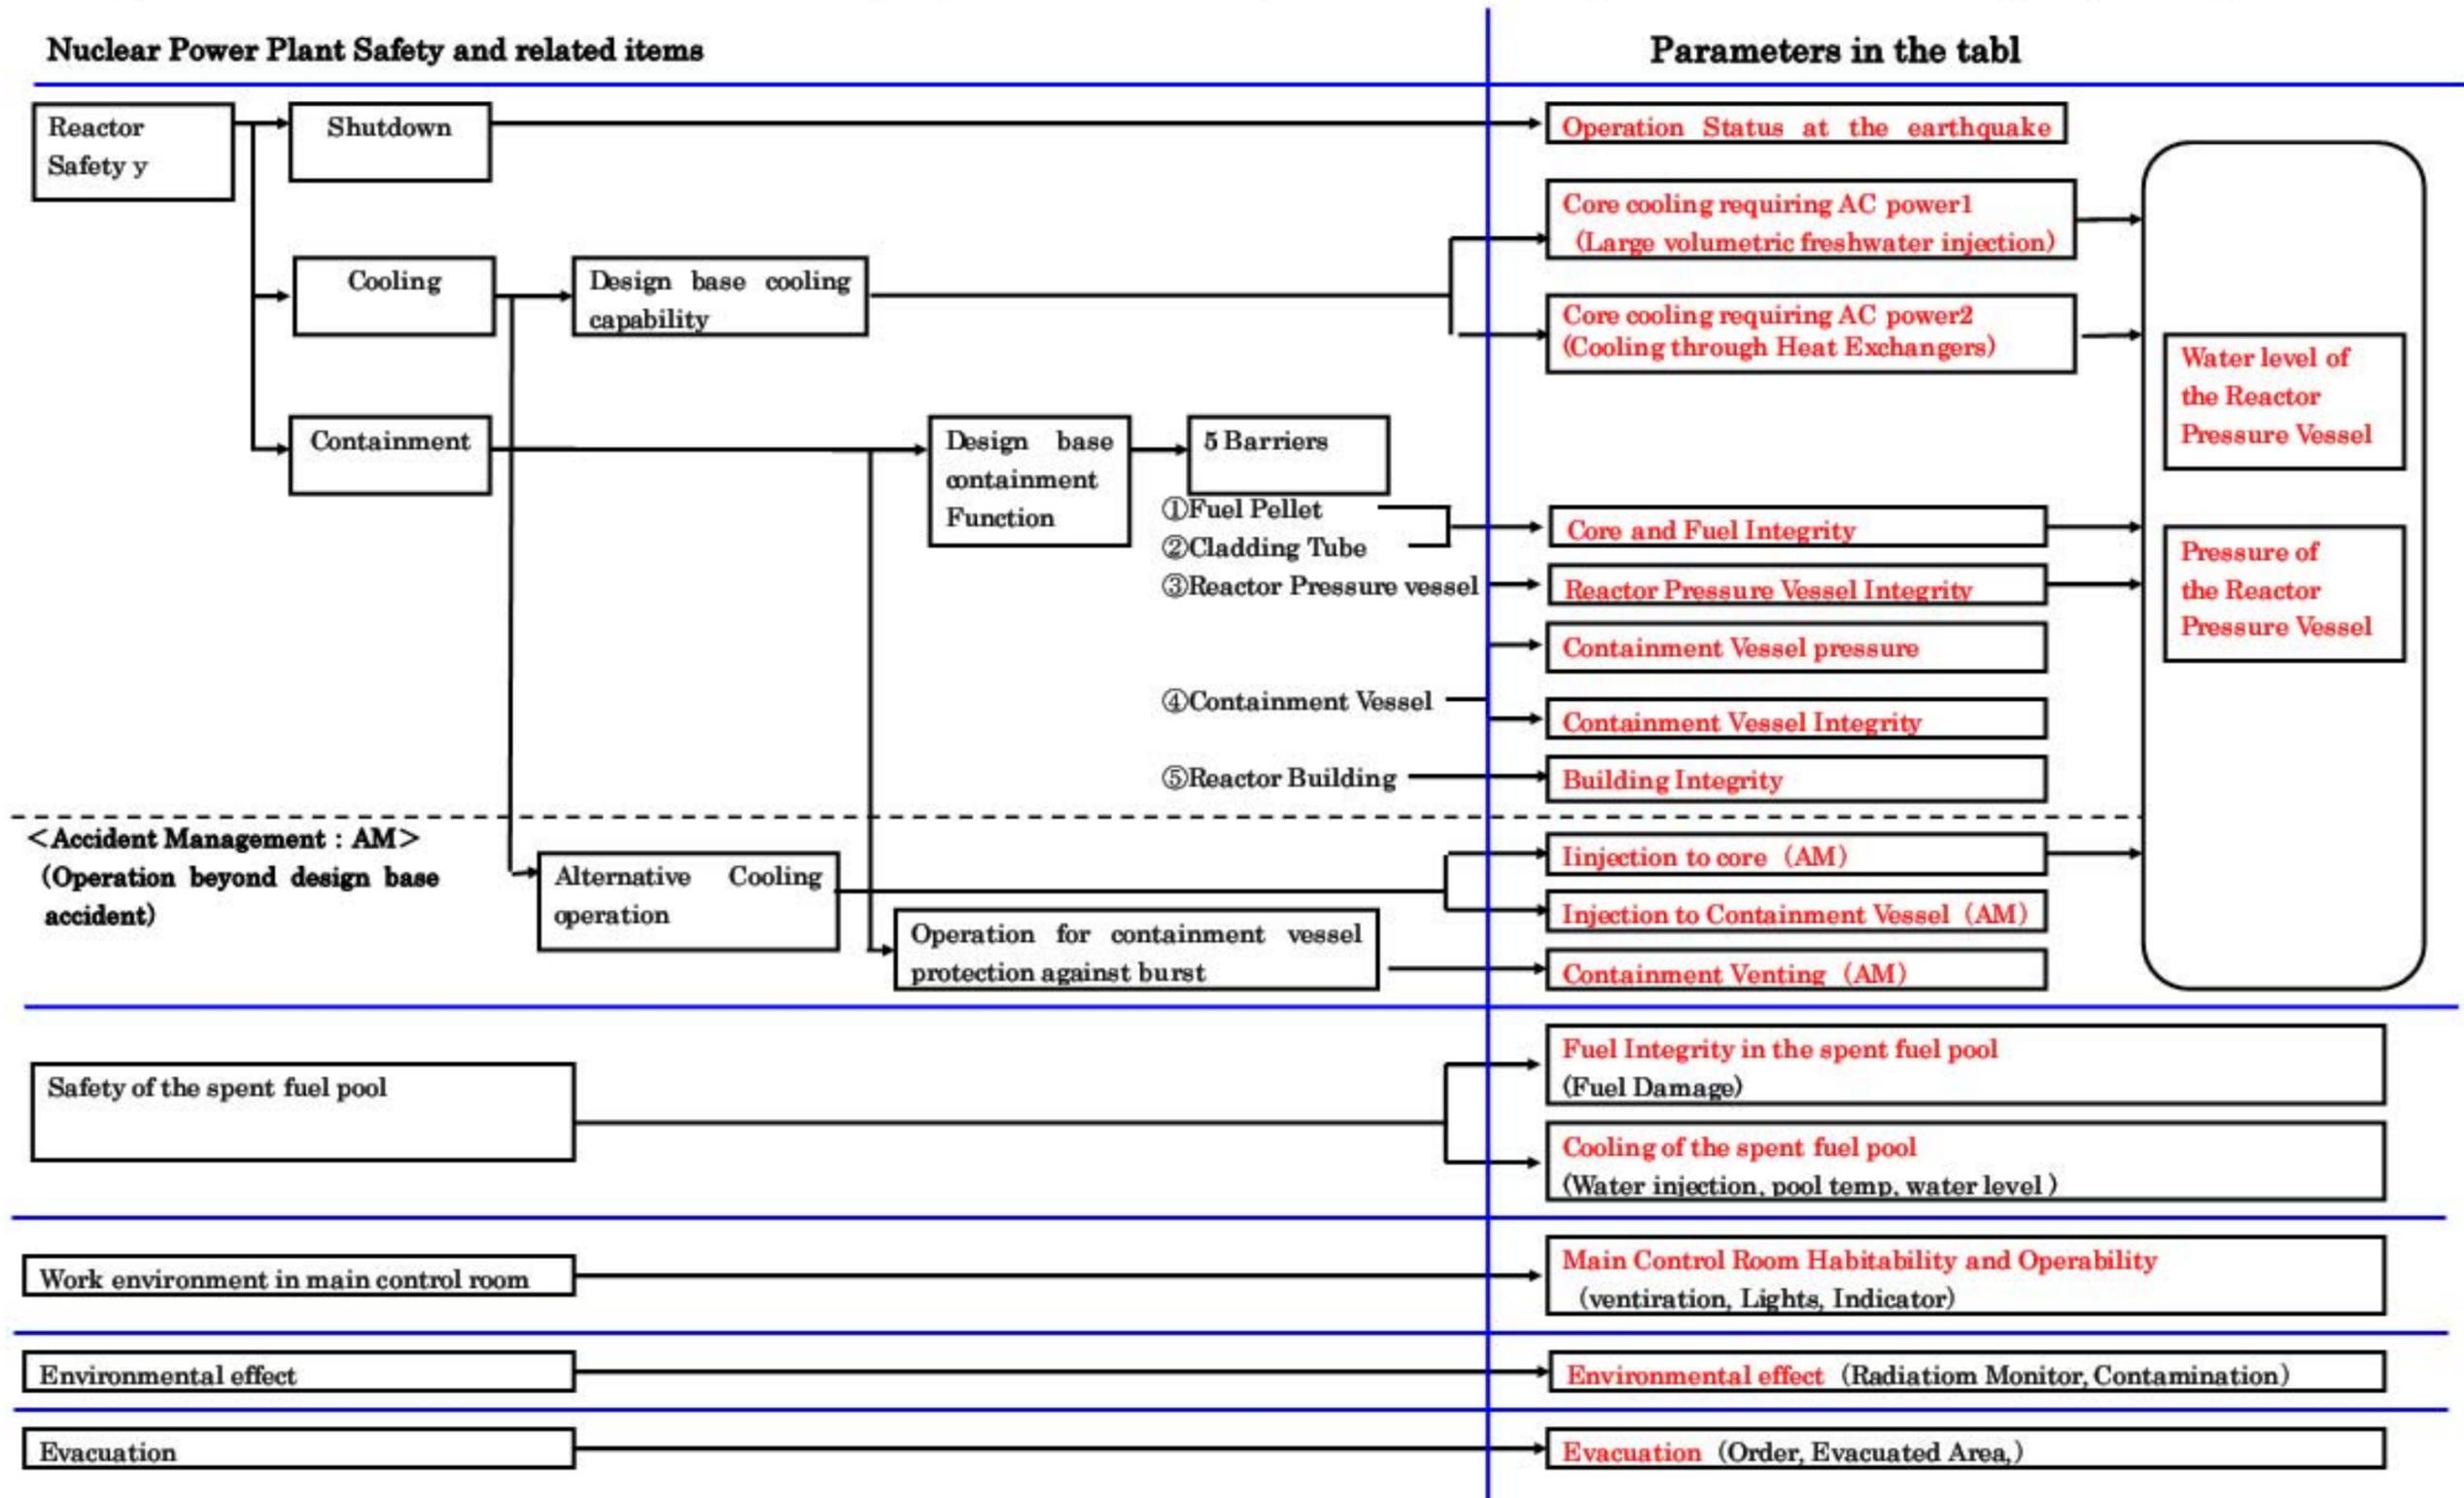
**Parameters in the Table**

JAIF picks up these parameters to evaluate safety condition of the nuclear plants during this accident from the view point of the principles of nuclear power plant safety, which are "Shutdown", "Cooling" and "Containment". Then we create the chart. The following diagram is to show the correspondence relation of these parameters in the table to nuclear power plant safety.
