Status of nuclear power plants in Fukushima as of 16:00 March 29 (Estimated by JAIF)

Status of the Nuclear Power Plants after the Earthquake

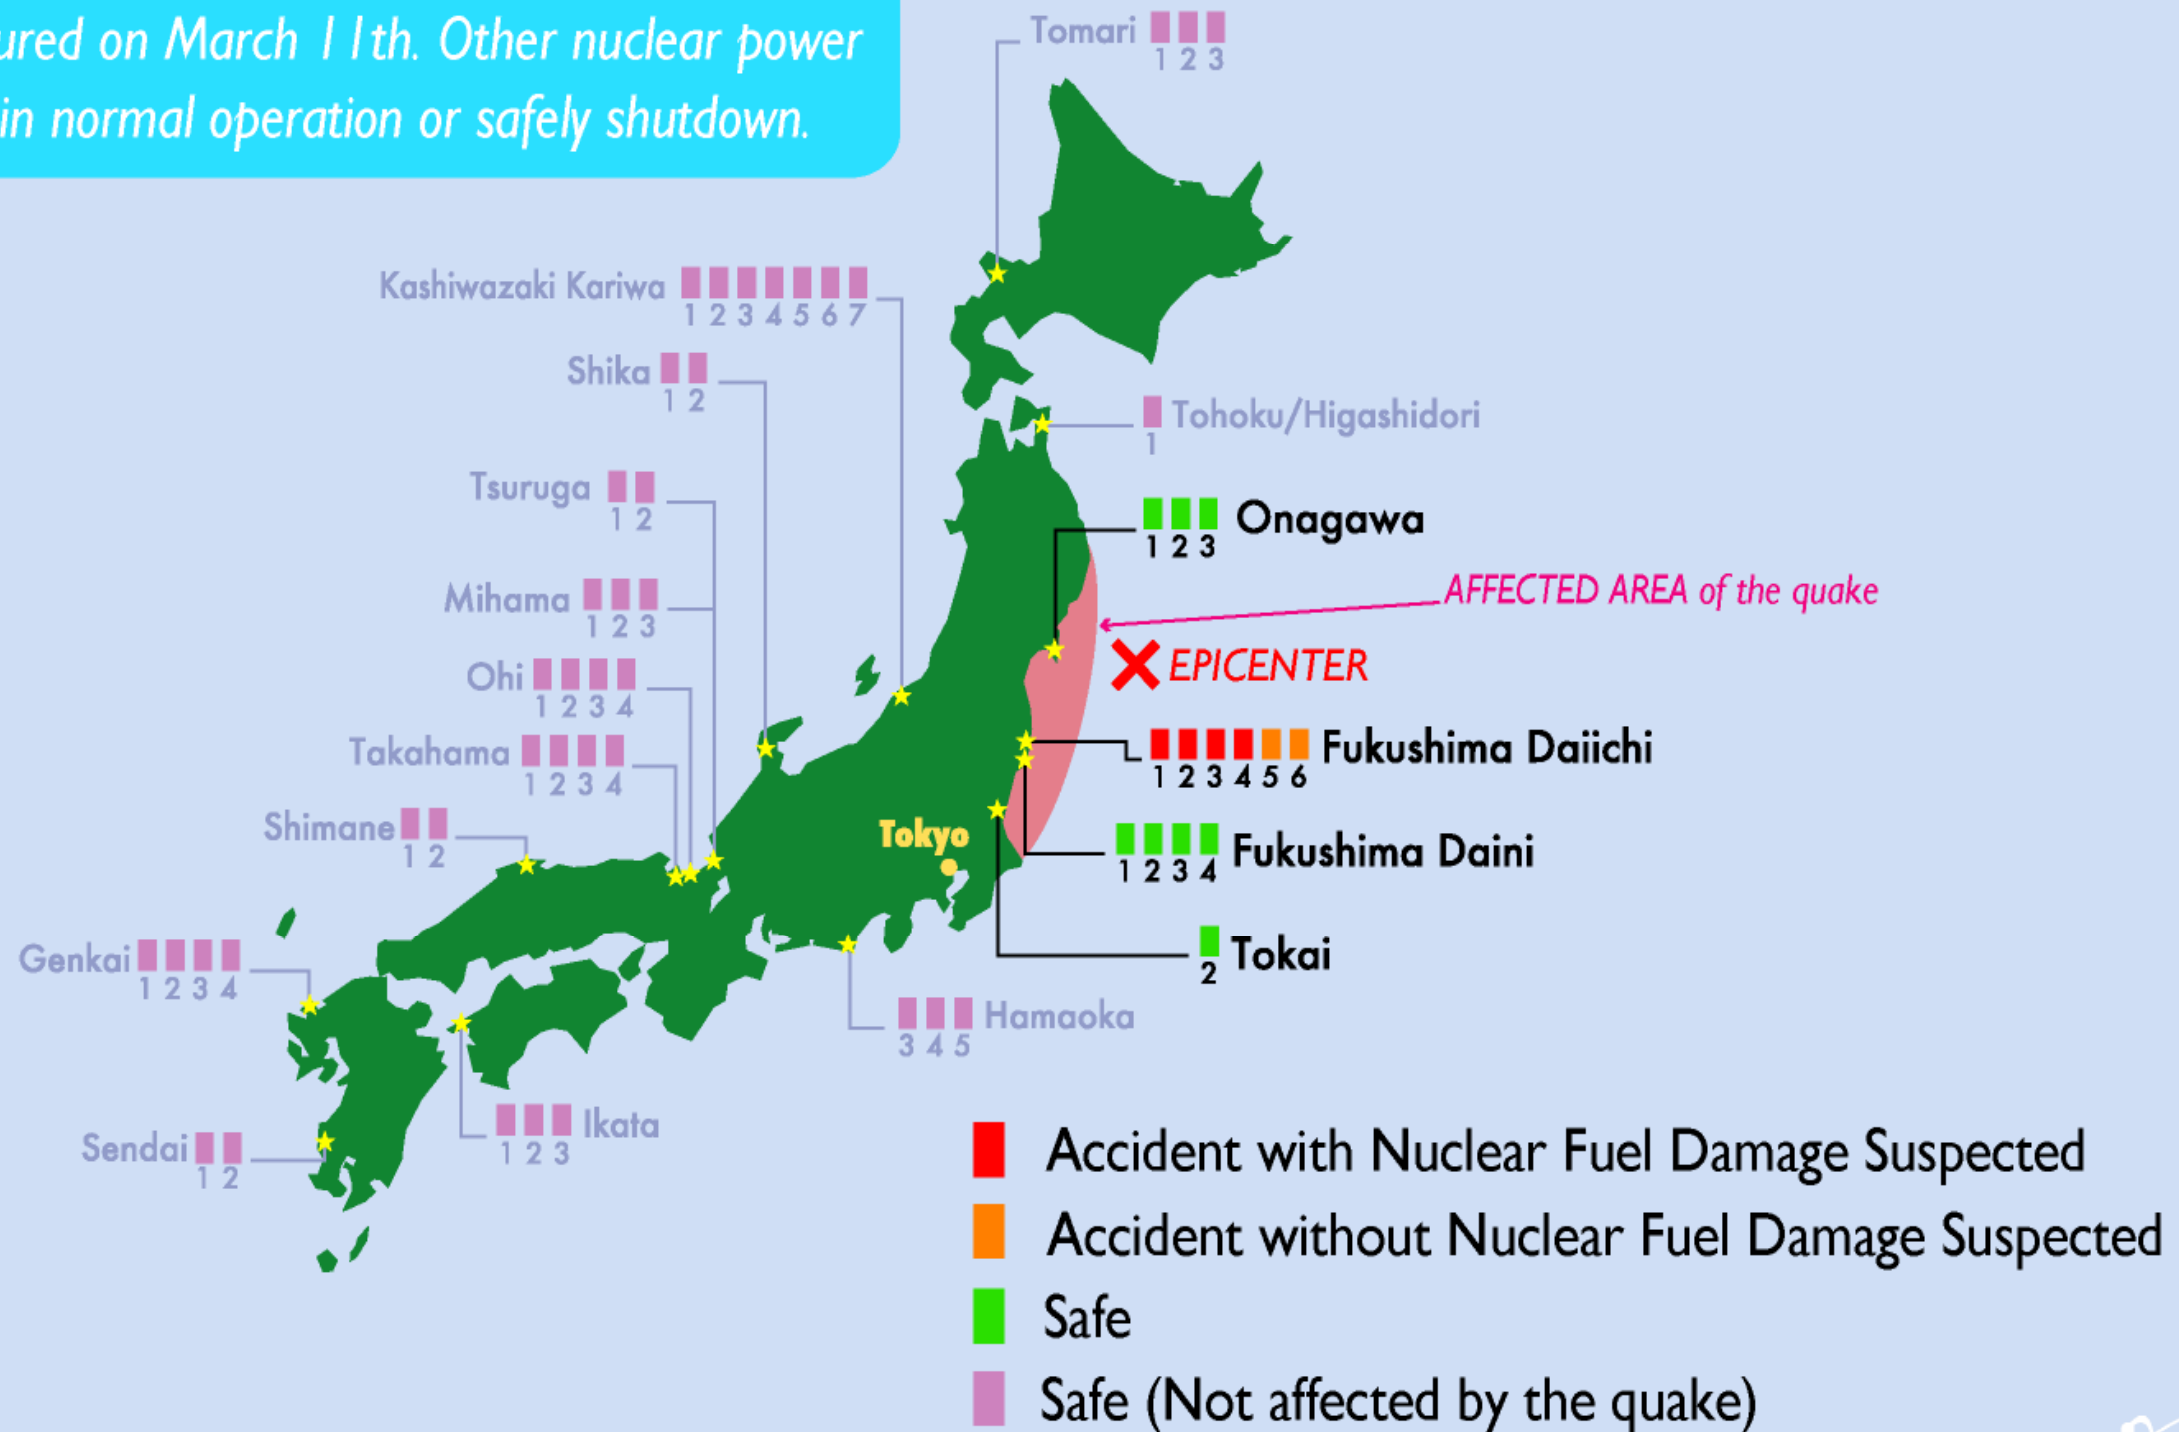
The accident that brings environmental impact is going on at several units in Fukushima Daiichi nuclear power Station after the earthquake occurred on March 11th. Other nuclear power plants in Japan are in normal operation or safely shutdown.
