Information on Status of Nuclear Power Plants in Fukushima

Japan Atomic Industrial Forum, Inc.

Status of nuclear power plants in Fukushima as of 21:00 March 31 (Estimated by JAIF)

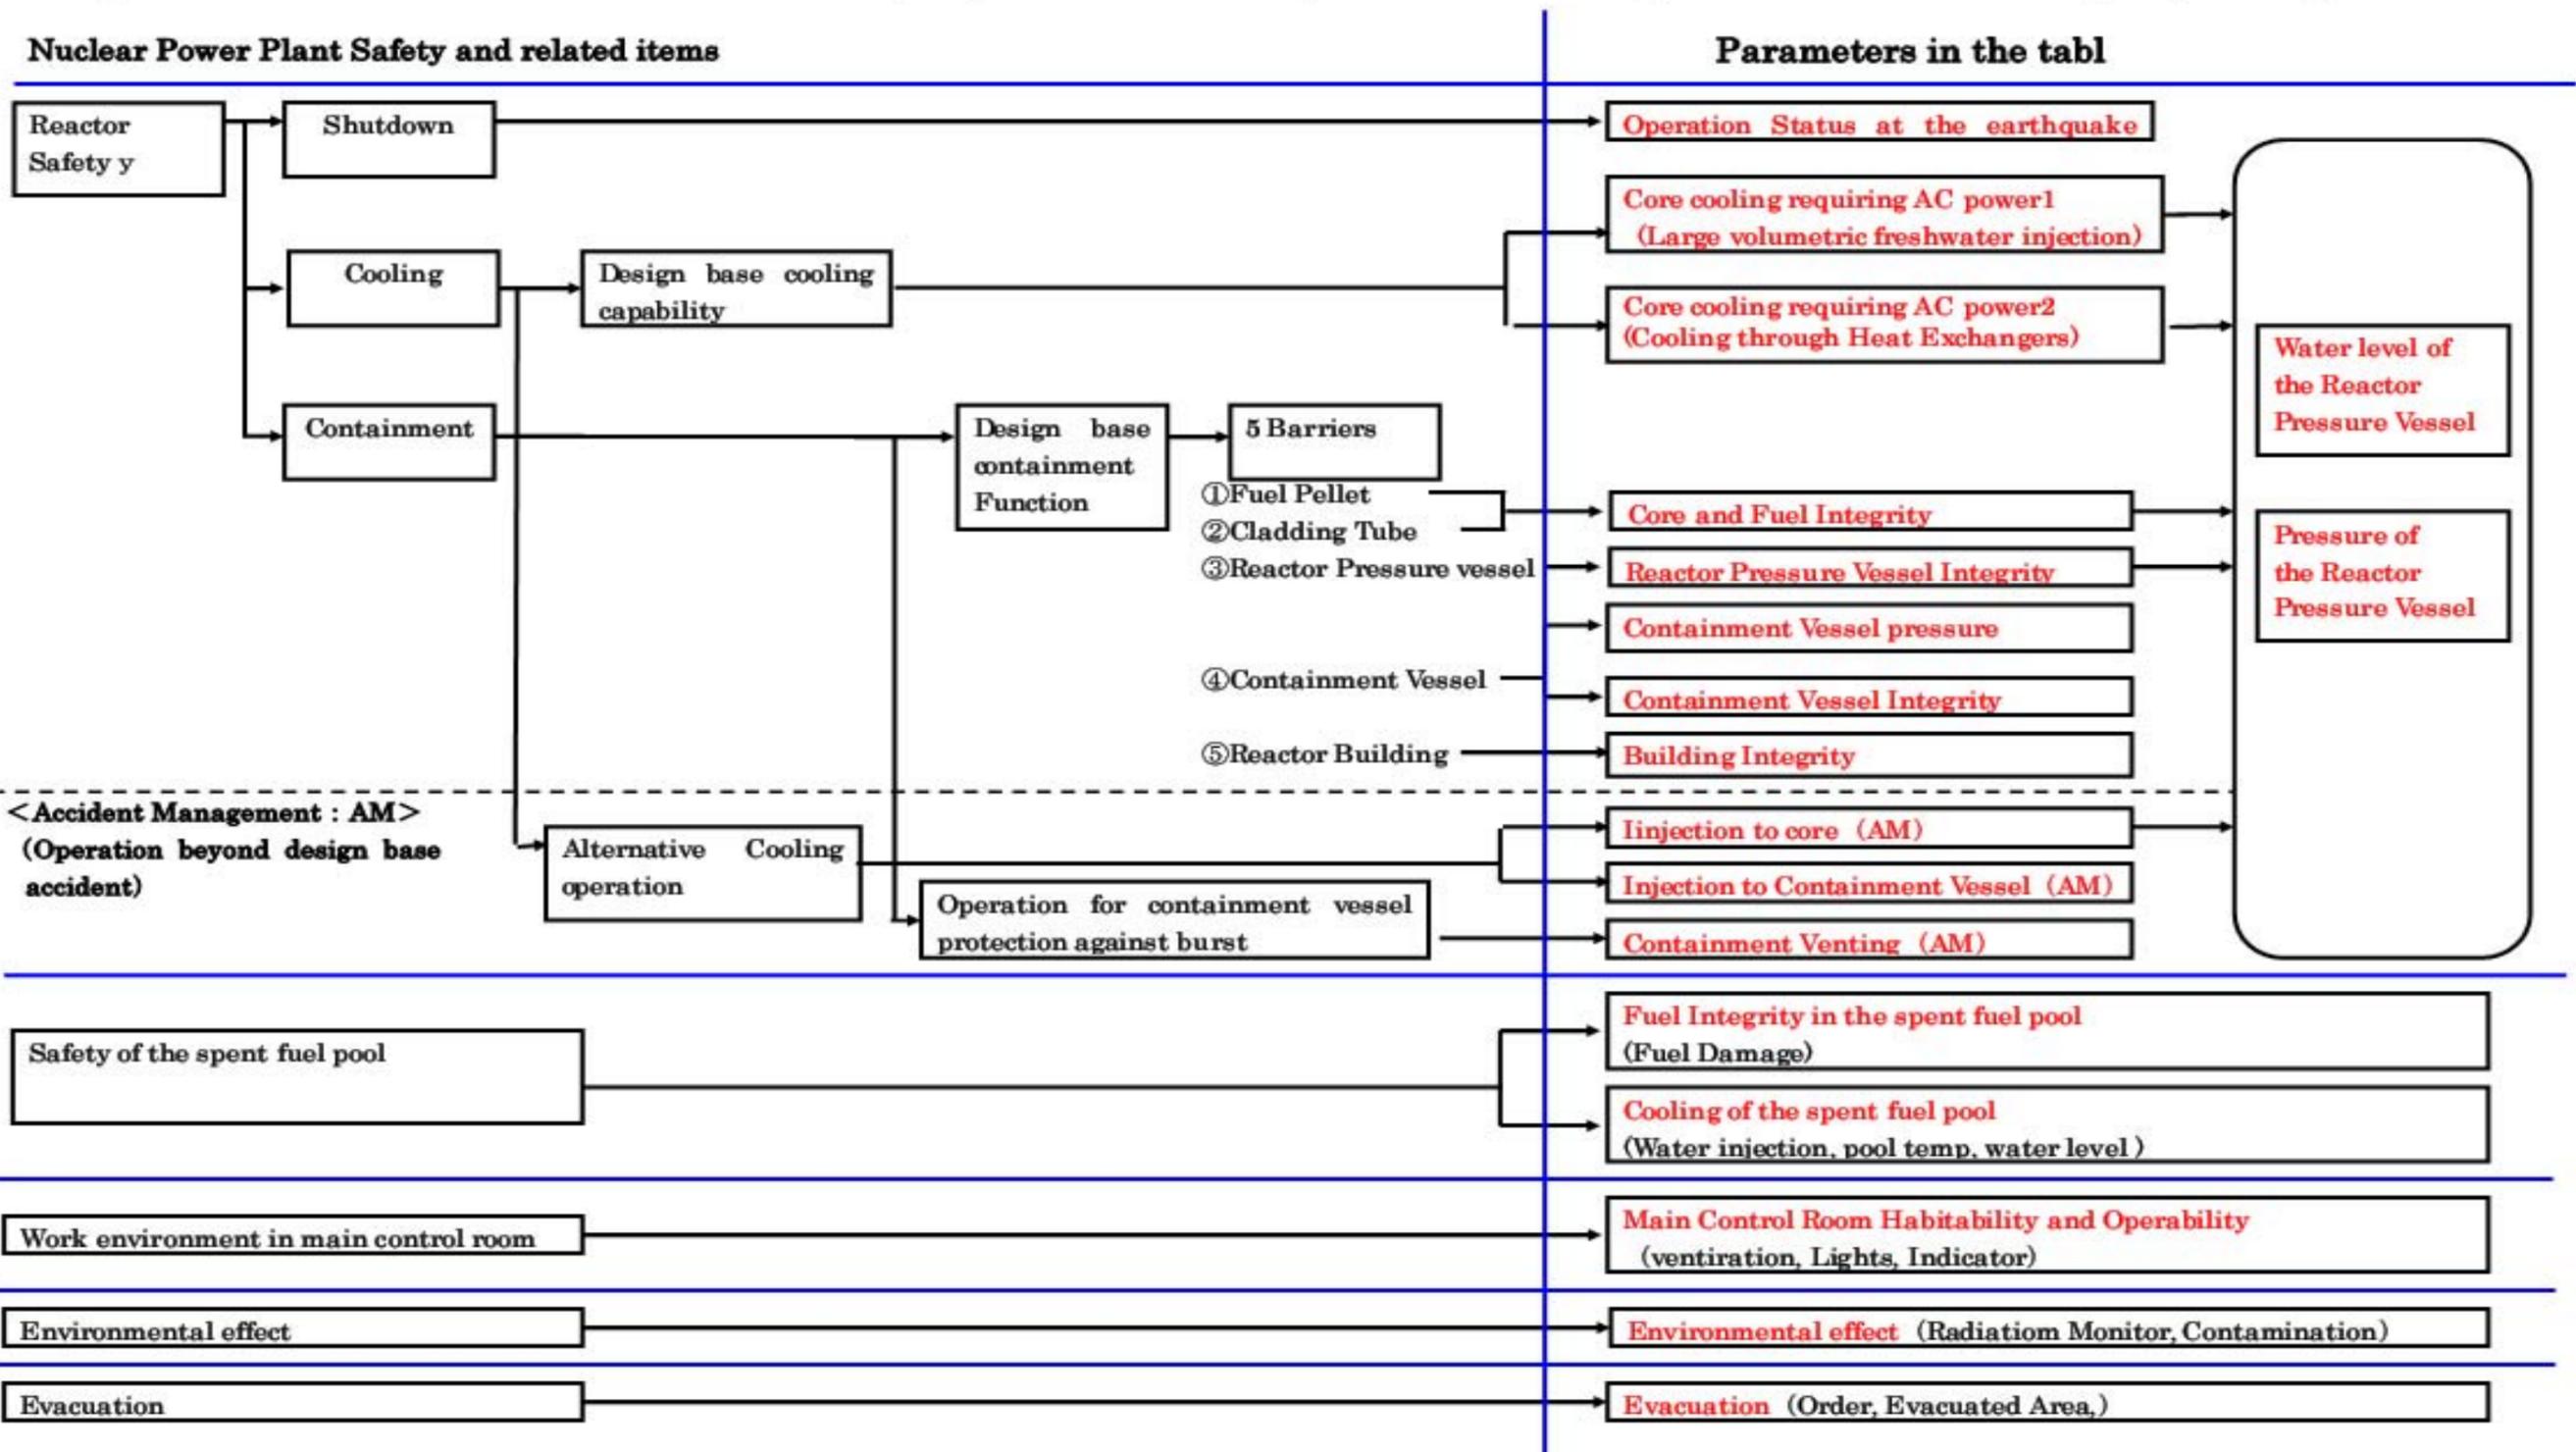
Parameters in the Table

JAIF picks up these parameters to evaluate safety condition of the nuclear plants during this accident from the view point of the principles of nuclear power plant safety, which are "Shutdown", "Cooling" and "Containment". Then we create the chart. The following diagram is to show the correspondence relation of these parameters in the table to nuclear power plant safety.

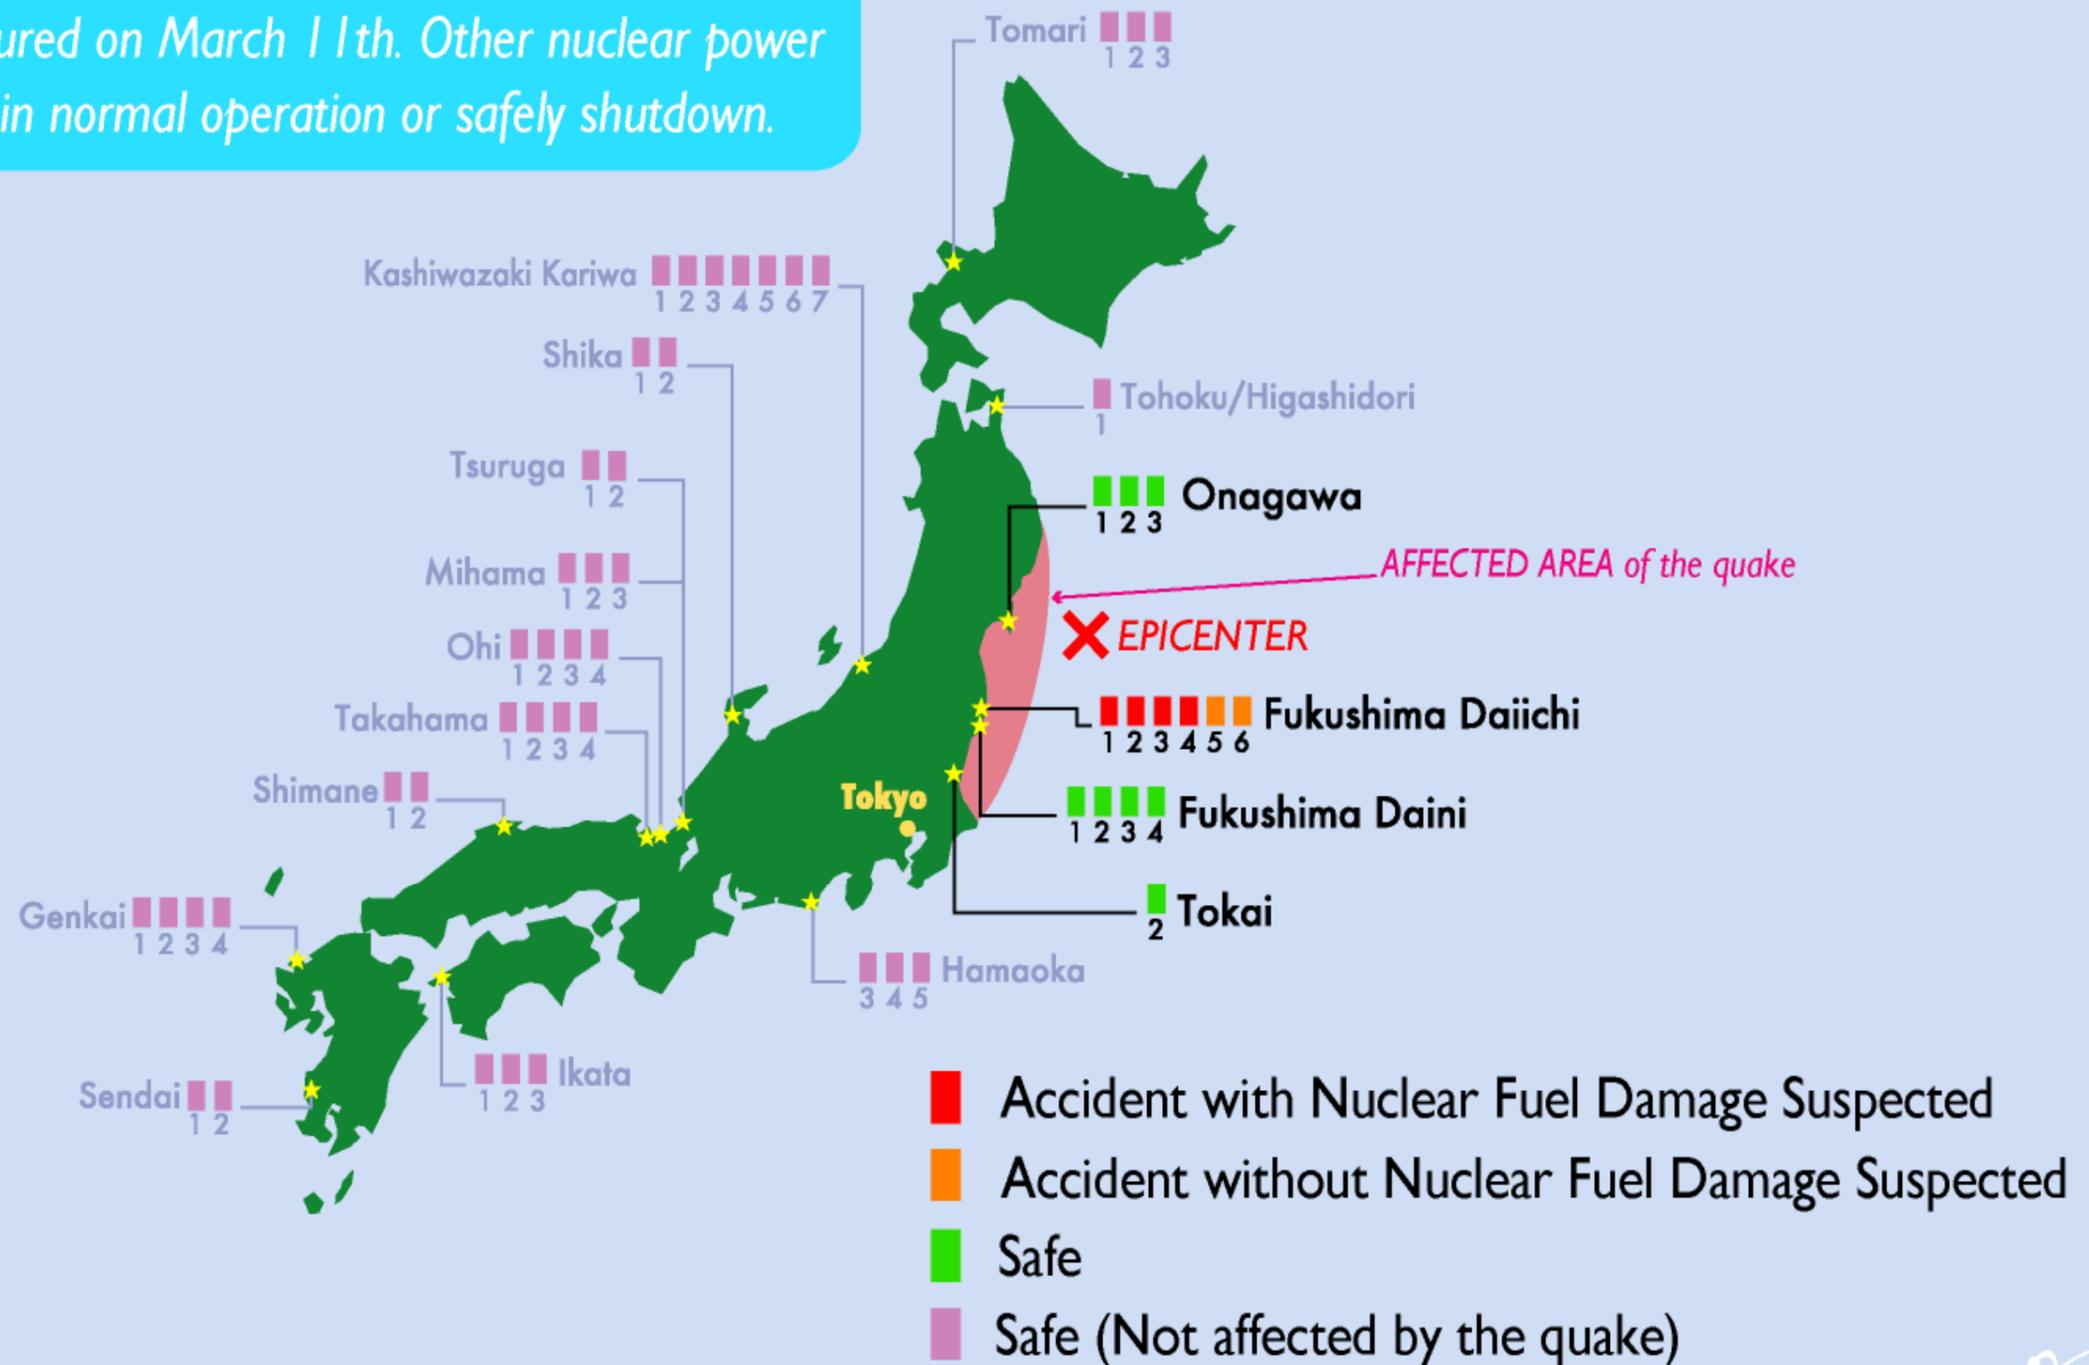
Status of the Nuclear Power Plants after the Earthquake

The accident that brings environmental impact is going on at several units in Fukushima Daiichi nuclear power Station after the earthquake occurred on March 11th. Other nuclear power plants in Japan are in normal operation or safely shutdown.
