Information on Status of Nuclear Power Plants in Fukushima

Japan Atomic Industrial Forum, Inc.

Status of nuclear power plants in Fukushima as of 10:00, April 5th (Estimated by JAIF)

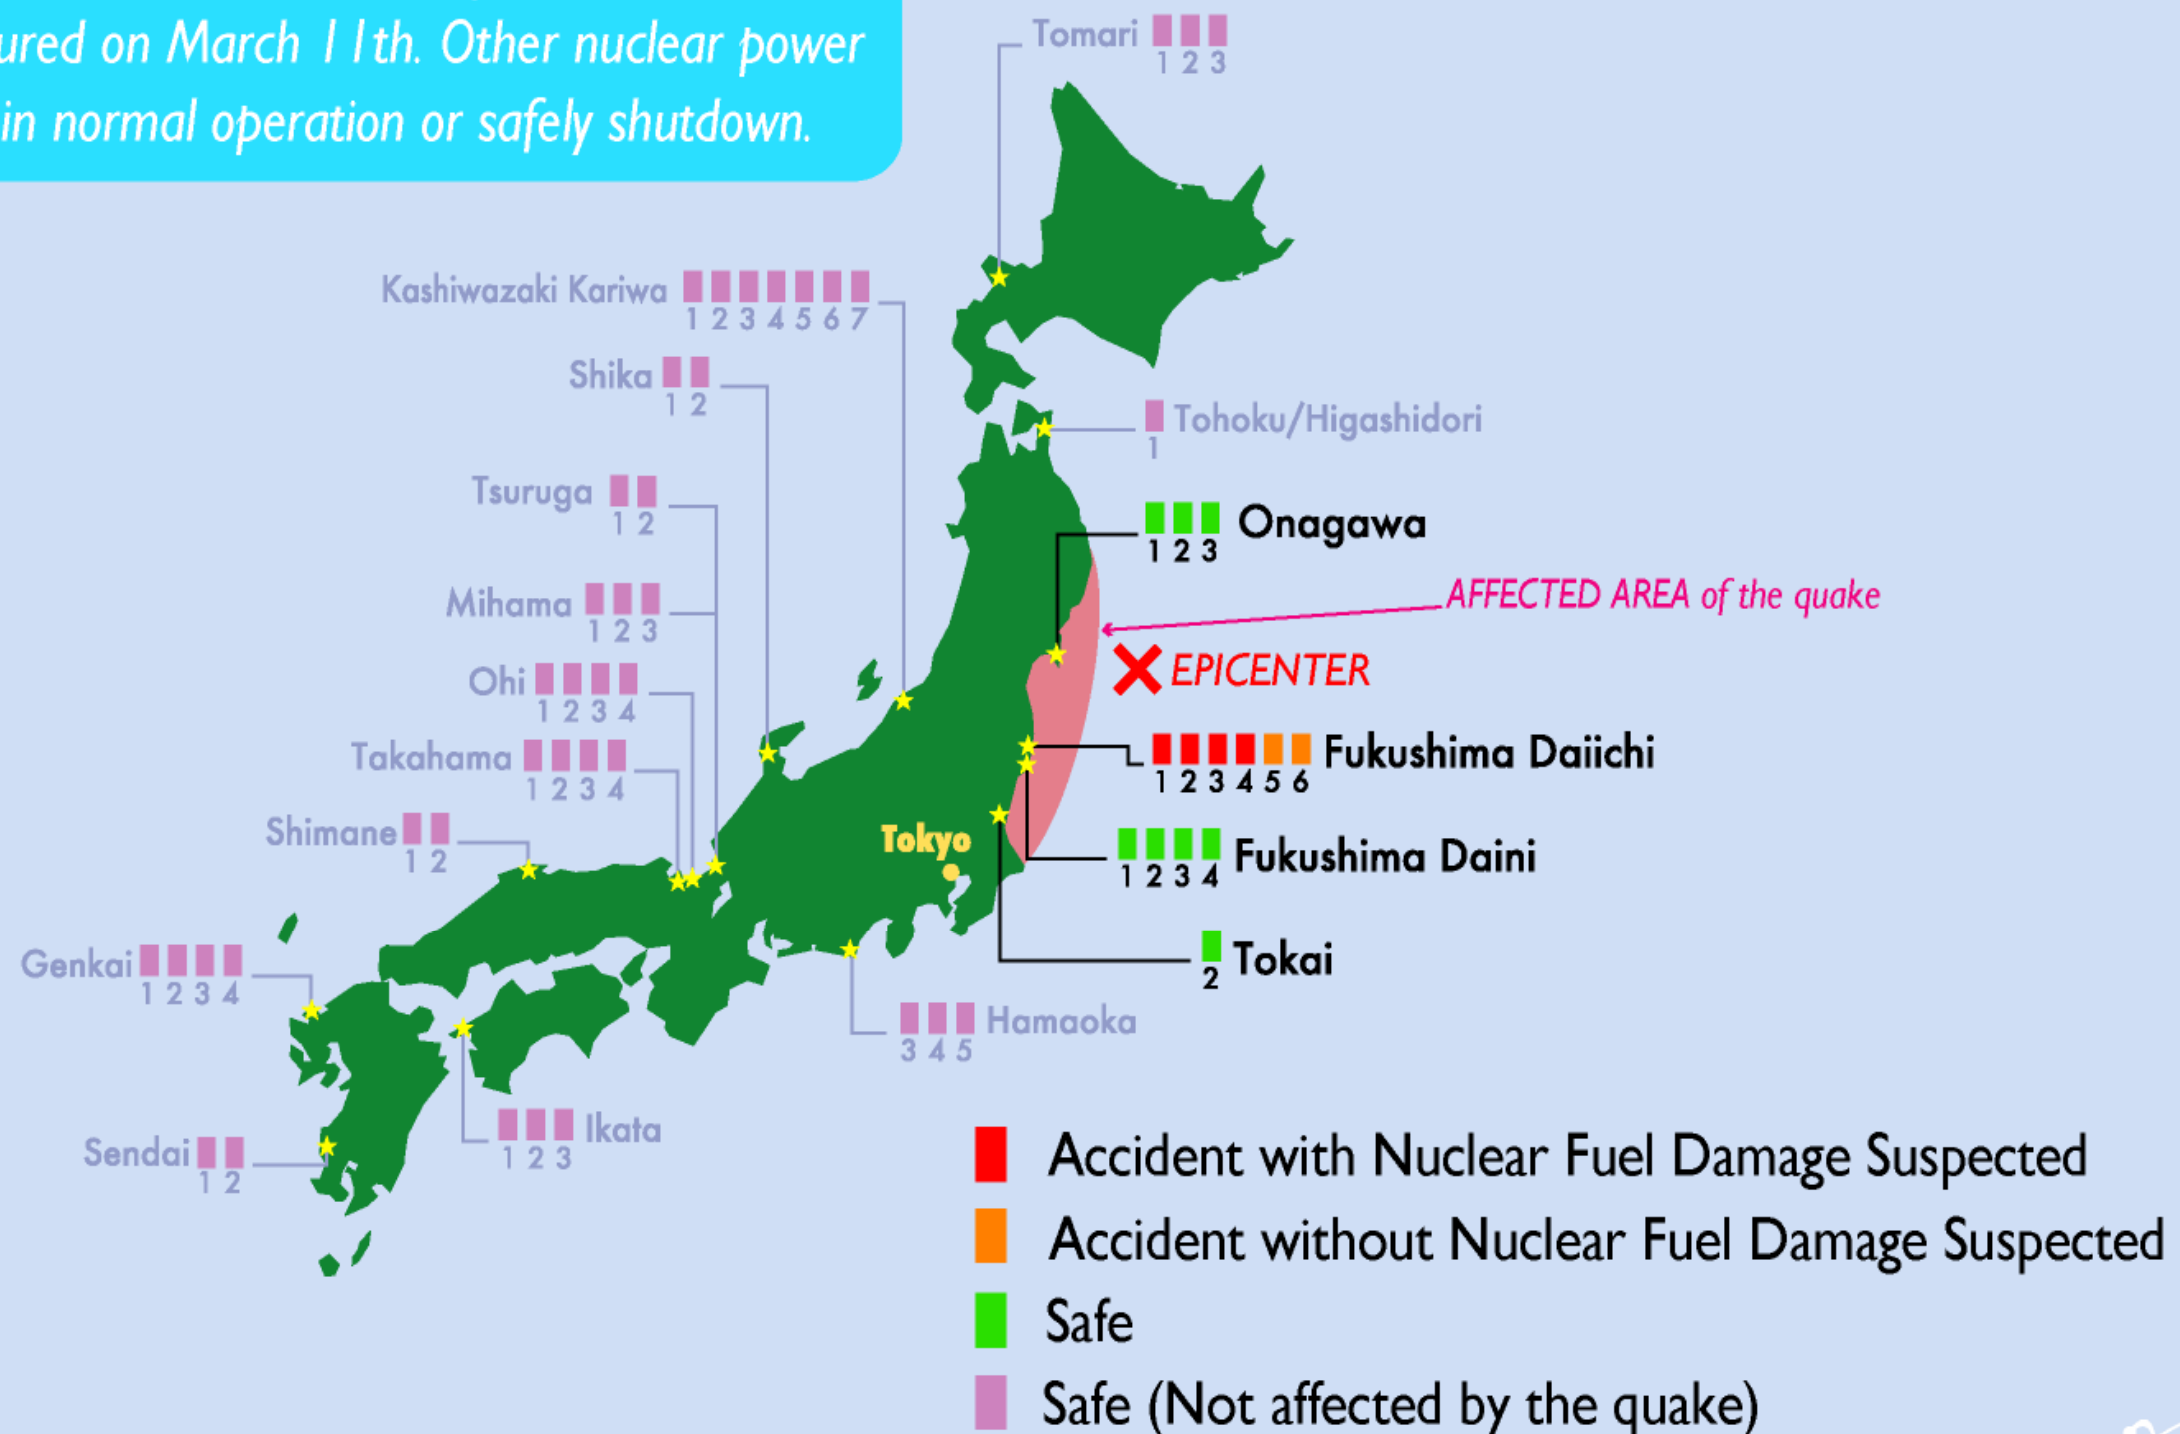
Status of the Nuclear Power Plants after the Earthquake

The accident that brings environmental impact is going on at several units in Fukushima Daiichi nuclear power Station after the earthquake occurred on March 11th. Other nuclear power plants in Japan are in normal operation or safely shutdown.
