Information on Status of Nuclear Power Plants in Fukushima

Japan Atomic Industrial Forum, Inc.

Status of nuclear power plants in Fukushima as of 16:00, April 5th (Estimated by JAIF)

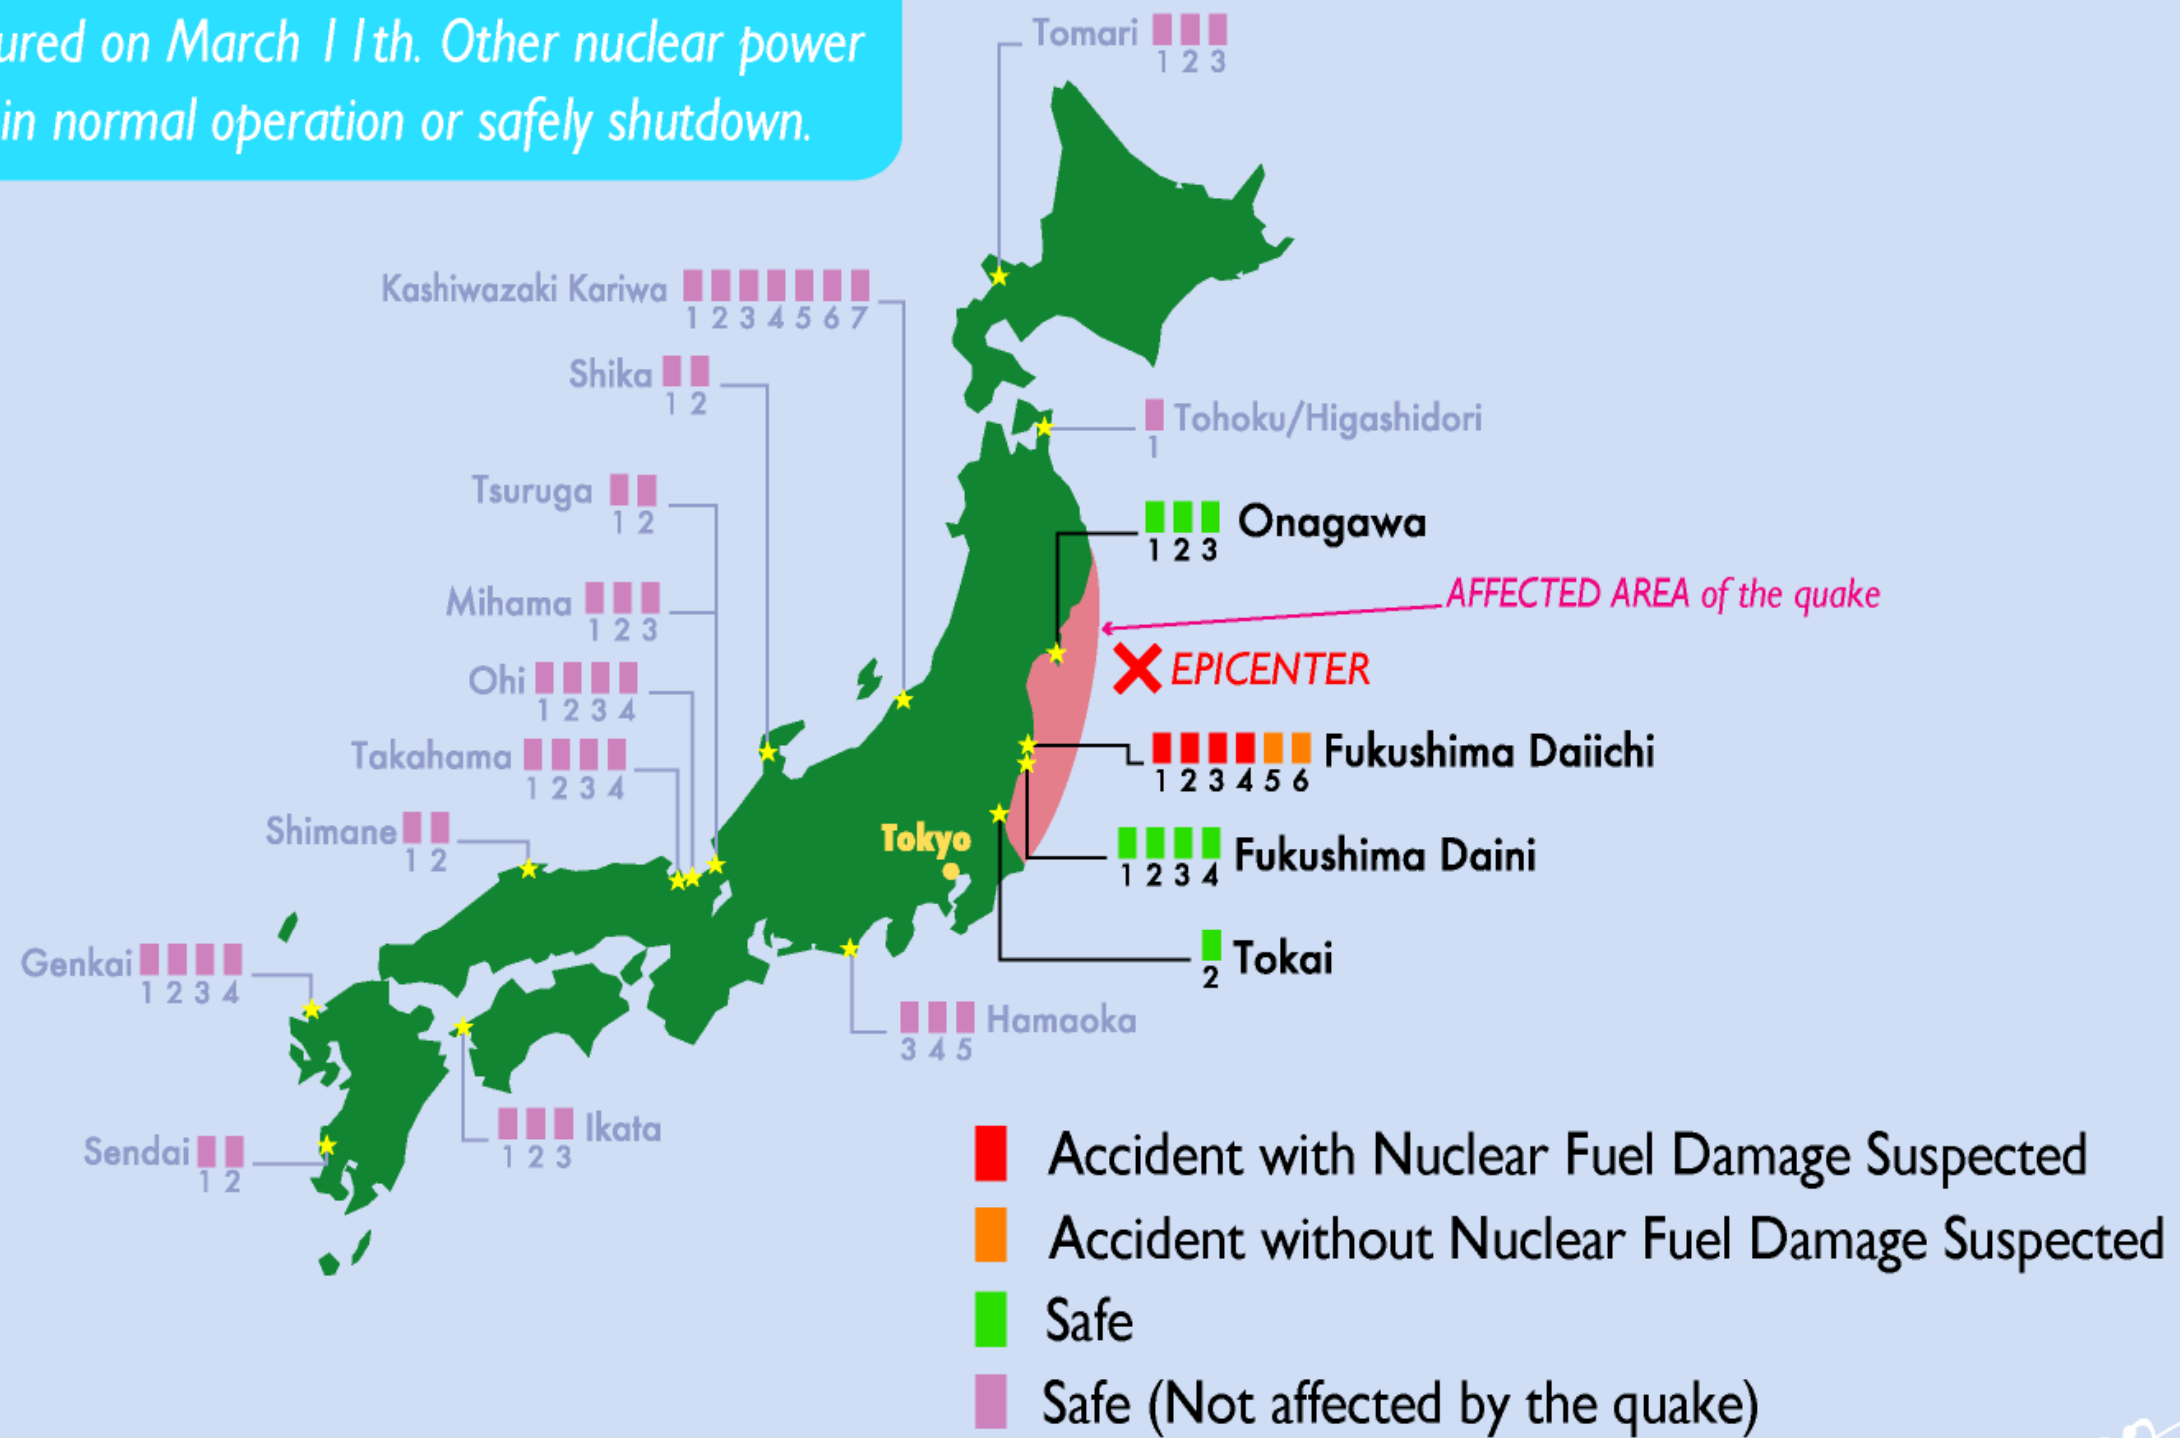
Status of the Nuclear Power Plants after the Earthquake

The accident that brings environmental impact is going on at several units in Fukushima Daiichi nuclear power Station after the earthquake occurred on March 11th. Other nuclear power plants in Japan are in normal operation or safely shutdown.
