# Information on Status of Nuclear Power Plants in Fukushima

Japan Atomic Industrial Forum, Inc.

**Status of nuclear power plants in Fukushima as of 10:00, April 8th (Estimated by JAIF)**

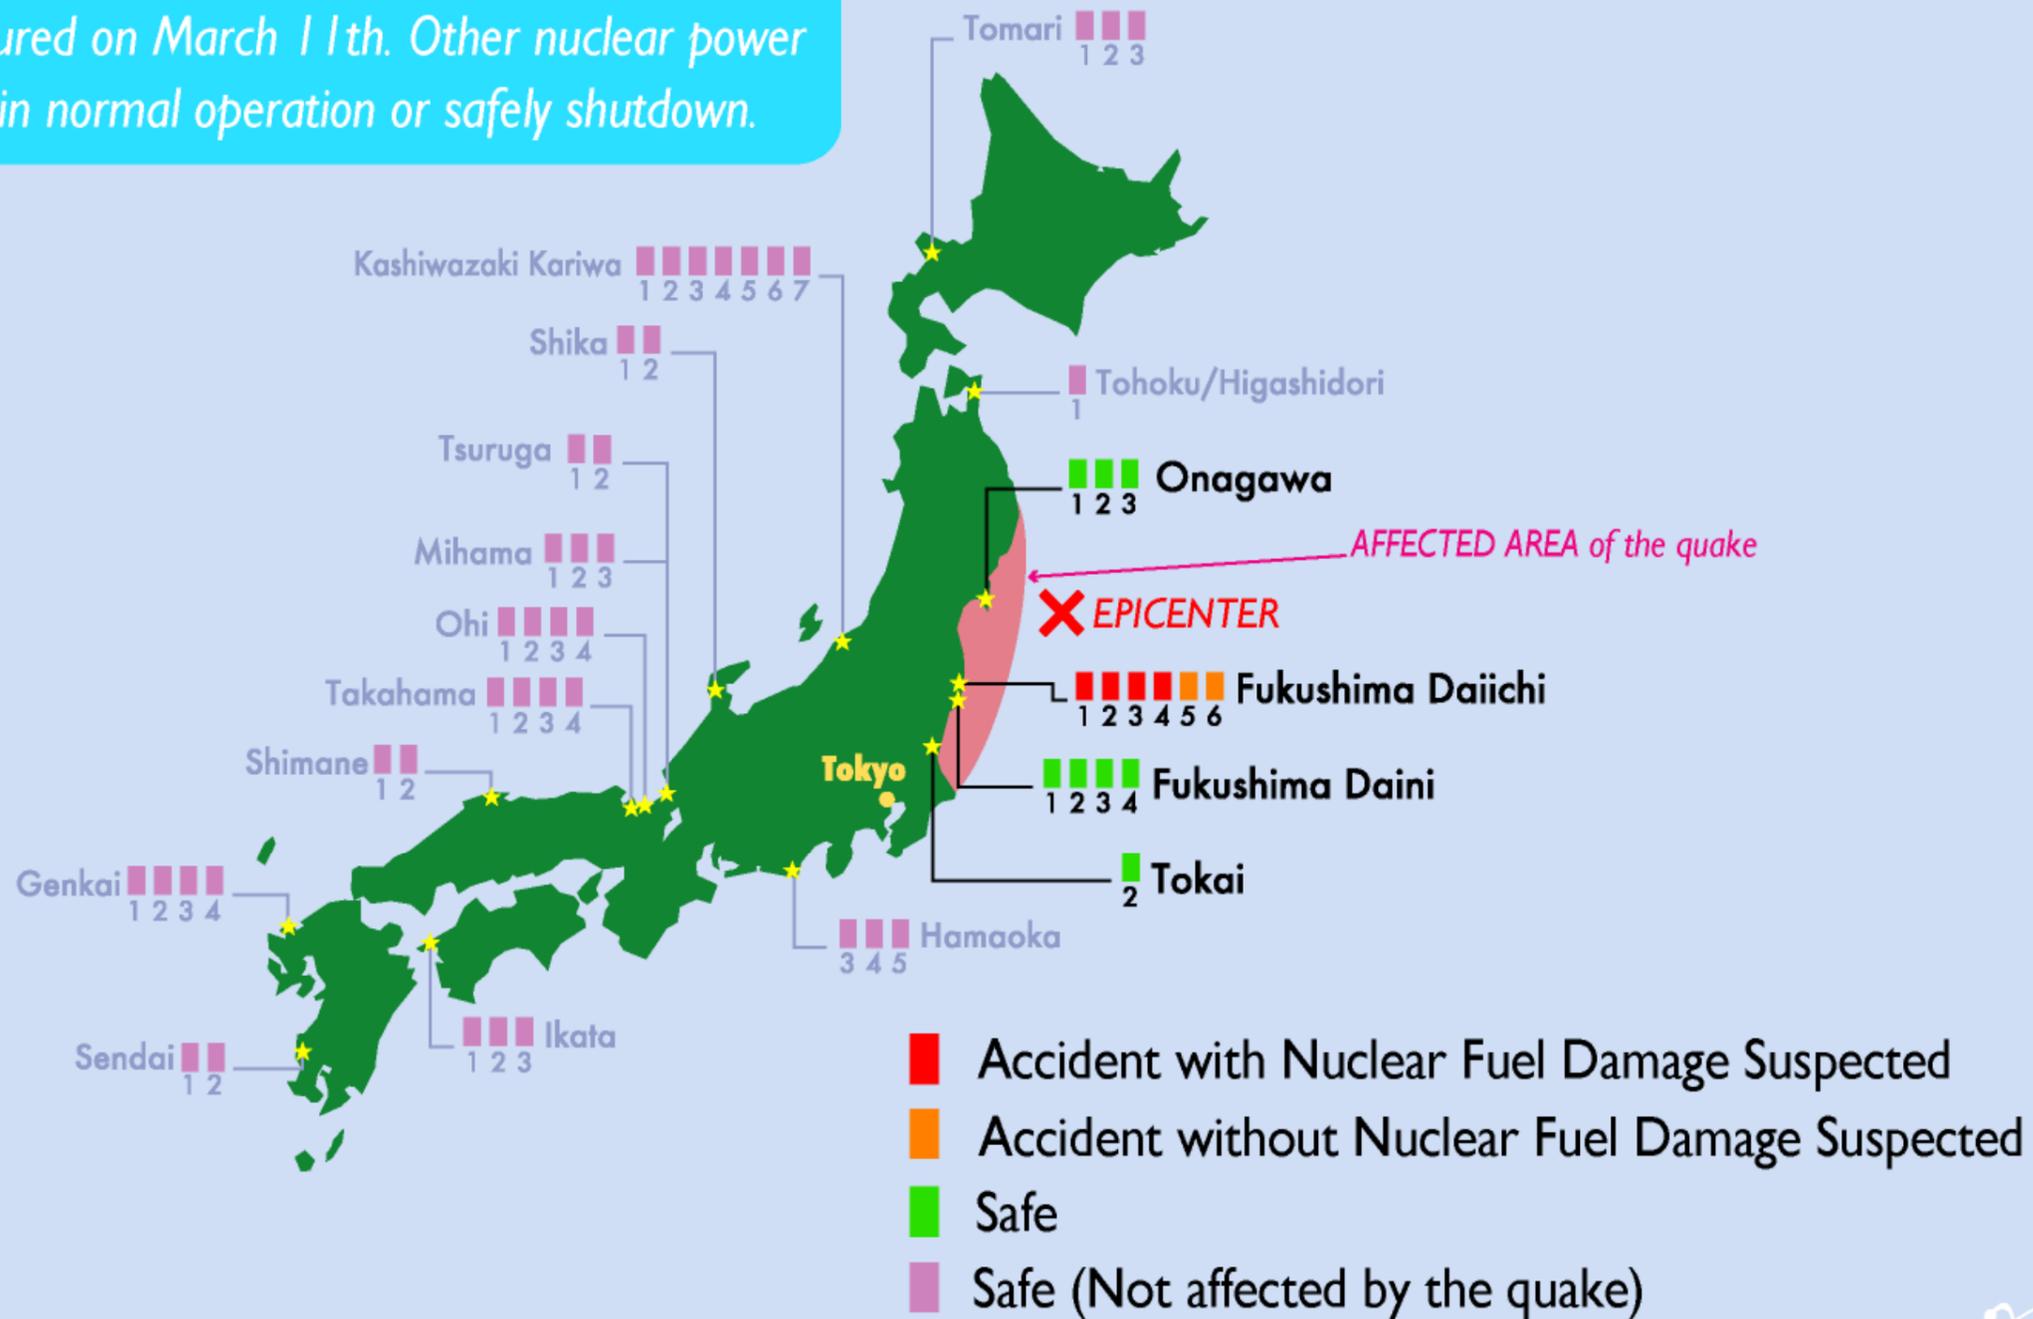
# Status of the Nuclear Power Plants after the Earthquake

The accident that brings environmental impact is going on at several units in Fukushima Daiichi nuclear power Station after the earthquake occurred on March 11th. Other nuclear power plants in Japan are in normal operation or safely shutdown.
