Information on Status of Nuclear Power Plants in Fukushima

Japan Atomic Industrial Forum, Inc.

Status of nuclear power plants in Fukushima as of 16:00, April 8th (Estimated by JAIF)

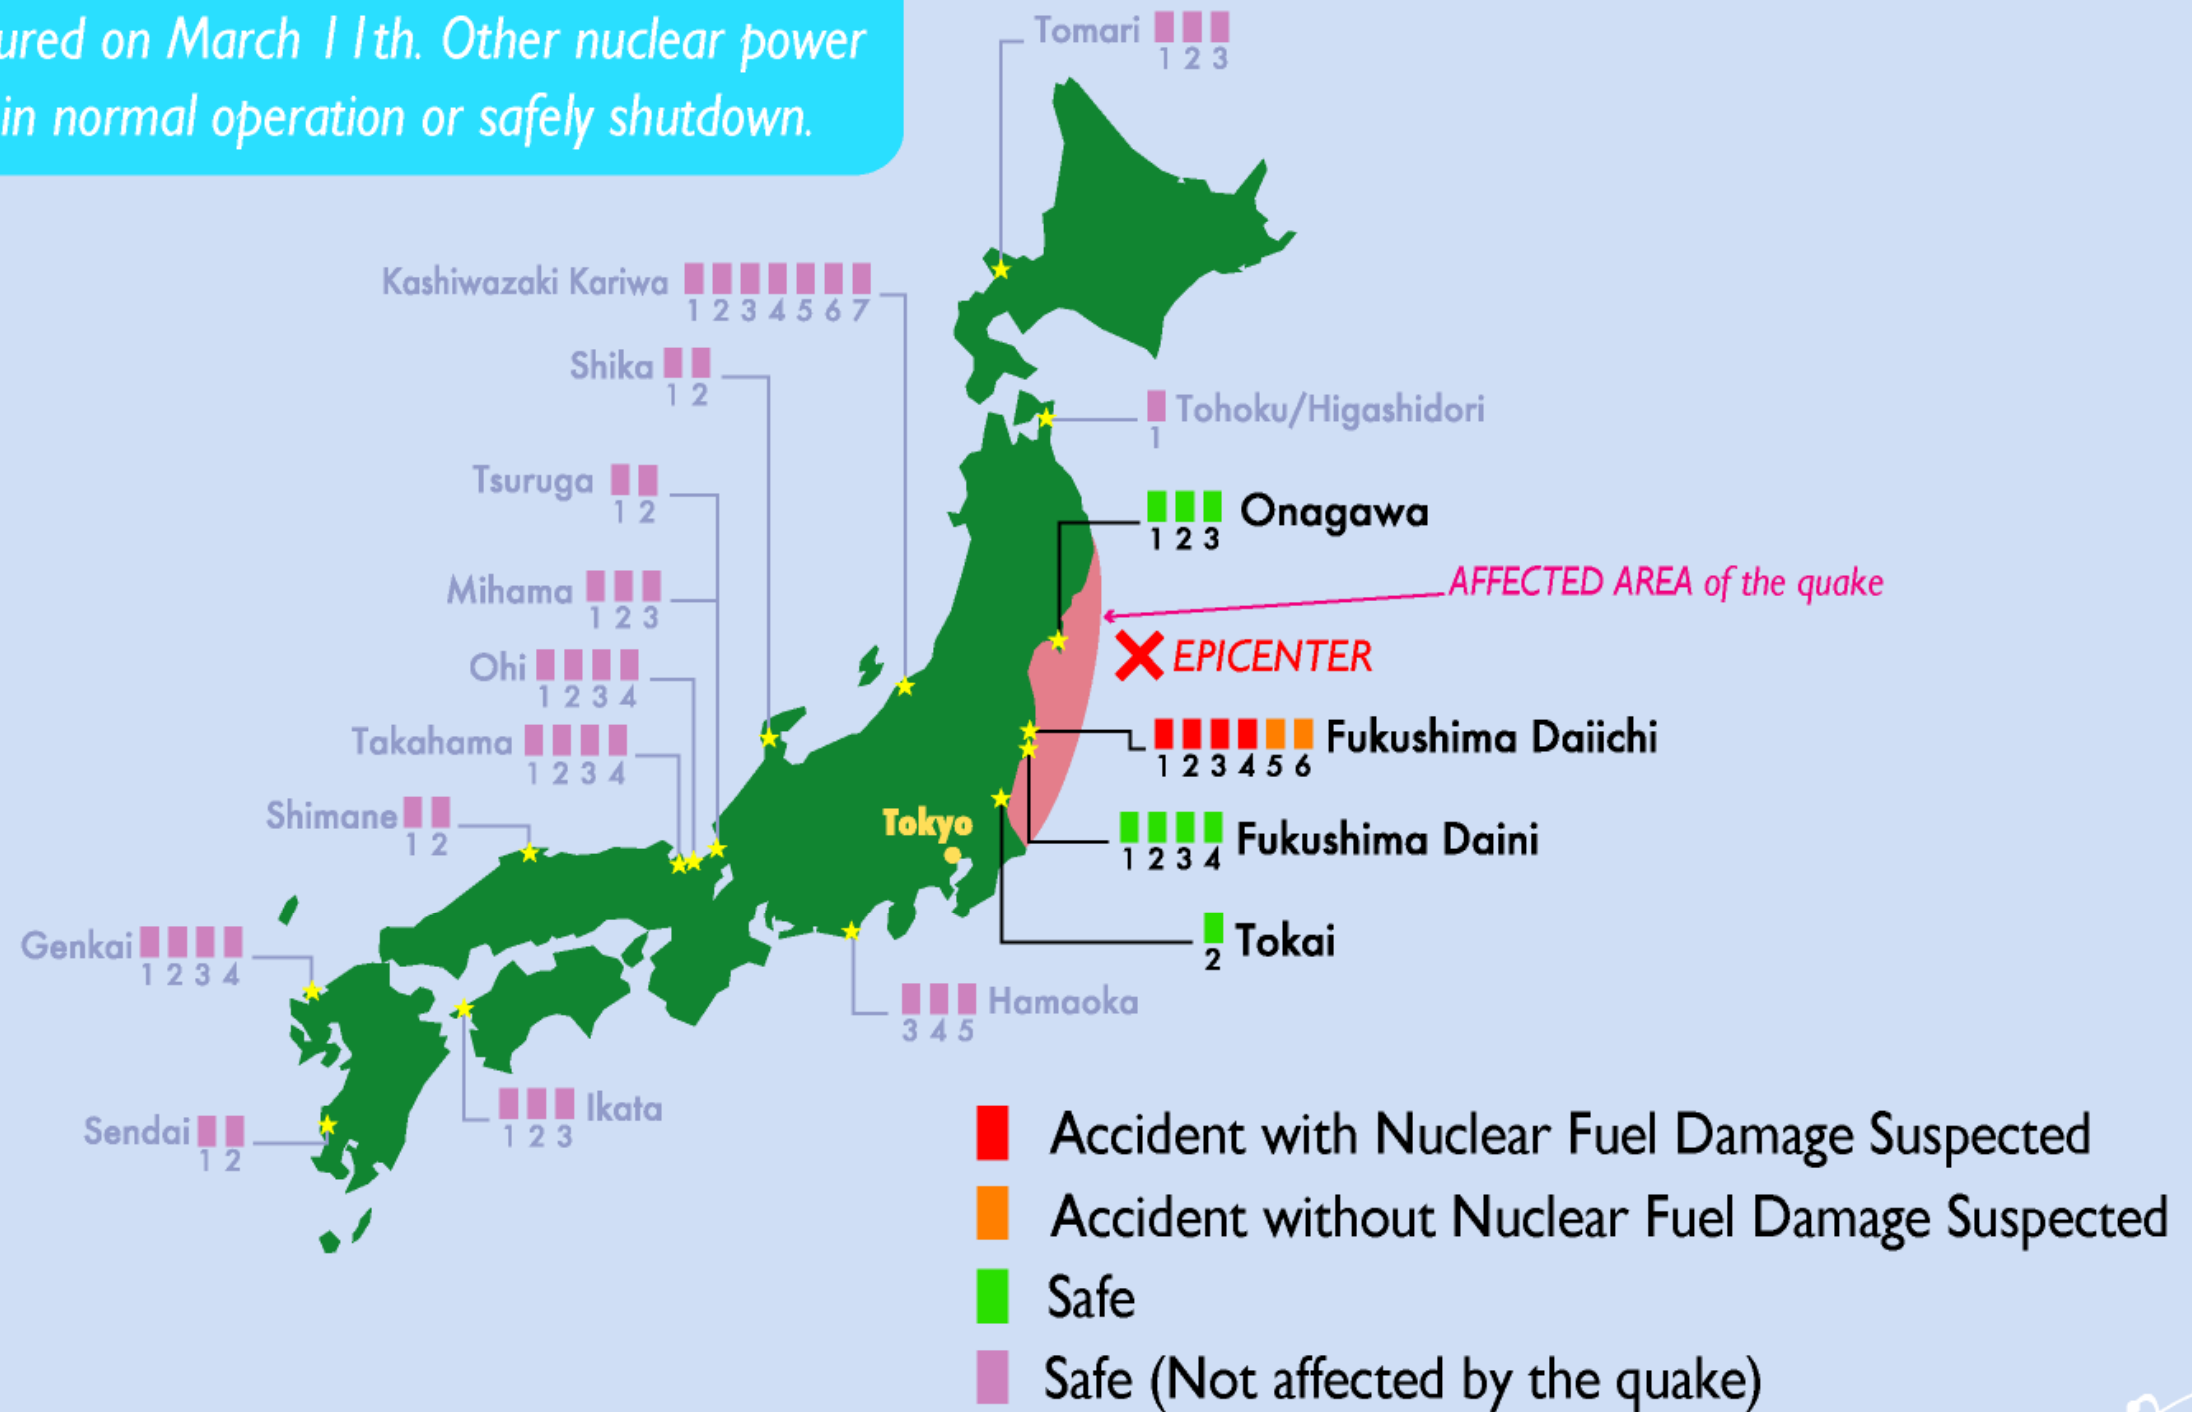
Status of the Nuclear Power Plants after the Earthquake

The accident that brings environmental impact is going on at several units in Fukushima Daiichi nuclear power Station after the earthquake occurred on March 11th. Other nuclear power plants in Japan are in normal operation or safely shutdown.
