Information on Status of Nuclear Power Plants in Fukushima

Japan Atomic Industrial Forum, Inc.

Status of nuclear power plants in Fukushima as of 20:00, April 19th (Estimated by JAIF)

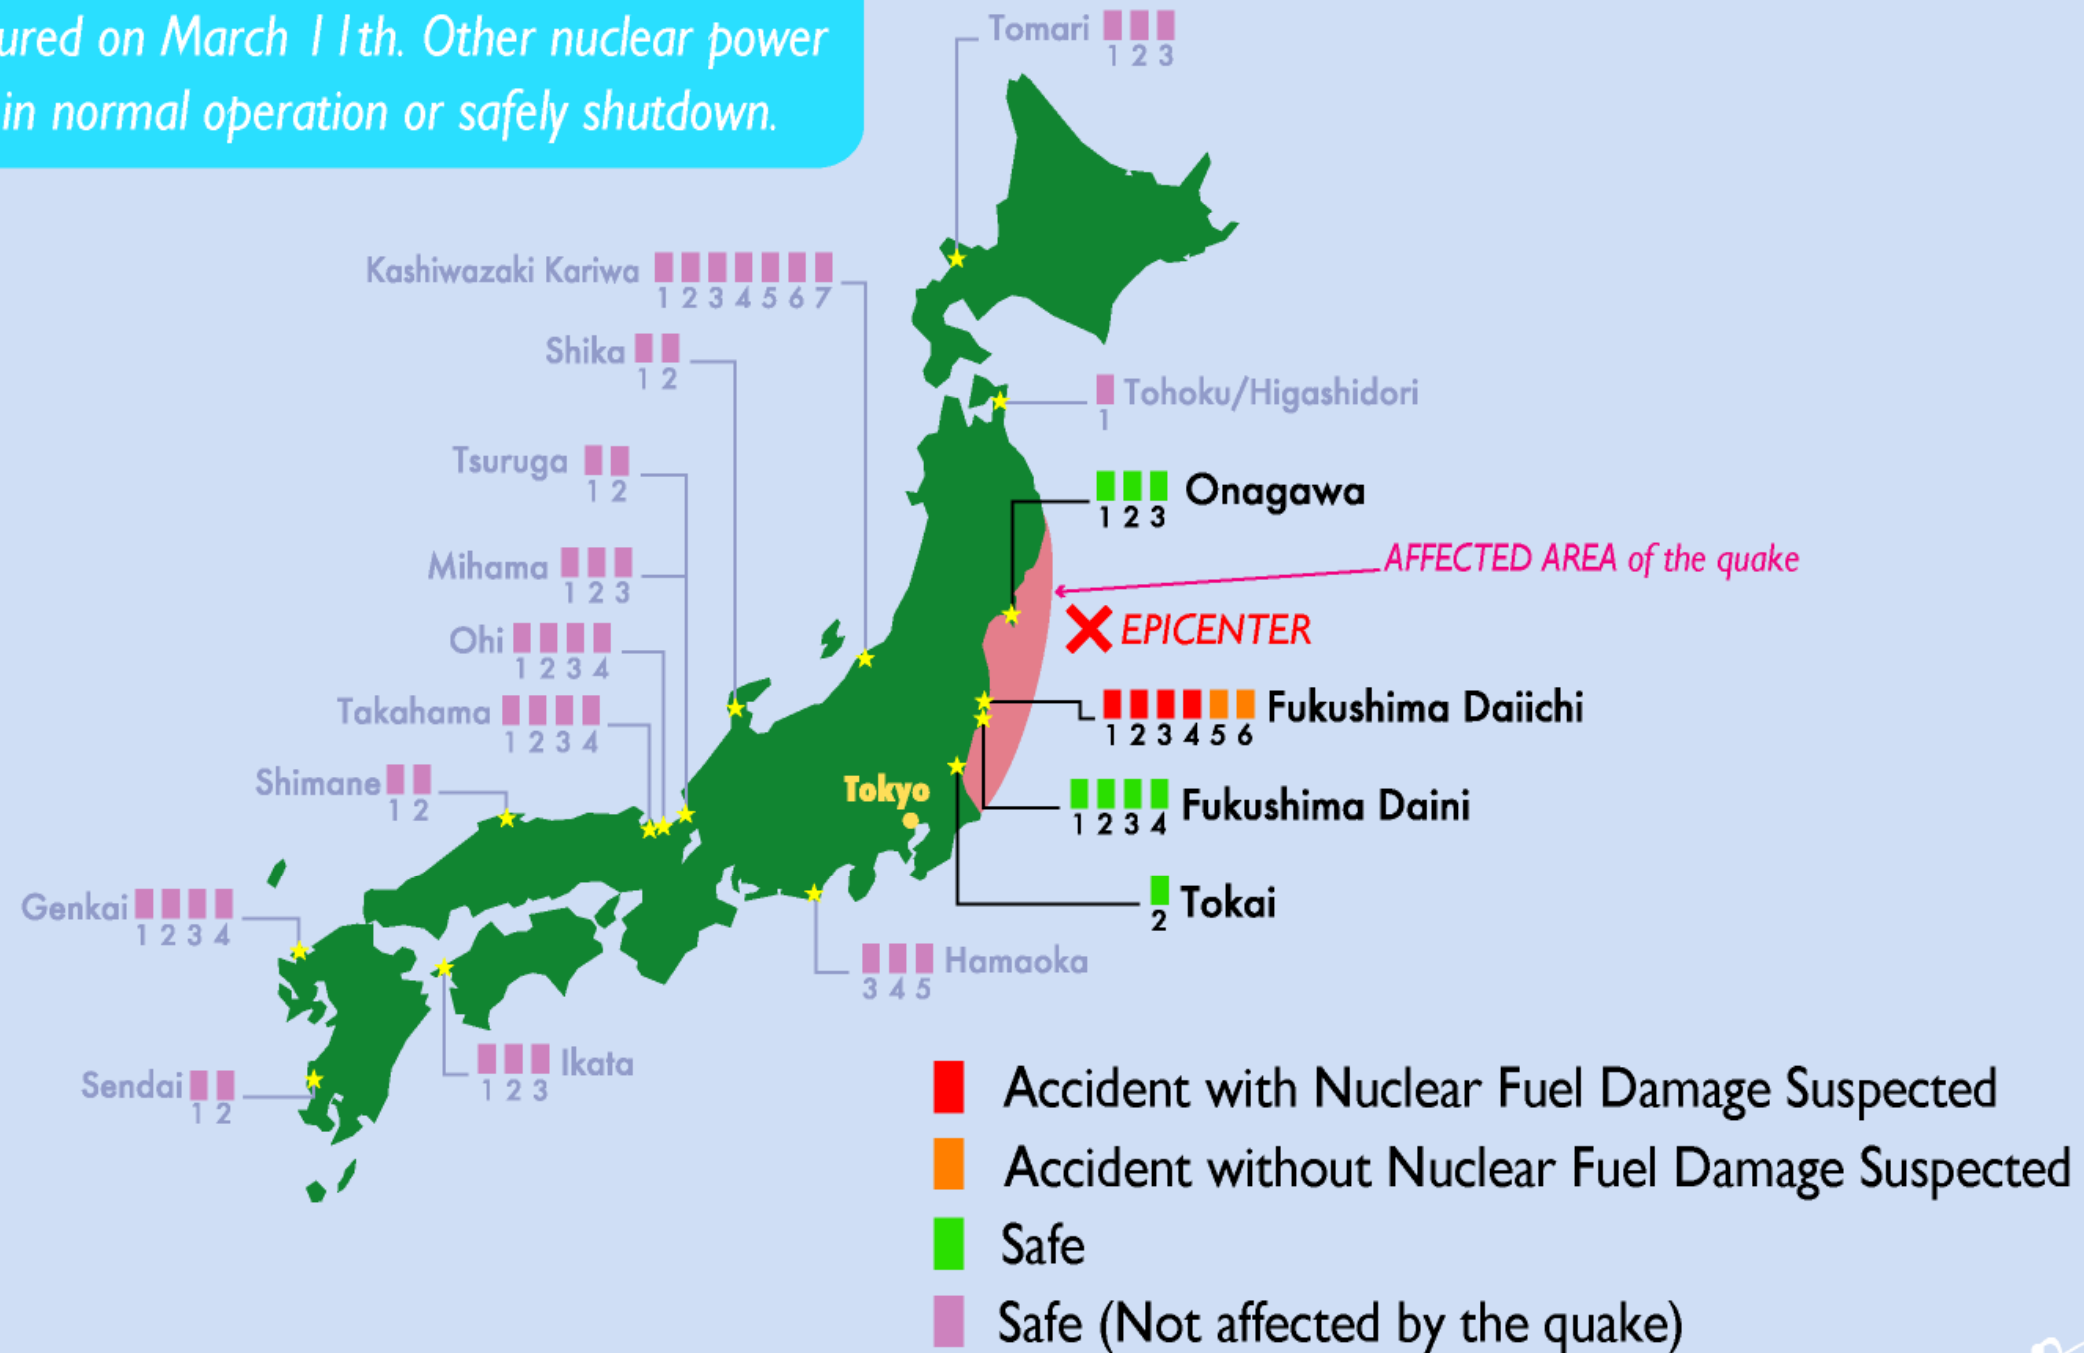
Status of the Nuclear Power Plants after the Earthquake

The accident that brings environmental impact is going on at several units in Fukushima Daiichi nuclear power Station after the earthquake occurred on March 11th. Other nuclear power plants in Japan are in normal operation or safely shutdown.
