Information on Status of Nuclear Power Plants in Fukushima

Japan Atomic Industrial Forum, Inc.

Status of nuclear power plants in Fukushima as of 18:00, April 17th (Estimated by JAIF)

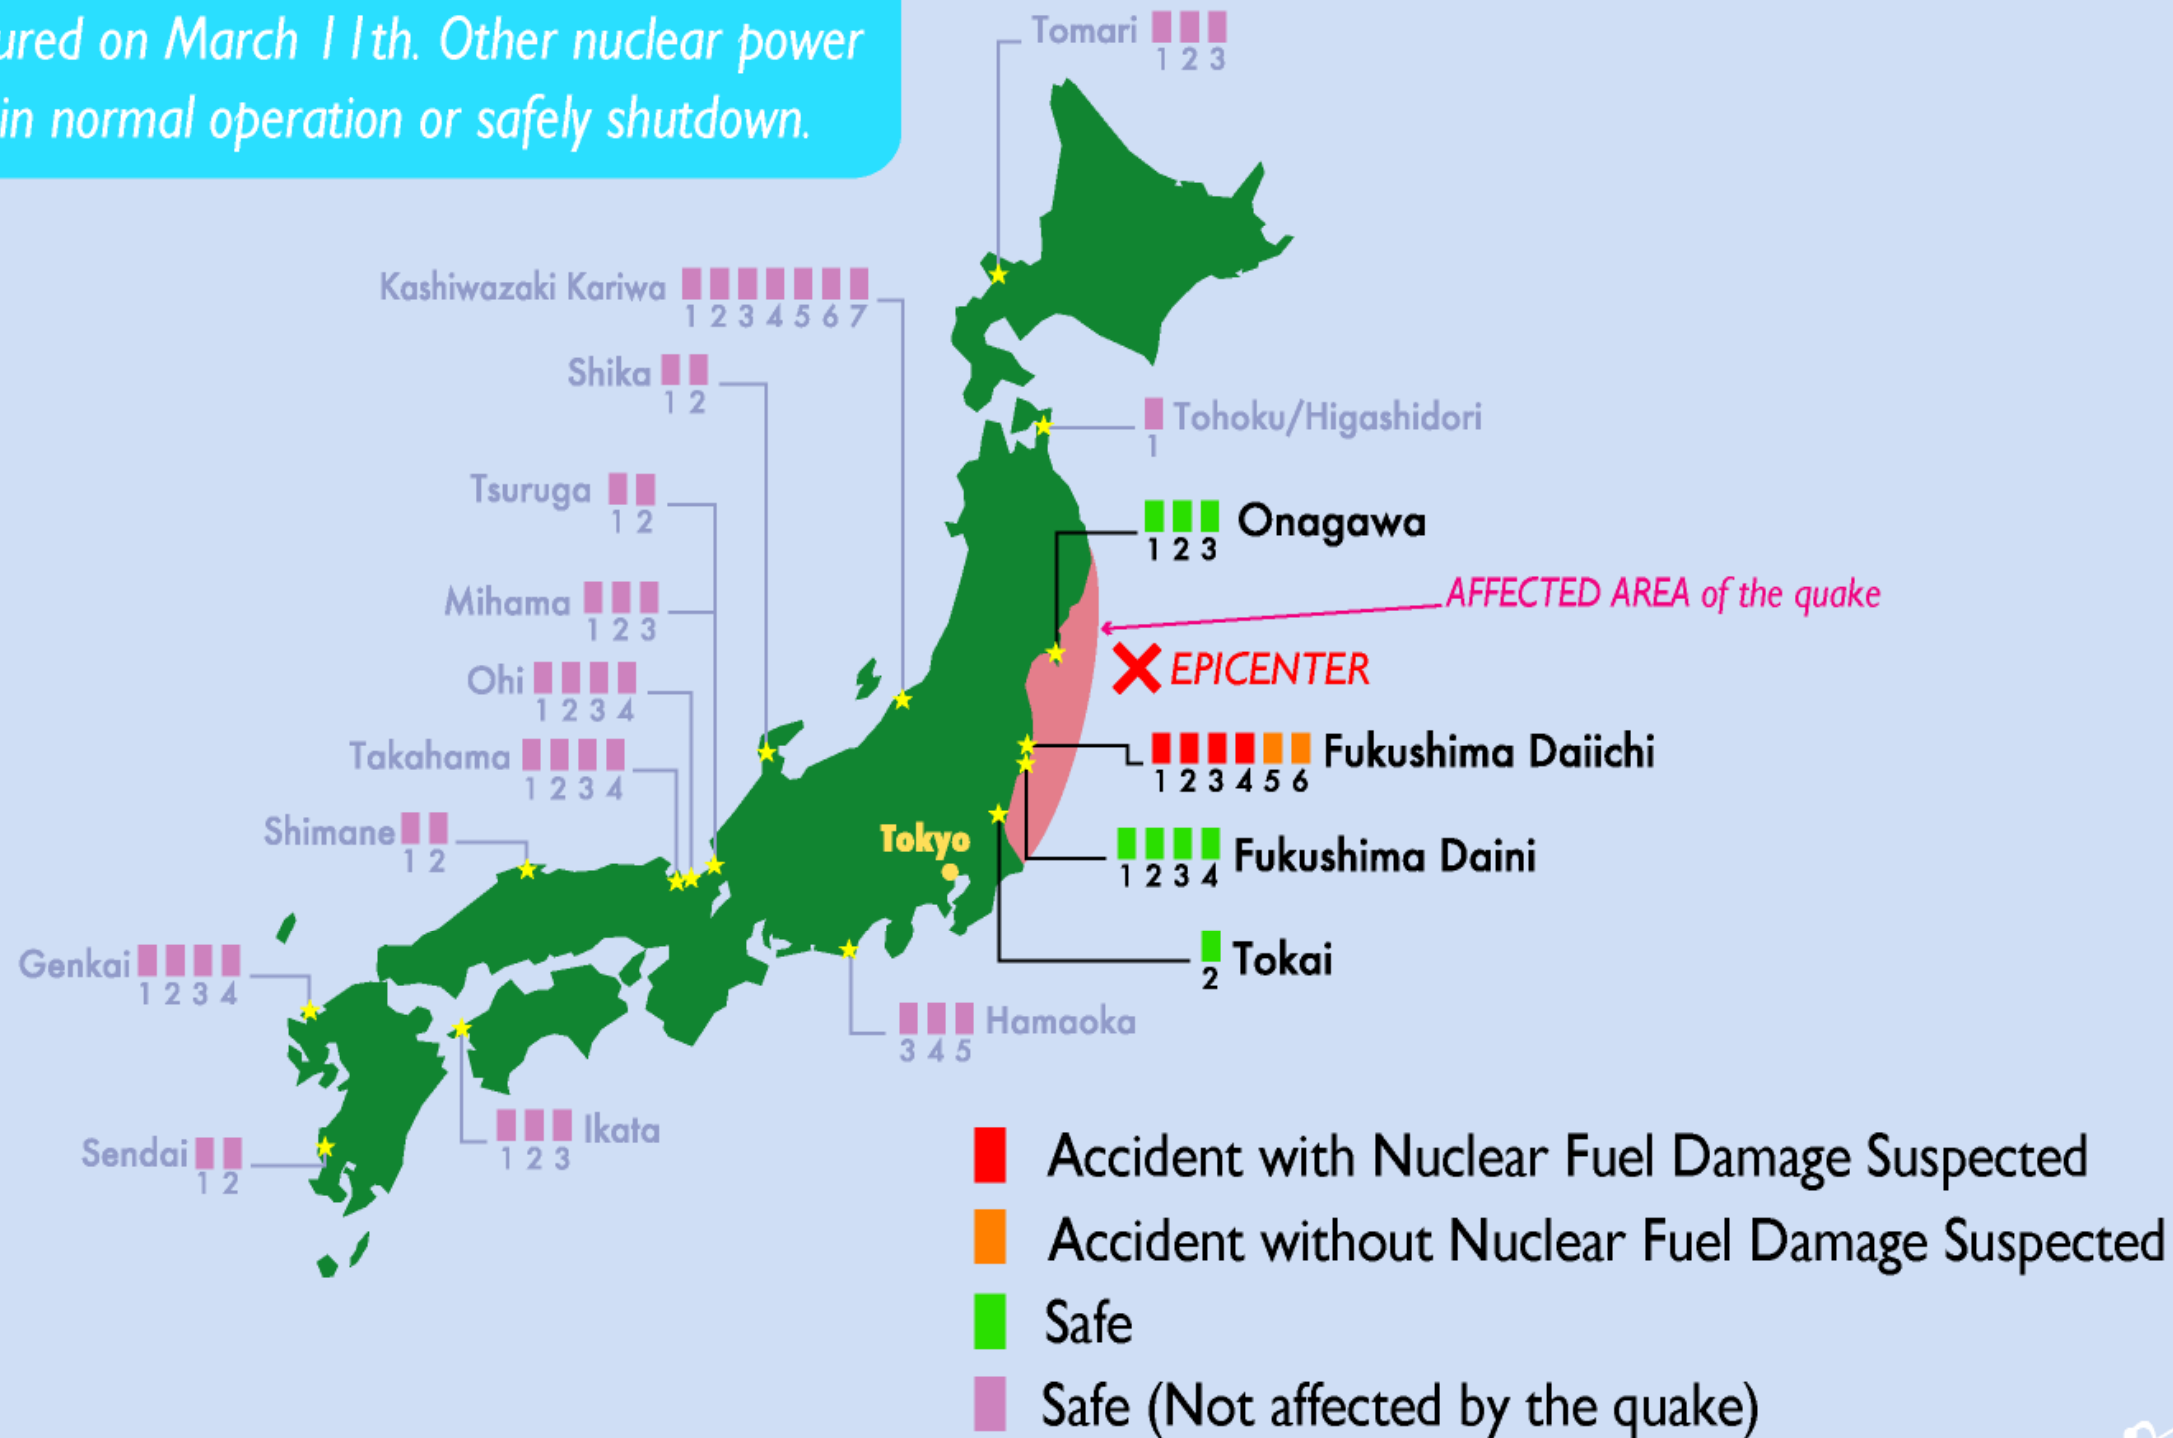
Status of the Nuclear Power Plants after the Earthquake

The accident that brings environmental impact is going on at several units in Fukushima Daiichi nuclear power Station after the earthquake occurred on March 11th. Other nuclear power plants in Japan are in normal operation or safely shutdown.
