Information on Status of Nuclear Power Plants in Fukushima

Japan Atomic Industrial Forum, Inc.

Status of nuclear power plants in Fukushima as of 12:00, May 2nd (Estimated by JAIF)

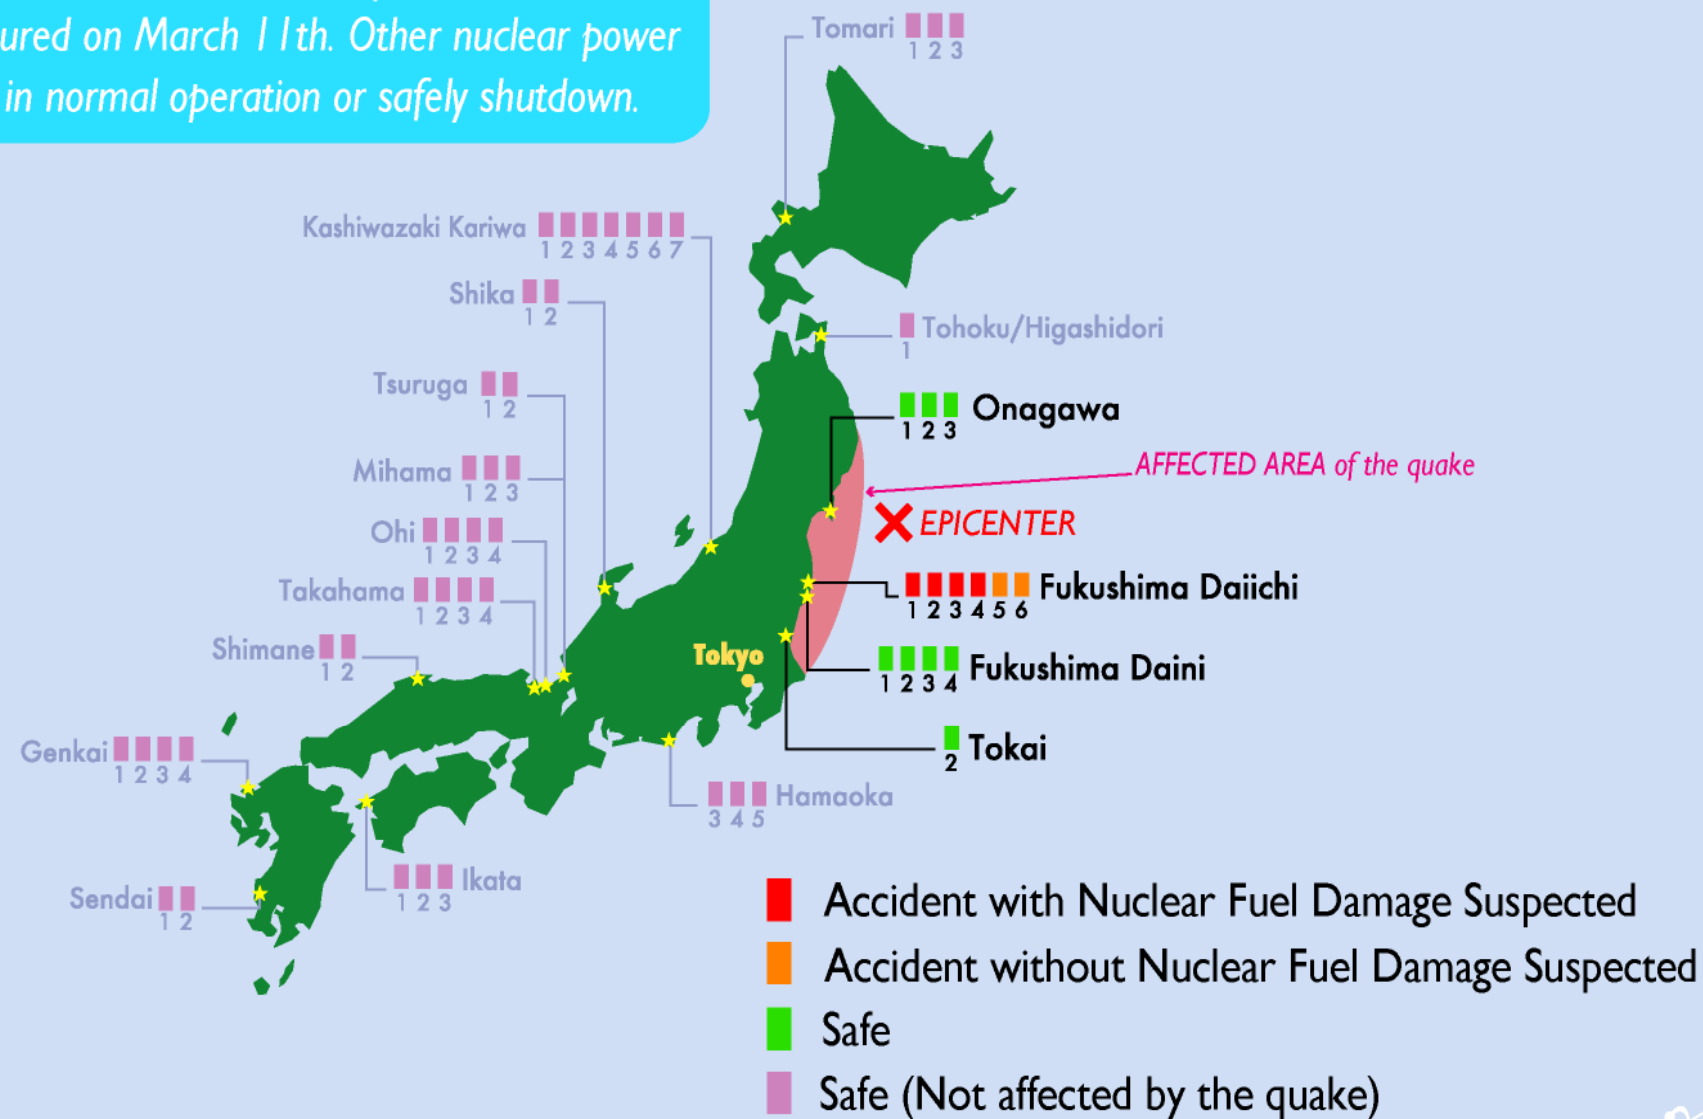
Status of the Nuclear Power Plants after the Earthquake

The accident that brings environmental impact is going on at several units in Fukushima Daiichi nuclear power Station after the earthquake occurred on March 11th. Other nuclear power plants in Japan are in normal operation or safely shutdown.
