Information on Status of Nuclear Power Plants in Fukushima

Japan Atomic Industrial Forum, Inc.

Status of nuclear power plants in Fukushima as of 12:00, May 4th (Estimated by JAIF)

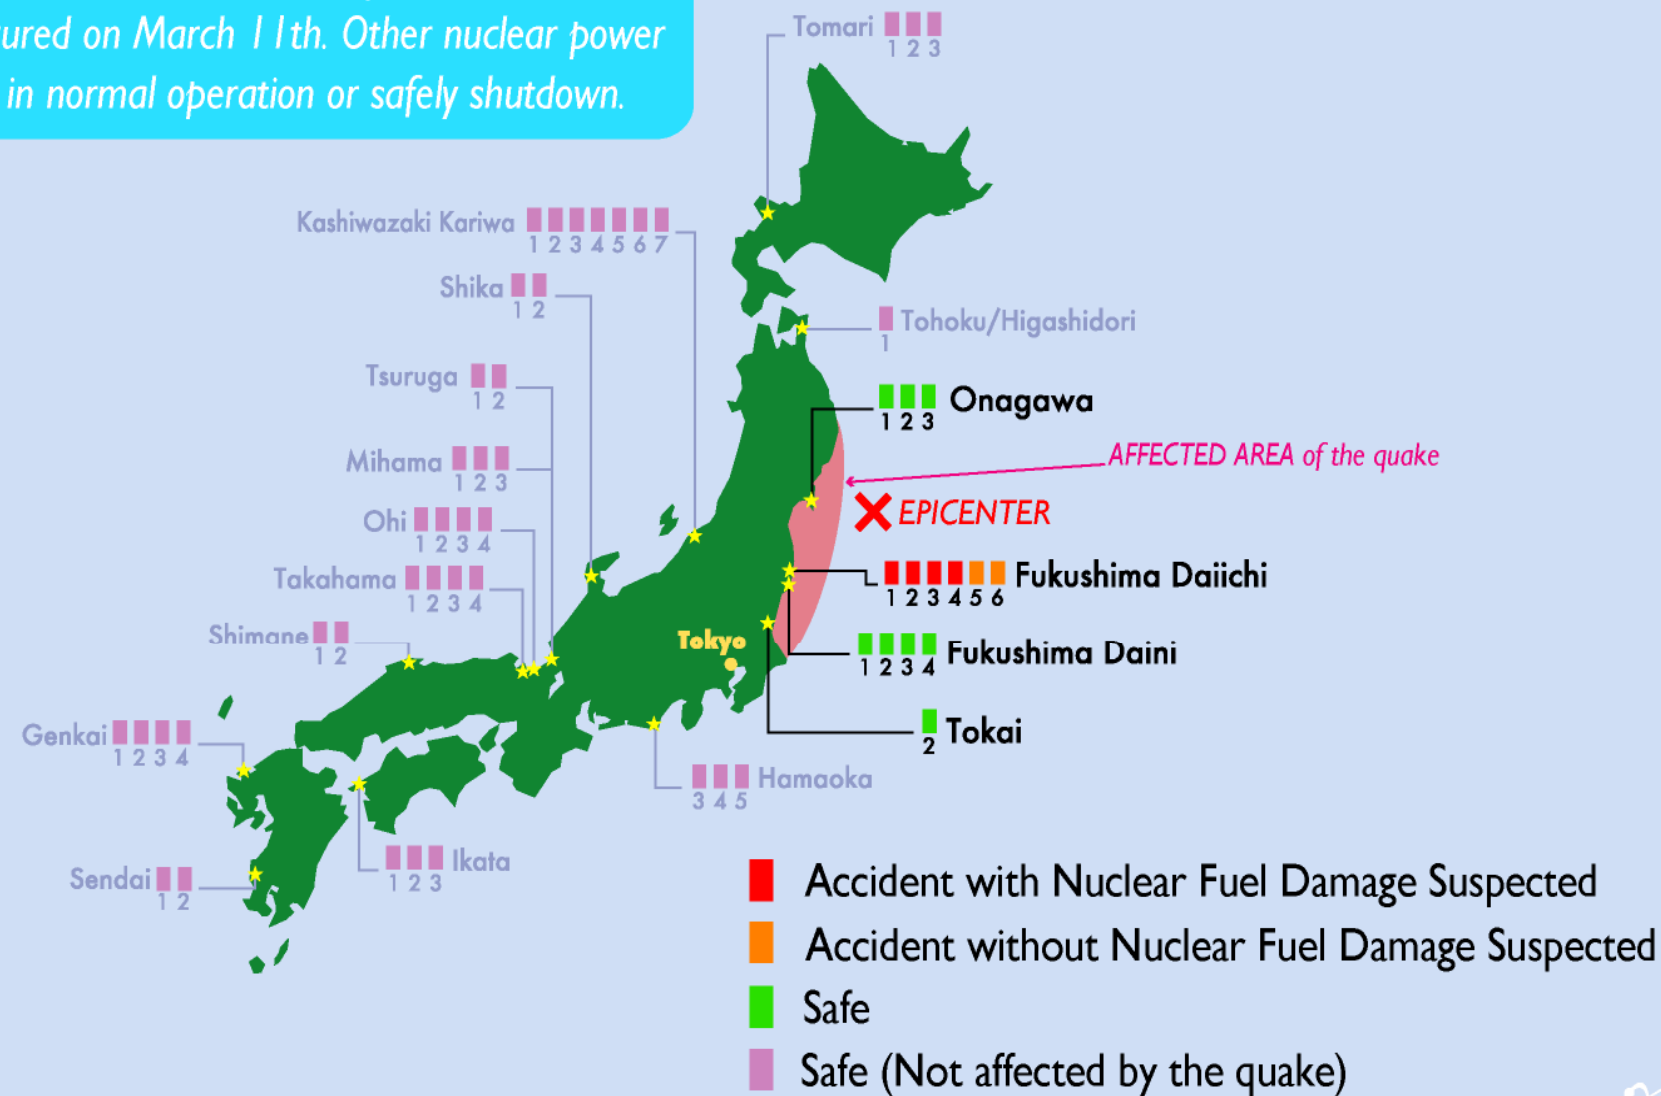
Status of the Nuclear Power Plants after the Earthquake

The accident that brings environmental impact is going on at several units in Fukushima Daiichi nuclear power Station after the earthquake occurred on March 11th. Other nuclear power plants in Japan are in normal operation or safely shutdown.
