Information on Status of Nuclear Power Plants in Fukushima

Japan Atomic Industrial Forum, Inc.

Status of nuclear power plants in Fukushima as of 12:00, May 5th (Estimated by JAIF)

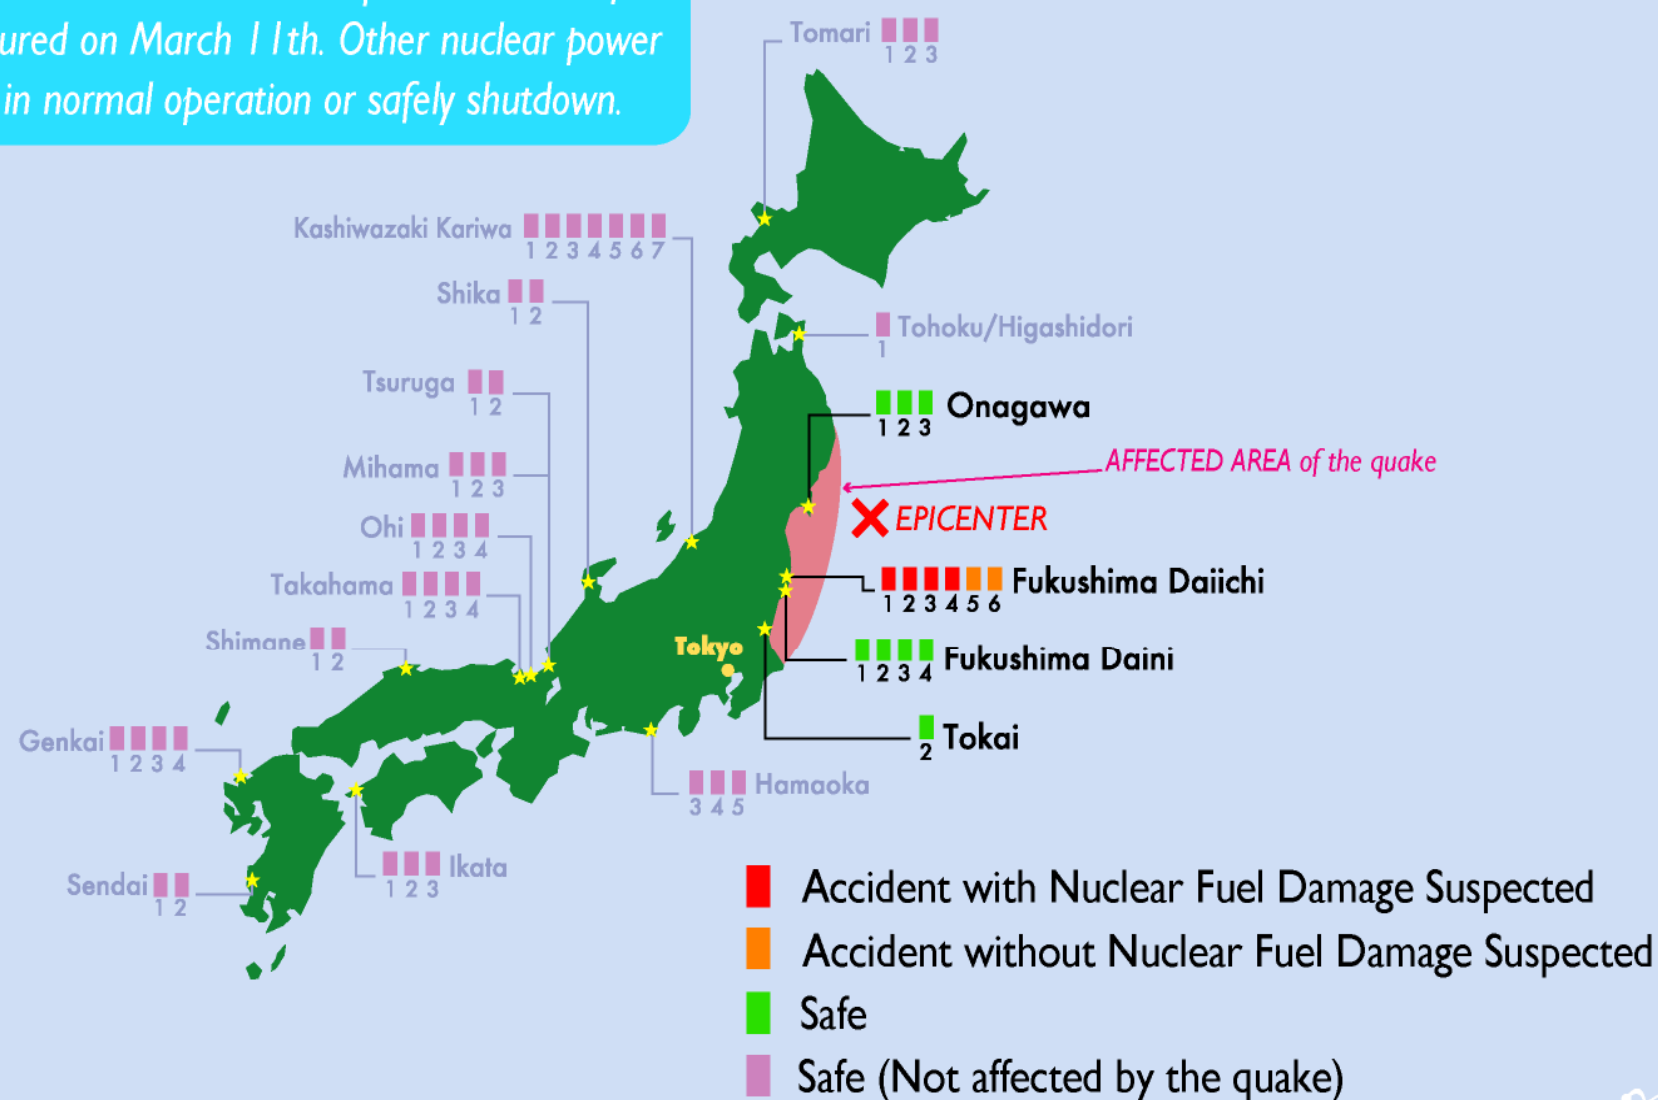
Status of the Nuclear Power Plants after the Earthquake

The accident that brings environmental impact is going on at several units in Fukushima Daiichi nuclear power Station after the earthquake occurred on March 11th. Other nuclear power plants in Japan are in normal operation or safely shutdown.
