Information on Status of Nuclear Power Plants in Fukushima

Japan Atomic Industrial Forum, Inc.

Status of nuclear power plants in Fukushima as of 12:00, May 7th (Estimated by JAIF)

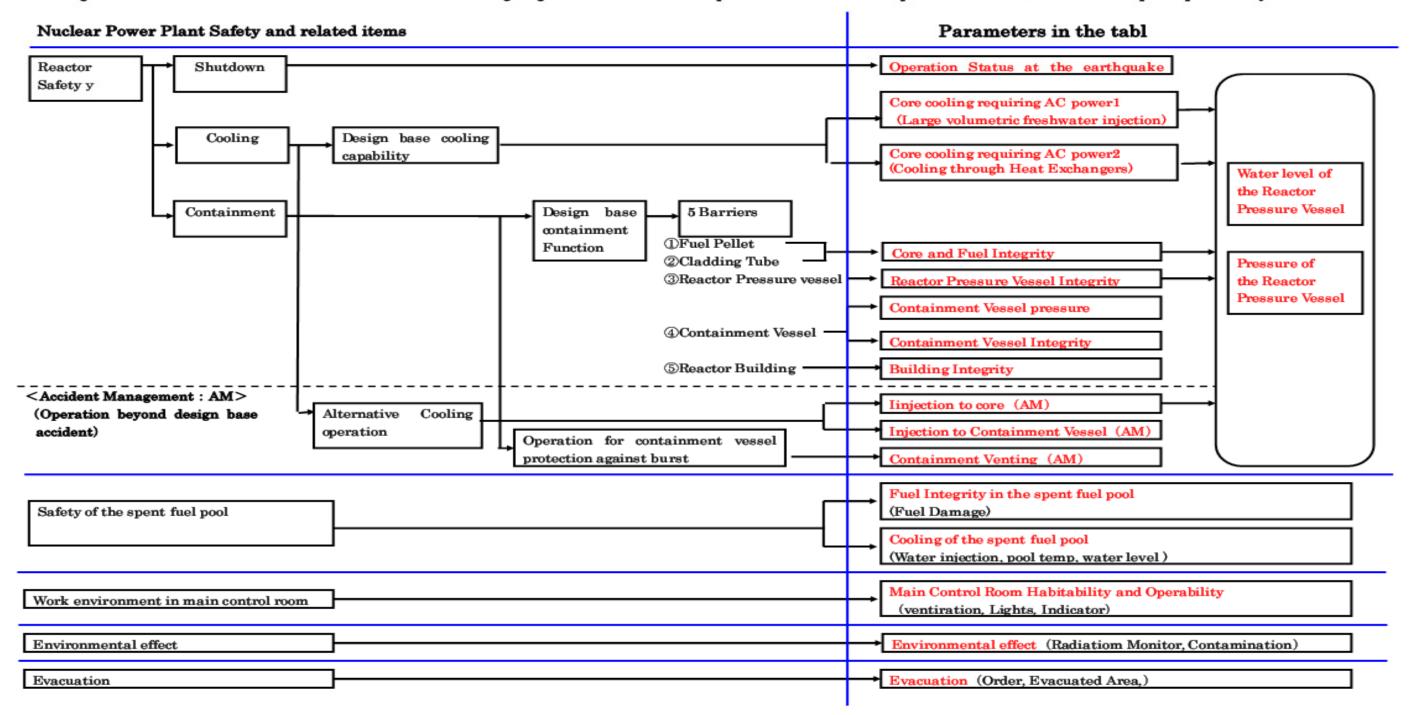
Parameters in the Table

JAIF picks up these parameters to evaluate safety condition of the nuclear plants during this accident from the view point of the principles of nuclear power plant safety, which are "Shutdown", "Cooling" and "Containment". Then we create the chart. The following diagram is to show the correspondence relation of these parameters in the table to nuclear power plant safety.
