# Information on Status of Nuclear Power Plants in Fukushima

Japan Atomic Industrial Forum, Inc.

**Status of nuclear power plants in Fukushima as of 12:00, May 9th (Estimated by JAIF)**

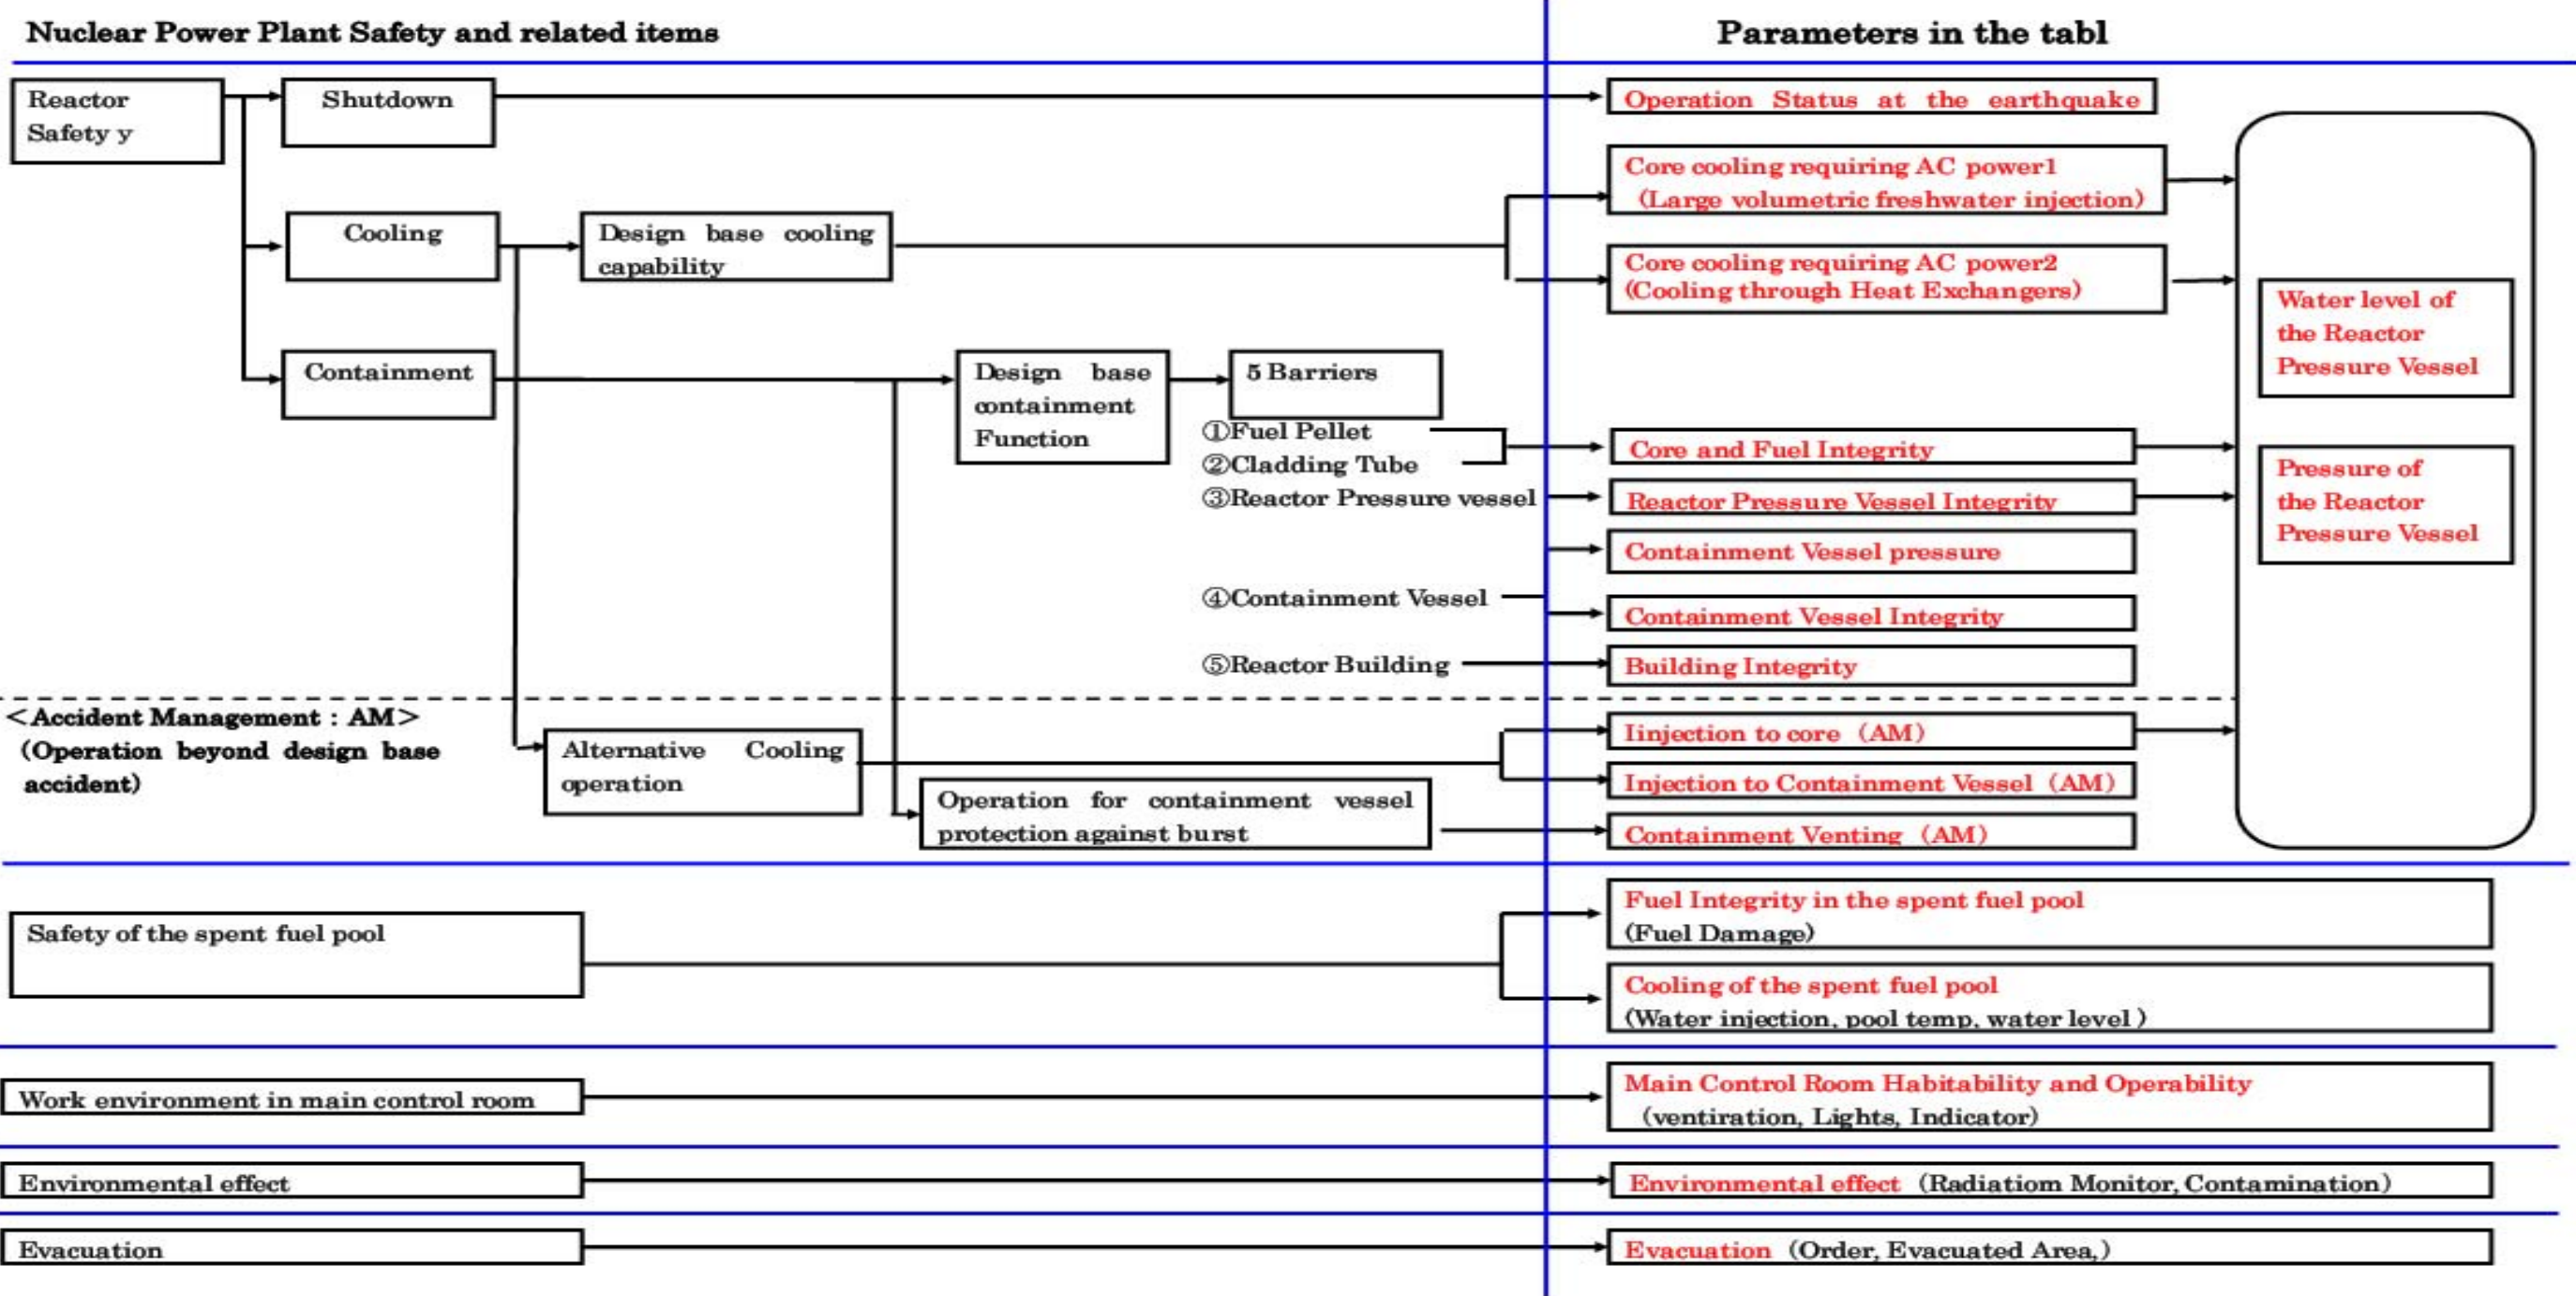
JAIF picks up these parameters to evaluate safety condition of the nuclear plants during this accident from the view point of the principles of nuclear power plant safety, which are "Shutdown", "Cooling" and "Containment". Then we create the chart. The following diagram is to show the correspondence relation of these parameters in the table to nuclear power plant safety.
